## **LAMINATED SAFETY GLASING** (SOME EXPERIENCES WITH WINDOWS AND WINDSCREENS IN BUS ROLLOVERS)

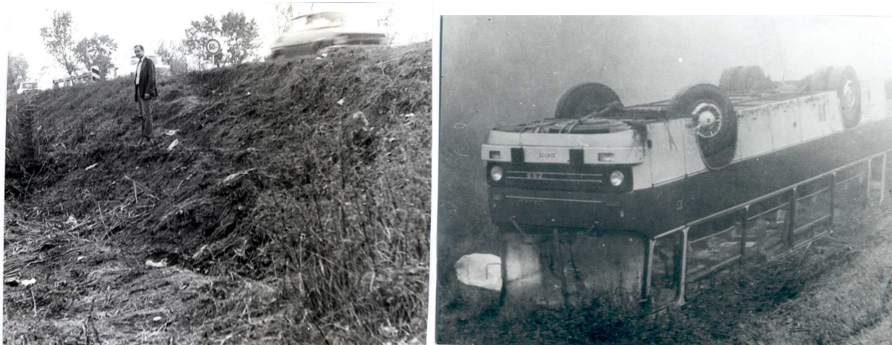
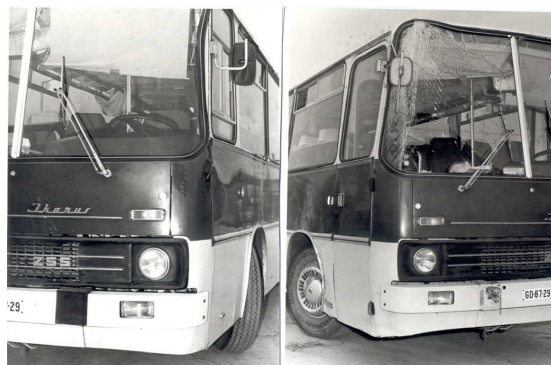
### 3.1. Real rollover accident

- Class III. 11 m. Strong, approved superstructure
- ½ rotation (stop on its roof), no significant structural deformation. Soft, grassy ground.
- two-part windscreen, laminated safety glass built in rubber profile. One side cracked, but did not drop out.
- Side windows (toughened safety glass) in rubber profile did not break or drop out.

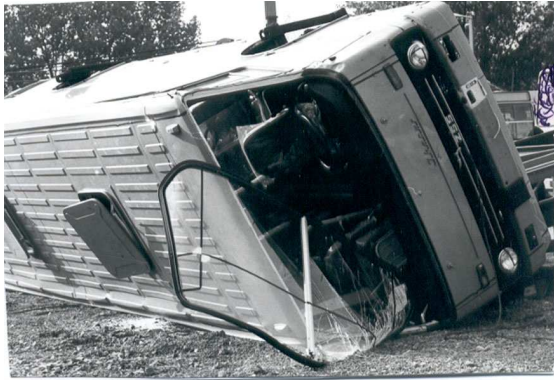
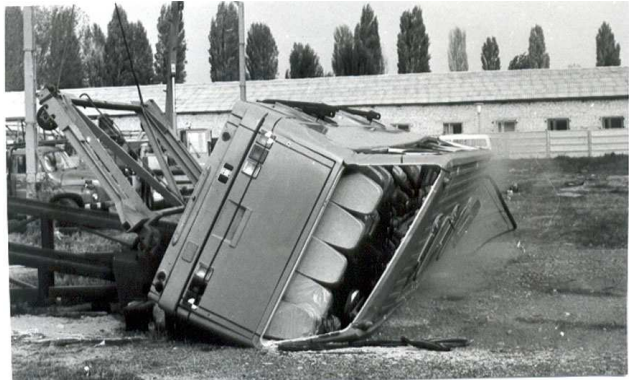
### 3.2. Rollover test (depth of the ditch was 1 m)

- The same vehicle shown in 3.1. but not approved yet, the superstructure before the final reinforcement.
- Large scale structural deformation, the residual space was harmed
- The windscreen (laminated glass) built in rubber profile fell out and cracked at the corner of the impacted cantrail.
- The rear window (toughened safety glass) built in rubber profile dropped out and broke.
- The side windows (also in rubber profile) were broken.

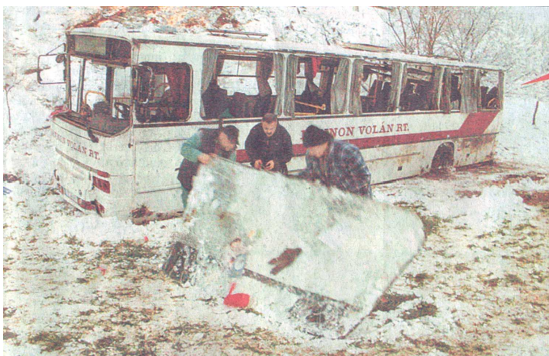
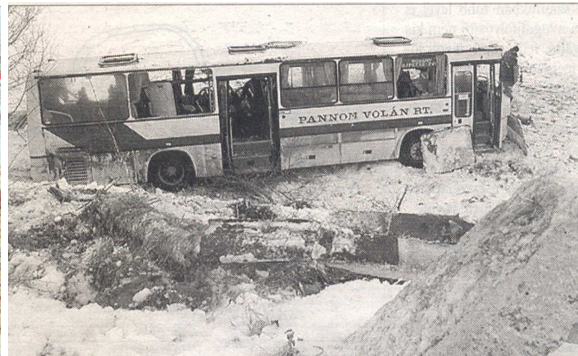
### 3.3. Real rollover accident

- Class II. Vehicle, 11 m, strong, approved superstructure
- Rolling down on a slope, 2 ¼ rotations, 9-10 m level difference
- Same superstructure as in 3.1.
- No significant structural deformation
- Laminated windscreen in rubber profile, cracked and dropped out.
- Side windows (toughened safety glass) in rubber profile, on the impacted side all windows were broken, but on the right side only two windows.

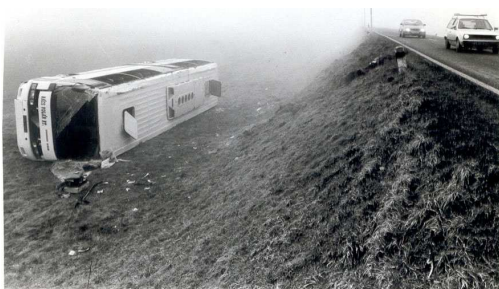
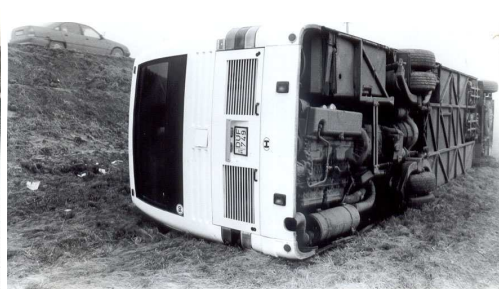
### 3.4. Real rollover accident

- Class III, 12 m Strong, approved superstructure
- $\frac{3}{4}$  rotation on a slope, no significant structural deformation. The ground was soft, grassy, blunted dynamic impact forces.
- Glued laminated safety glass windscreen cracked and it was broken out for emergency exit. (At the upper edge of the windscreen the overlapping for the gluing is rather narrow)
- Glued side windows were broken, but not all of them
- The glued rear window did not break

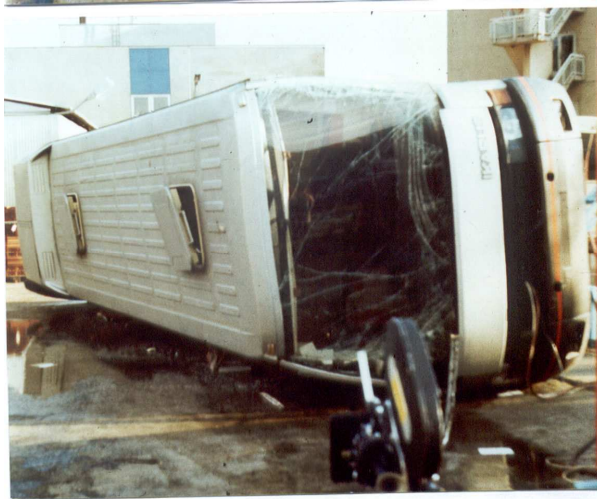
### 3.5. Rollover approval test

- Same vehicle as shown in 3.4.
- Small structural deformation, the residual space remained intact.
- Glued windscreen (laminated glass) cracked but remained in its place
- Some of the glued side windows were broken but not all.
- The glued rear window did not break.

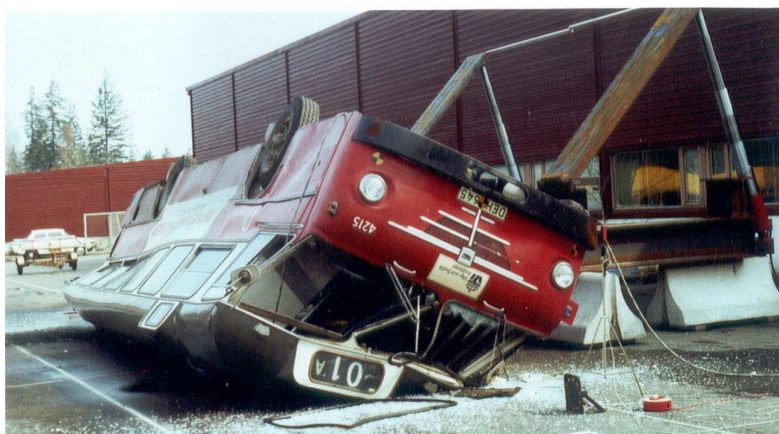
### 3.6. Rollover test (depth of the ditch was 1,4 m)

- Class I. vehicle, 11 m
- Large scale structural deformation, the residual space was harmed
- All the glasses were toughened safety glass built in rubber profile
- The windscreen dropped out and broke
- The side windows on the impact side were broken, but on the other side they did not break or fell out.

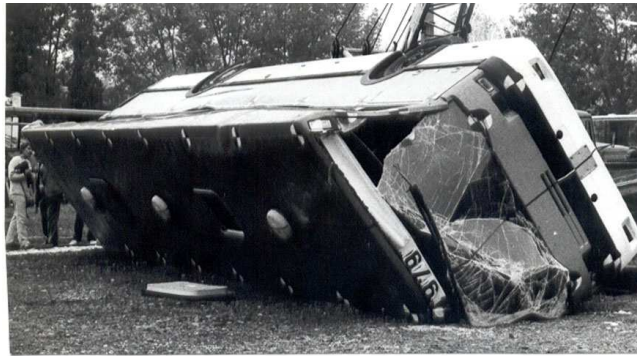
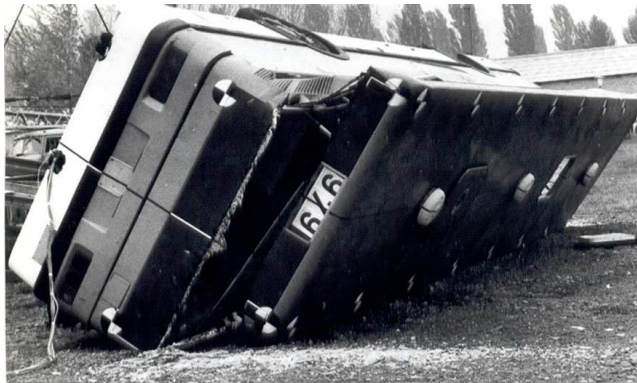
### 3.7. Rollover test (depth of the ditch was 1 m)

- Class I. and II. 11,4 m
- Large scale structural deformation, the residual space was harmed.
- All the glasses were glued.
- The windscreen (laminated glass) was cracked and broken but generally it remained in its place. It was glued to an auxiliary frame (profile) which was separated from the main frame.
- The rear windows was completely broken
- Some of the side windows were cracked or partially broken, but most of them survived.

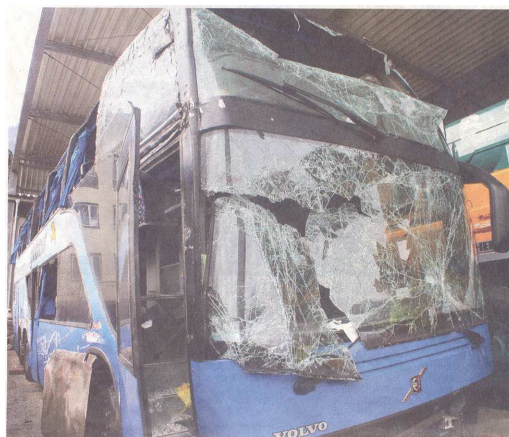
### 3.8. Real rollover accident

- DD coach, tip over (Austria, 2006)
- Both windscreens (upper and lower) glued laminated safety glass, cracked but did not drop out. The upper one probably was “opened” for emergency exit.
- Slight deformation of the upper superstructure, all side windows were broken out.

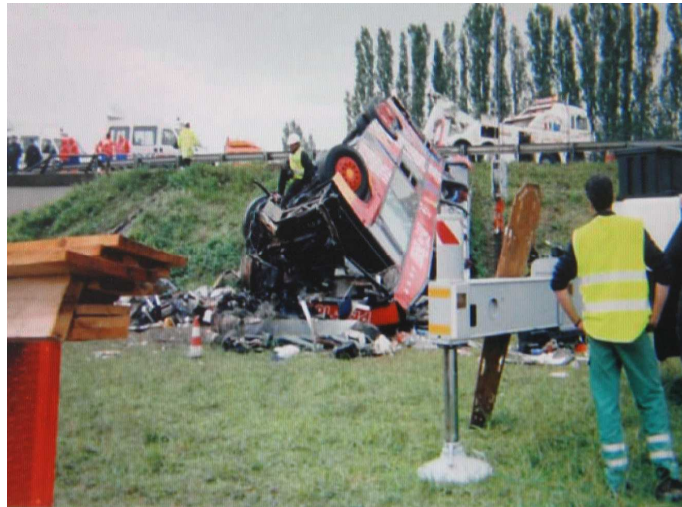
### 3.9. Real rollover accident (after frontal collision)

- DD coach, rollover
- Upper superstructure collapsed, all upper side windows were broken out.
- Lower side windows remained in their place, one was broken out probably for emergency exit.

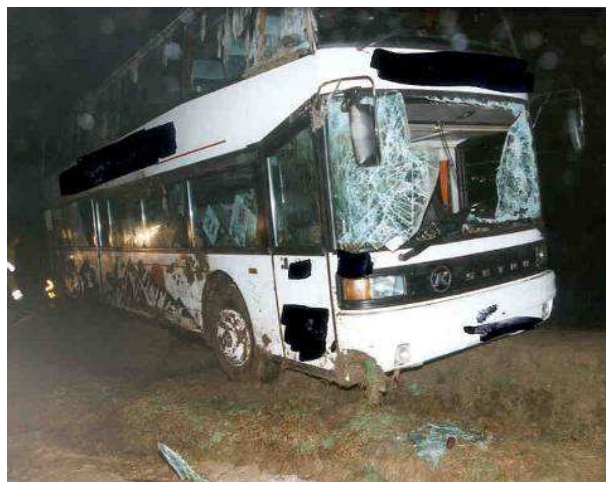
### 3.10. Real rollover (tip over) accident

- DD coach, turned on its side
- The glued lower windscreen was cracked and “opened” probably for emergency exit.
- No structural deformation, the glued side windows remained intact.

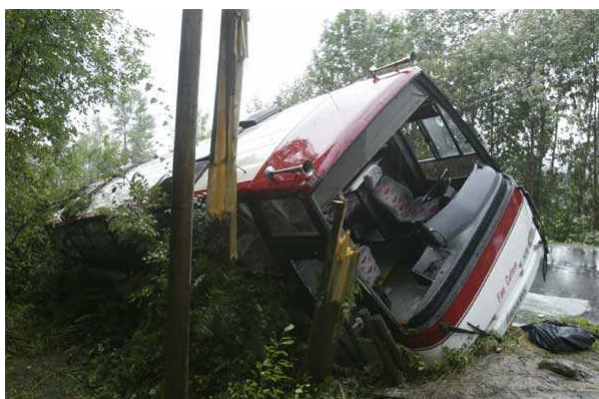
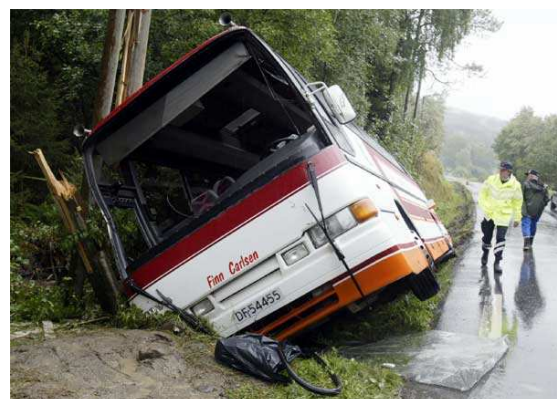
### 3.11. Real “rollover” accident

- Class III. vehicle
- The windscreen (laminated safety glass) built in rubber profile. It dropped out, fall down, cracked but remained in one piece.

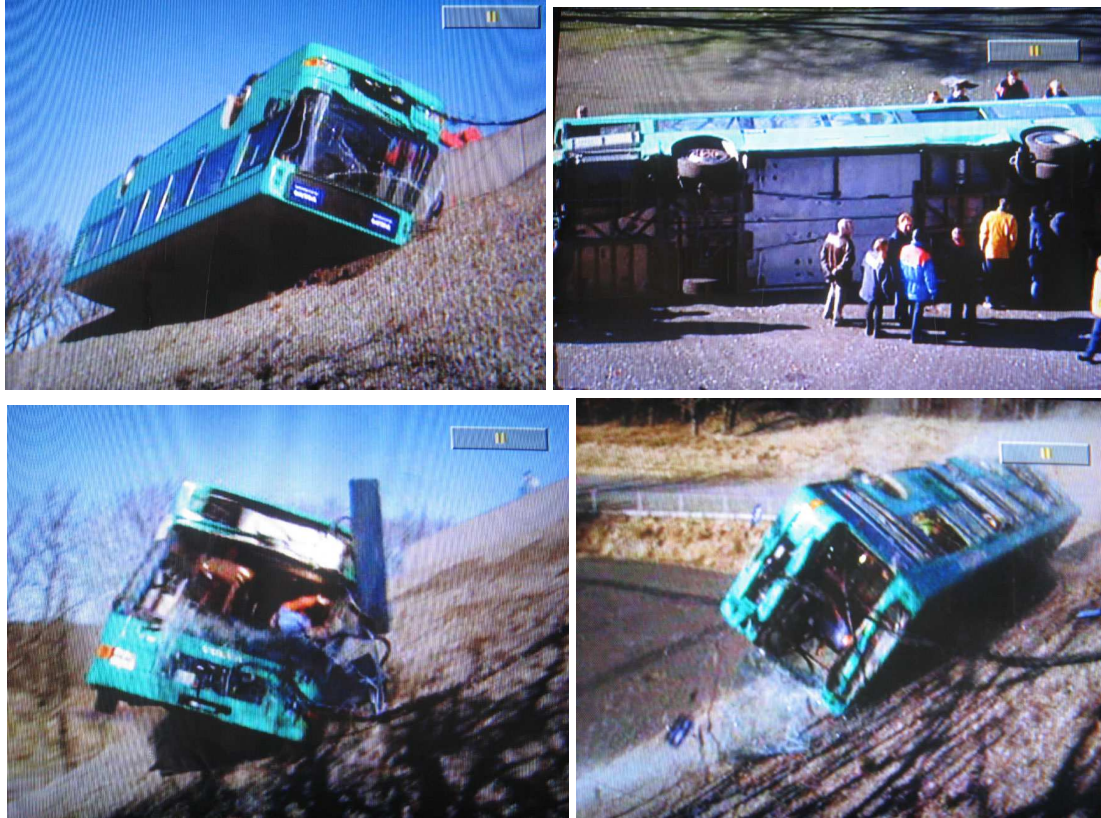
### 3.12. Rollover tests (very severe one made by VOLVO)

- Class I. low floor vehicle, strong, approved superstructure
- Rollover on a slope, 3 ¼ rotations, 18-20 m level difference. The ground was hard, stony, strong dynamic impact forces.
- Laminated windscreen built in rubber profile. After the first impact it started to fall out as one unit. After the second impact it left completely its bed.
- One of the glued side windows (toughened safety glass) was broken out (on the left side), the others remained intact after 3 ¼ rotations.
- The side window of the driver's cab – in a special frame – dropped out and broke in the first rotations.
