Tanks: United Kingdom experience with improperly manufactured and wrongly certificated road tank vehicles

Presentation on Petroleum road fuel tankers: construction issues and research into tanker integrity

Transmitted by the Government of United Kingdom

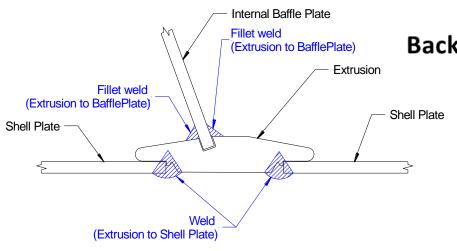
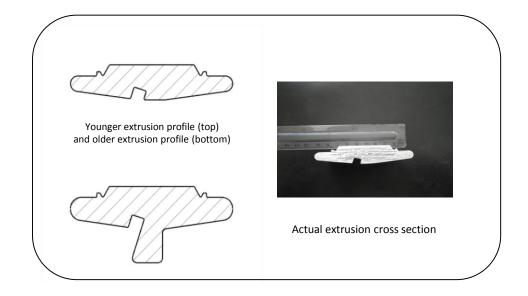
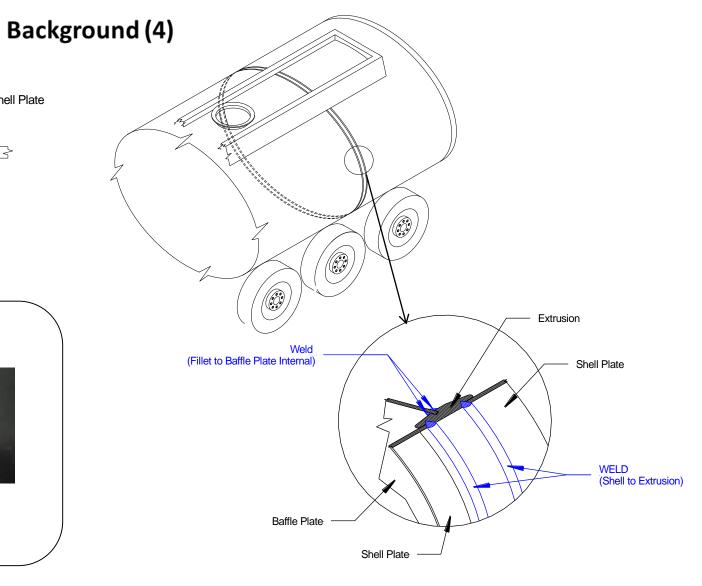
- Radiography not completed in accordance with ADR ADR requires radiography
 of all "tee" junctions and not less than 10% of the total length of all longitudinal,
 circumferential and radial welds [ADR 6.8.2.1.23]
- Some tankers radiographed by operators and circumferential welds seen to contain numerous and extensive indications typical of lack of fusion defects – samples taken by HSE and the defects confirmed

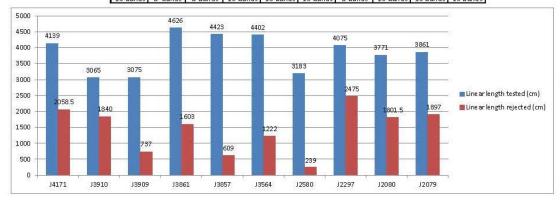
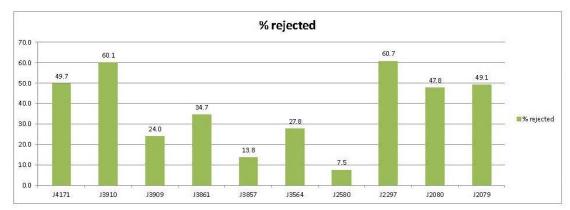
Radiography results for circumferential welds on a sample of ten tankers

Linear length tested vs linear defect length

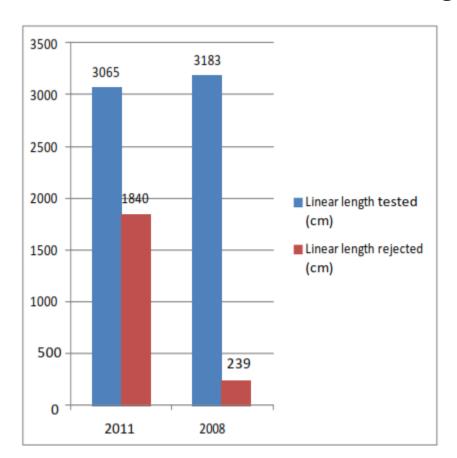
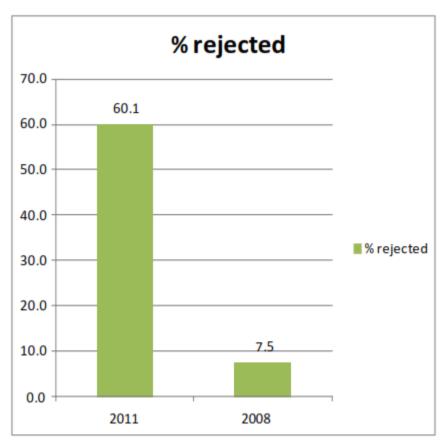
Circumferential welds on two tankers selected from a sample of ten

Linear length tested vs linear defect length

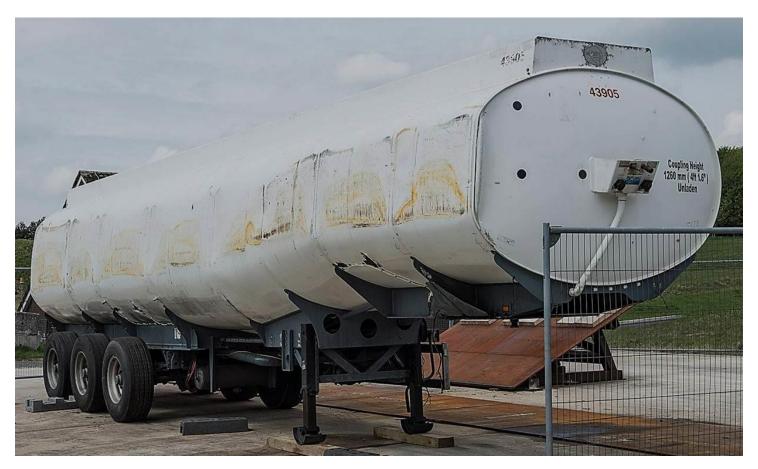
2008 tanker – impact damage

- 2008 tanker all compartments lost integrity
- 2011 tanker integrity lost between compartments 1 and 2 and between compartments 4 and 5

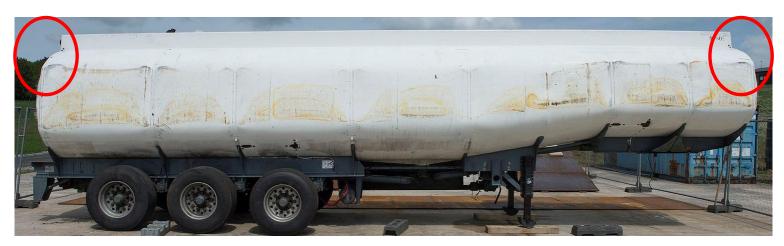
2008 tanker – leak at rear Top of impact zone 2011 tanker – leak at front

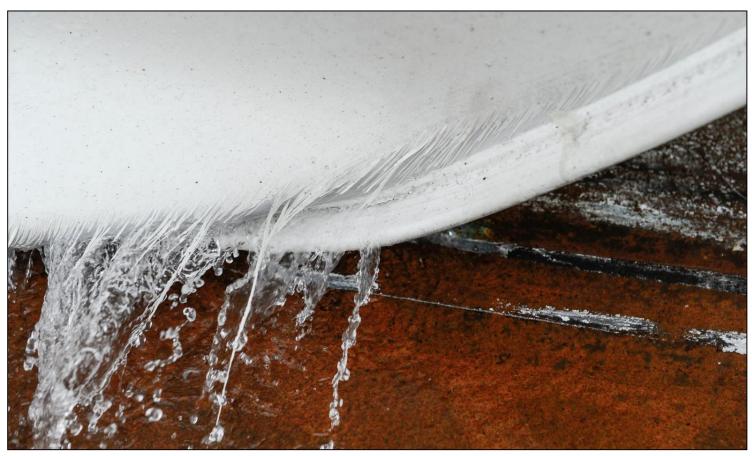
2008 - leak at the top of the impact area – rear end dish

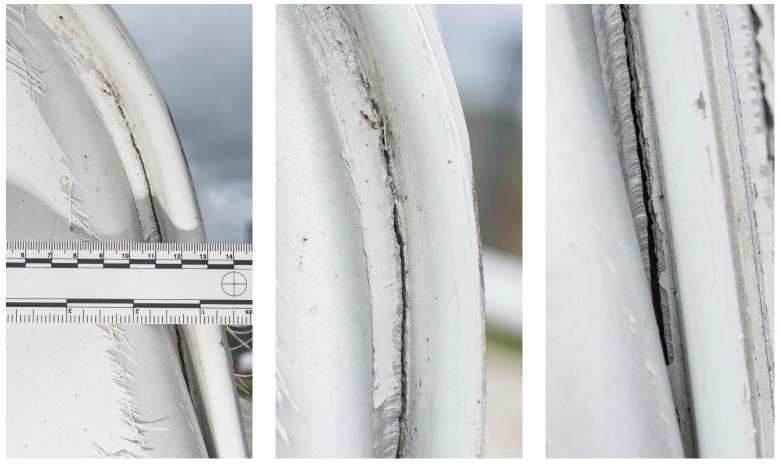
2008 - rupture within the fillet weld between the rear end dish and extrusion band at the top of the impact area

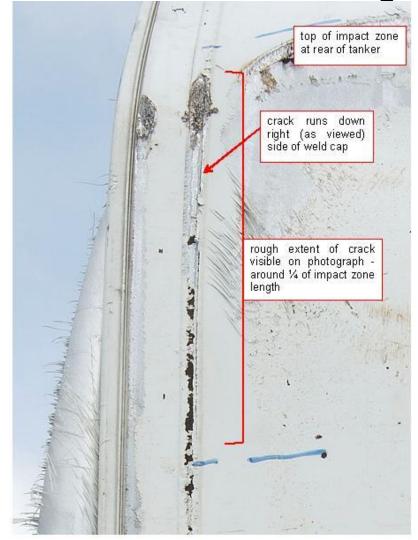
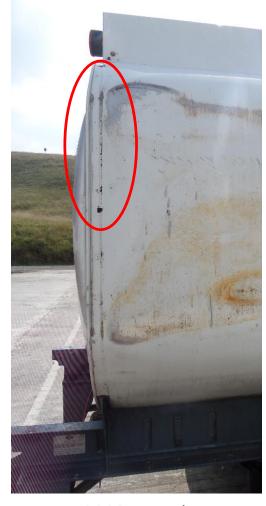
2008 – crack

- Under rollover conditions, critical defect height for a weld of "average" geometry is 1.1 mm when no internal fillet weld is present
- Agrees well with experimental observation of through-wall rupture of circumferential weld resulting from lack of fusion defect 1.0 mm deep and longer than 230 mm in a 2008 tanker

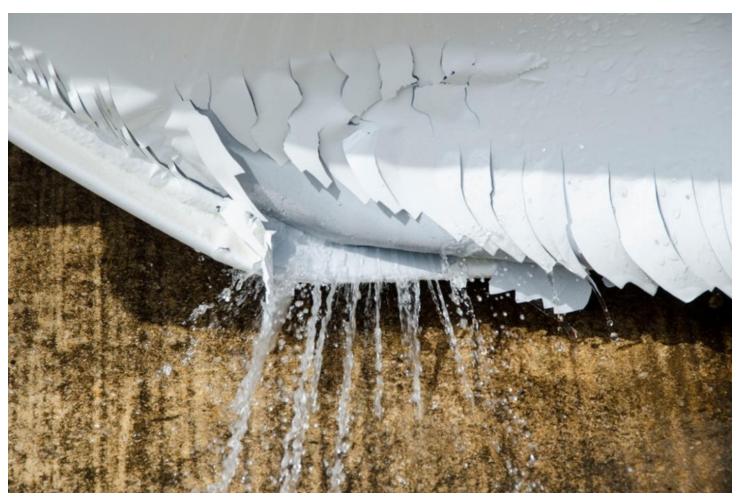
2011 - leak at the top of the impact area – front end dish

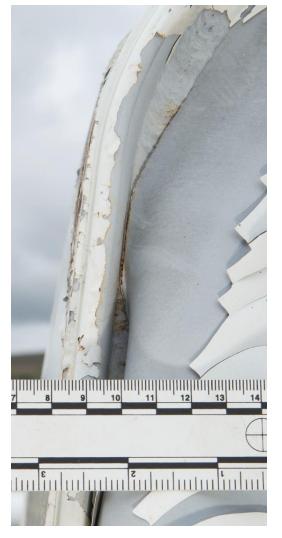
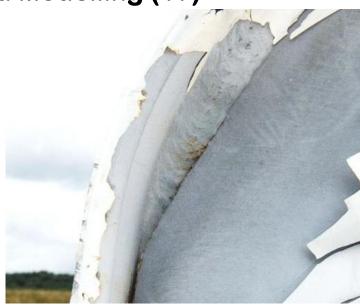
2011 - rupture at the toe of the fillet weld between the front end dish and extrusion band at the top of the impact area

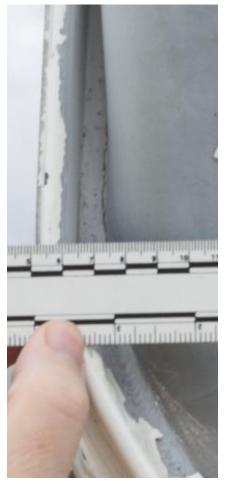
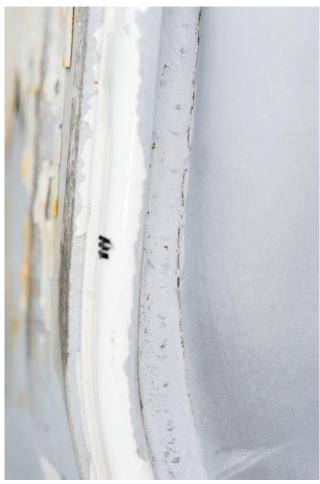
2011 - crack at the toe of the fillet weld between the front end dish and extrusion band at the bottom of the impact area
