**Joint Meeting of the RID Committee of Experts and the  
Working Party on the Transport of Dangerous Goods**

Bern, 8-11 September 2009 and  
Geneva, 14-18 September 2009  
Item 5 of the provisional agenda

**Manhole covers of tanks**

**Note by Germany**

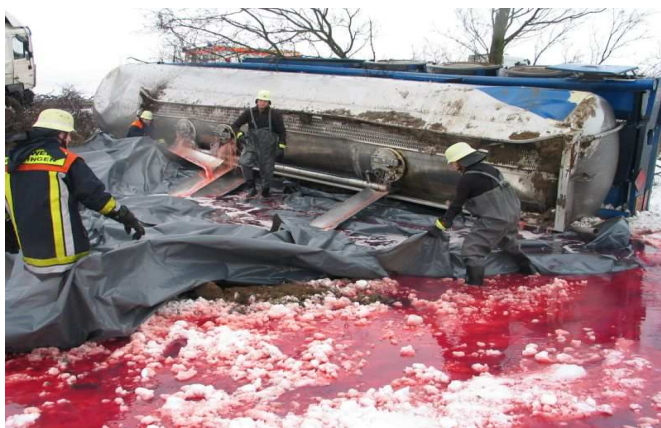
Picture 1: Leaking dome covers after an accident

The analysis of the annual reports on occurrences under 1.8.5 of ADR has revealed that in overturning accidents of mineral oil tanks the tanks were usually not damaged but the loaded goods leaked through inspection opening covers.

This condition is not permissible under 6.8.2.2.1 of ADR.

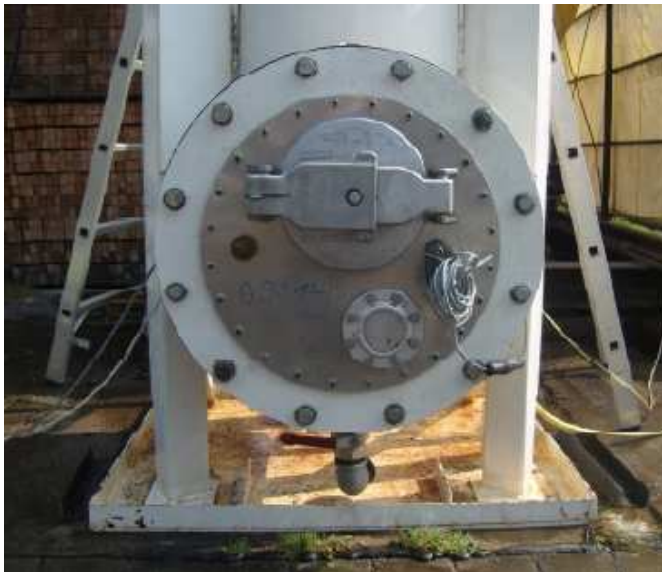
Picture 2: Dome cover manufactured in an ADR member state fitted to the test apparatus

This cover, which was fitted with a spring loaded fill hole cover, failed the drop tests conducted at the Federal Institute for Materials Research and Testing in accordance with EN 13 317 by means of the test device specified therein. Pictures 3 and 4 show how the drop test affected the cover.

The cover is from a series which, according to the test report of a major internationally operating testing company, was tested in accordance with standard EN 13 317.

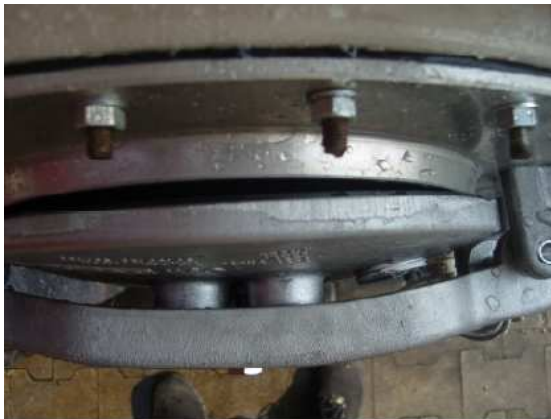
Picture 3: Failing filling hole cover after the test

In this respect, it is deemed necessary to include an exclusion of spring-loaded filling hole covers in standards EN 13 314 and EN 13 317. This had been agreed by the Joint Meeting at the session in September of 2004 by rejecting standard EN 14 596 (see TRANS/WP.15/AC.1/96 paragraphs 46-48). The Joint Meeting did not want the filling hole cover to be used as a device for protection against excess pressure.

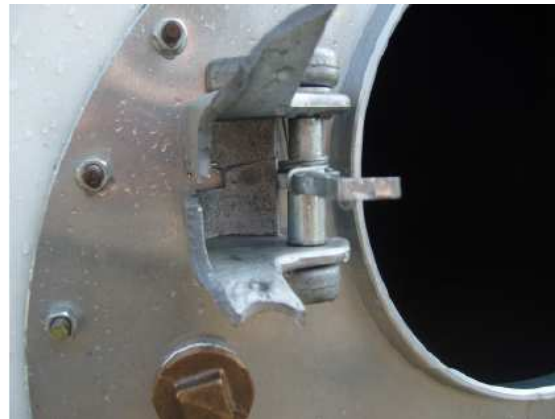
Picture 4: Broken locking device after the test
