**OFFICE OF INTERNATIONAL POLICY AND HARMONIZATION
NATIONAL HIGHWAY TRAFFIC SAFETY ADMINISTRATION
KIA FRONT ROW SEATS
FMVSS 202A S4.2.5/5.2.5 - ENERGY ABSORPTION TEST SERIES
(PO #DTNH22-05-P-02098, REQ. #NVS-133-5-02098)**

TEST REPORT

MGA REPORT NO.: G05Q7-003.1

TEST DESCRIPTION: FMVSS 202A S4.2.5/5.2.5 - Energy Absorption

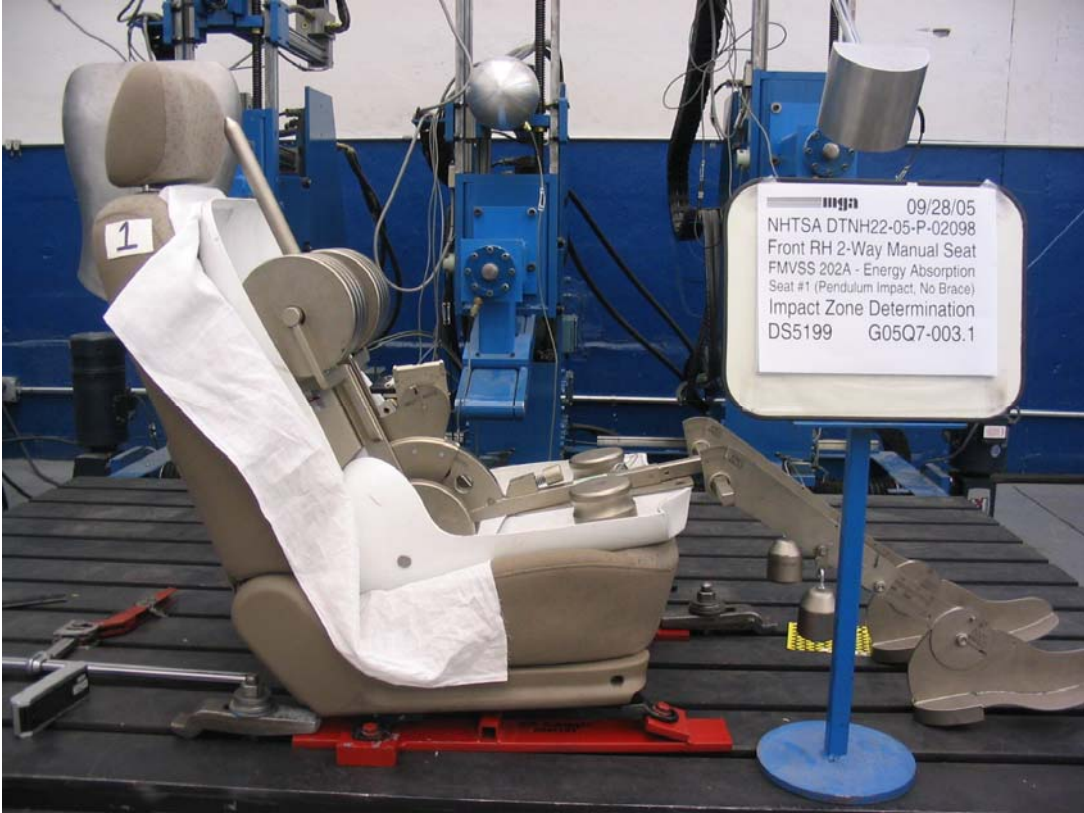
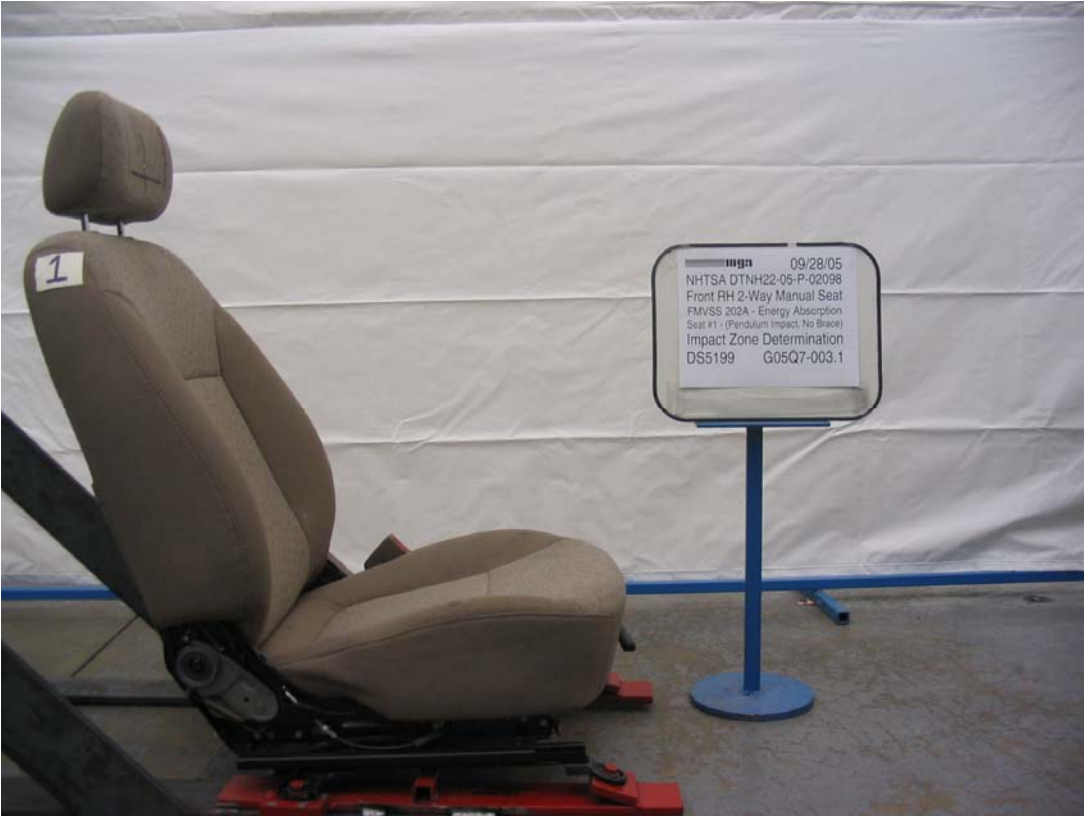
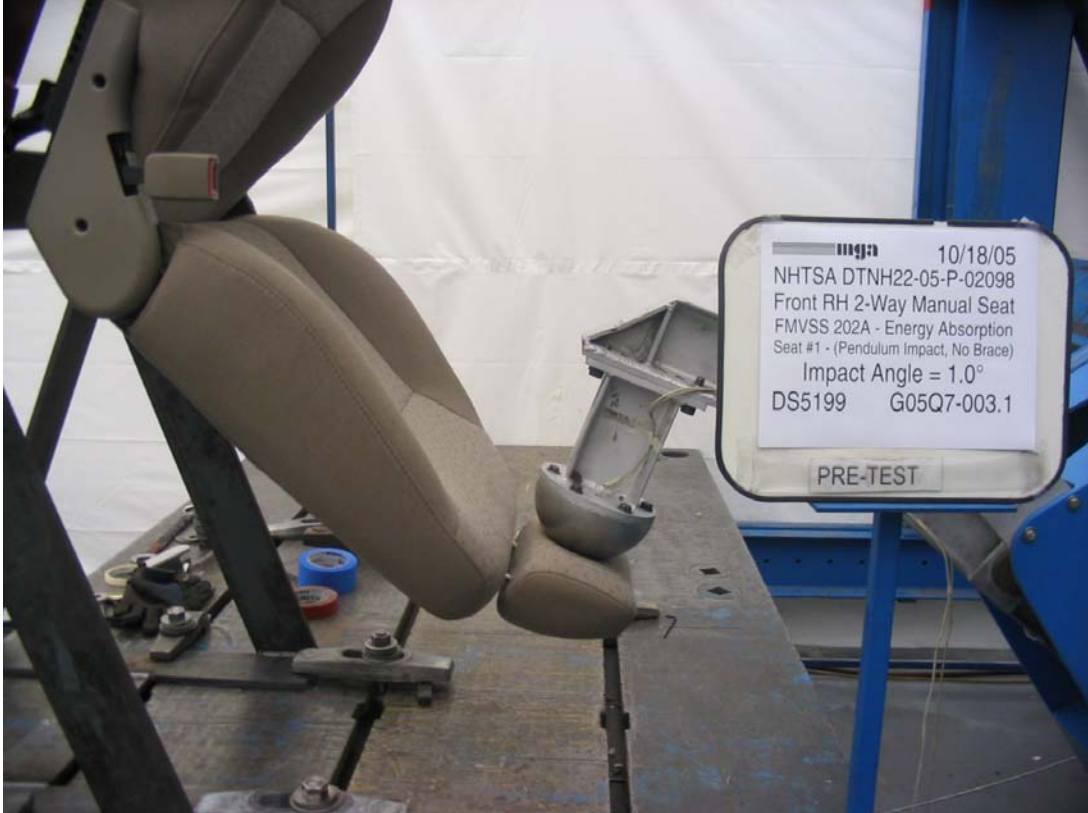
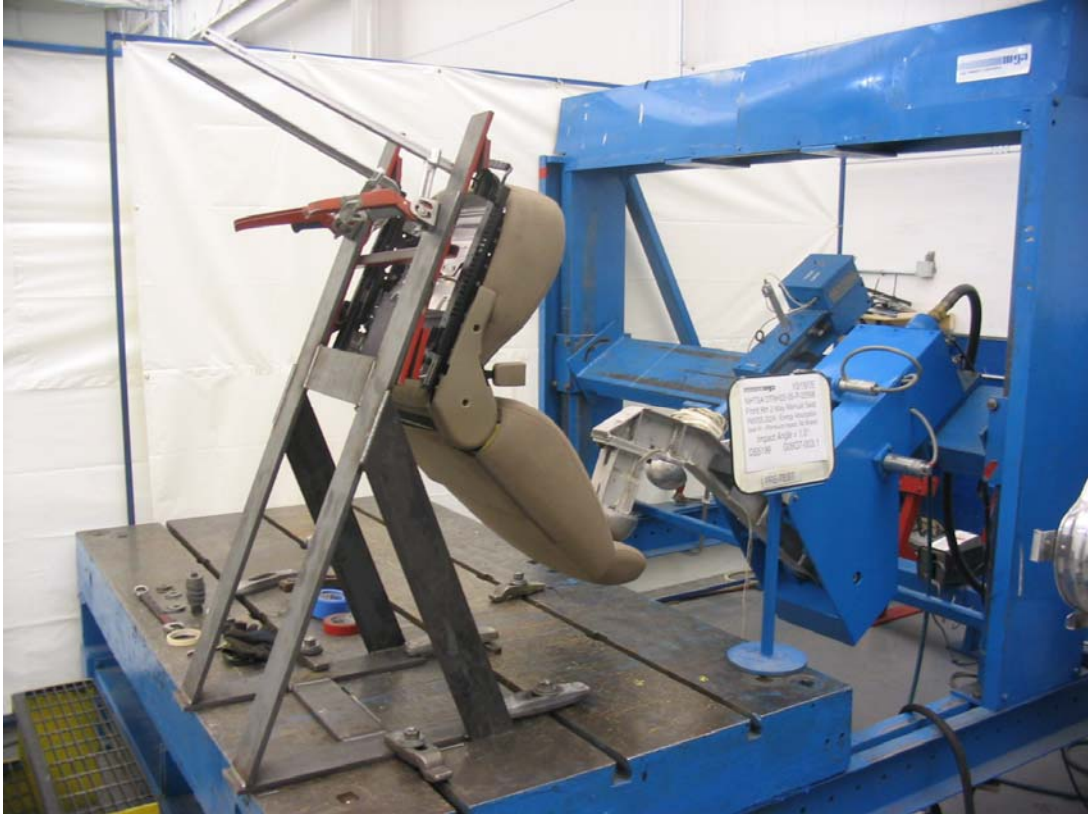
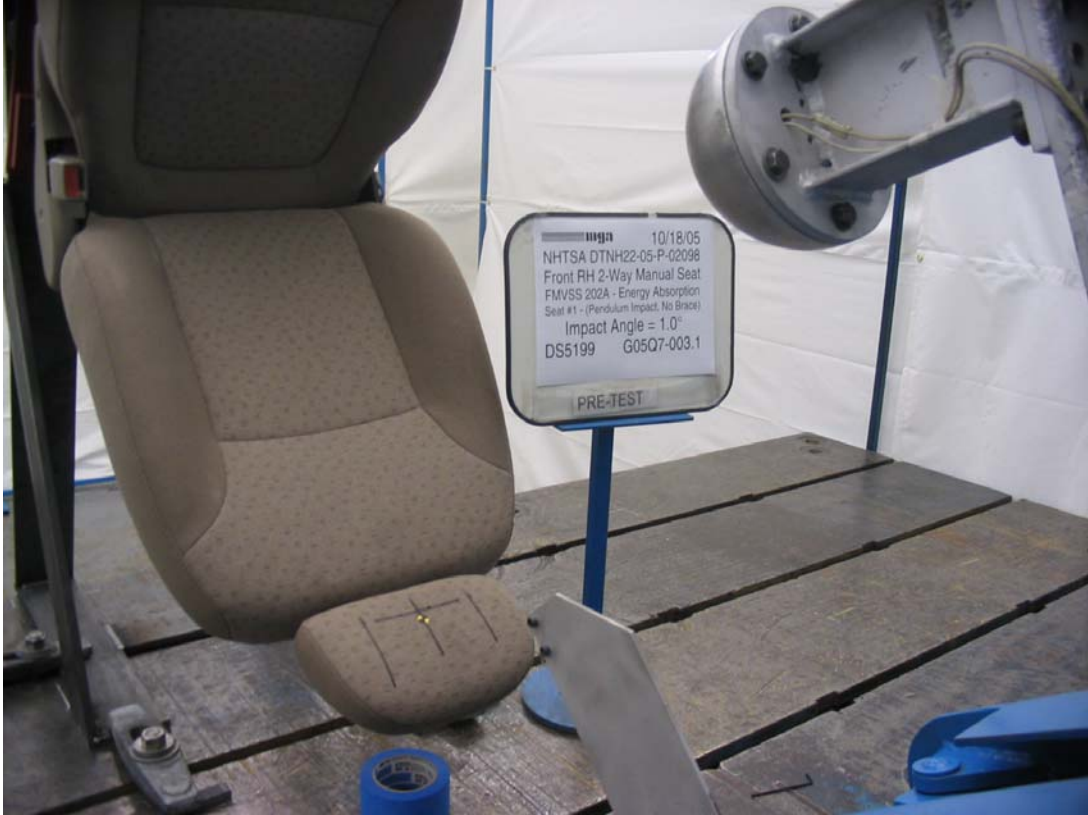
Pre-Test Photo #1 of Test #DS5199

Pre-Test Photo #2 of Test #DS5199

Pre-Test Photo #3 of Test #DS5199

Pre-Test Photo #4 of Test #DS5199

Pre-Test Photo #5 of Test #DS5199

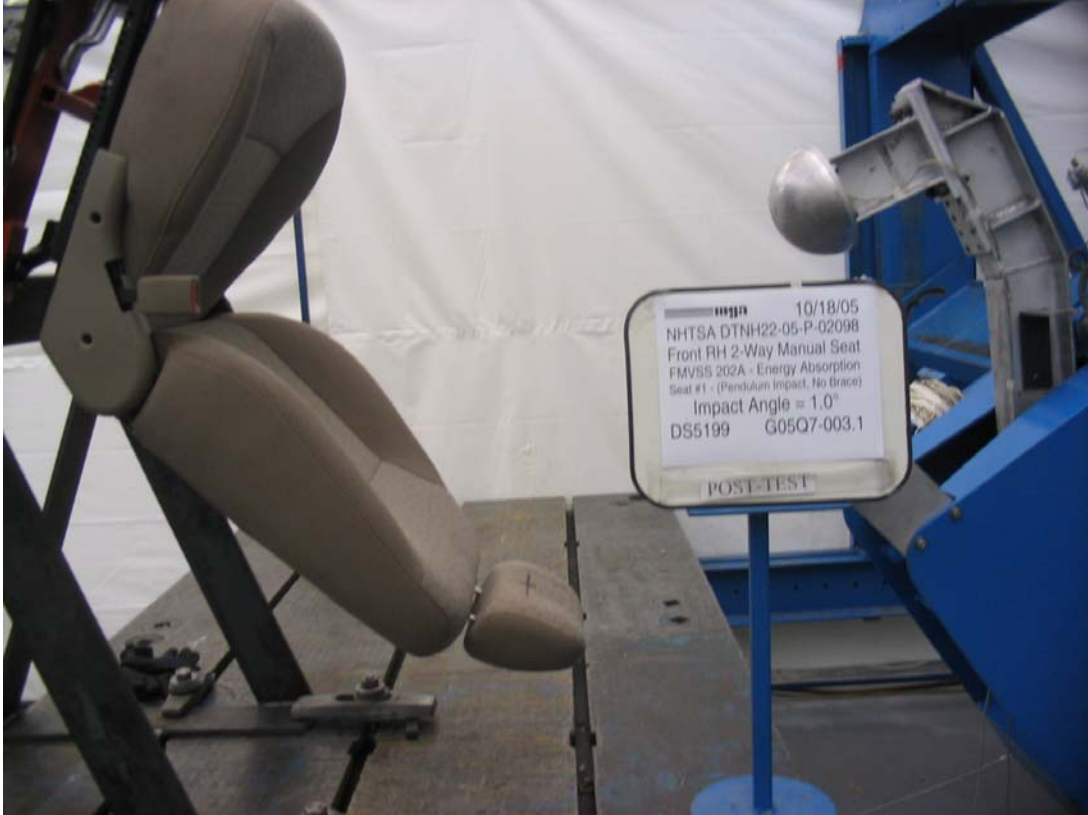
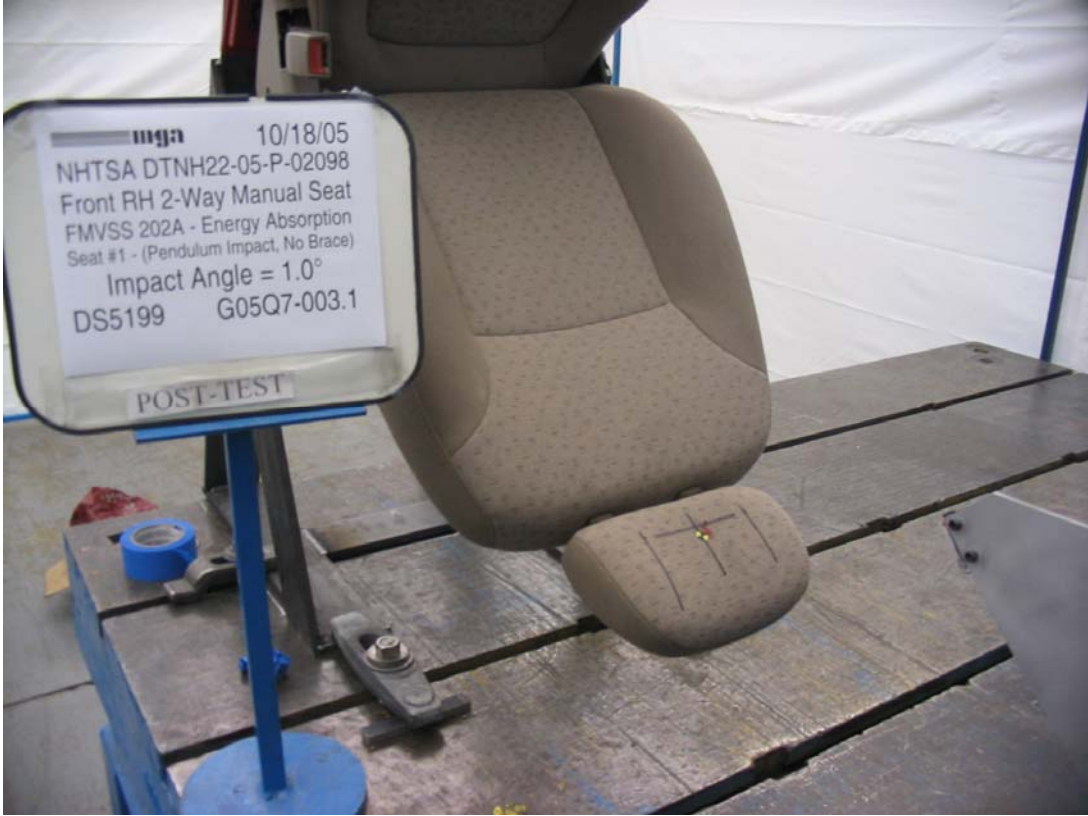
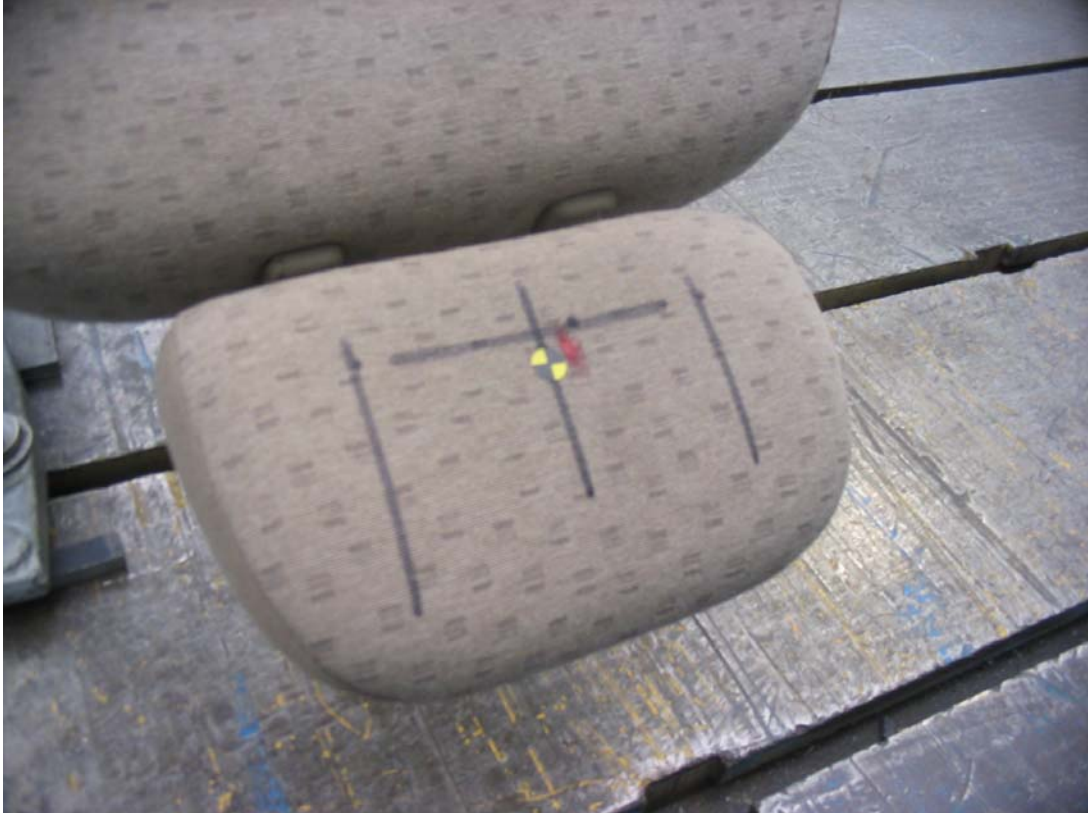
No sharp edges or damage evident.

Post-Test Photo #1 of Test #DS5199

Post-Test Photo #2 of Test #DS5199

Post-Test Photo #3 of Test #DS5199

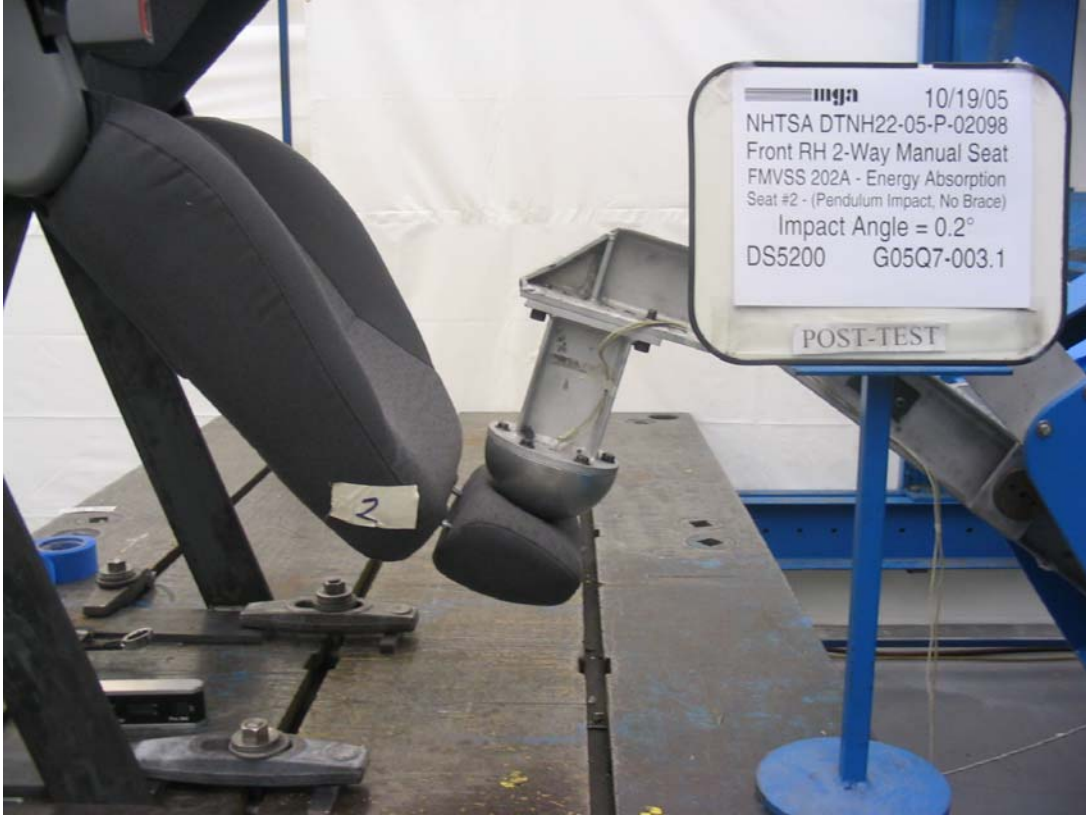
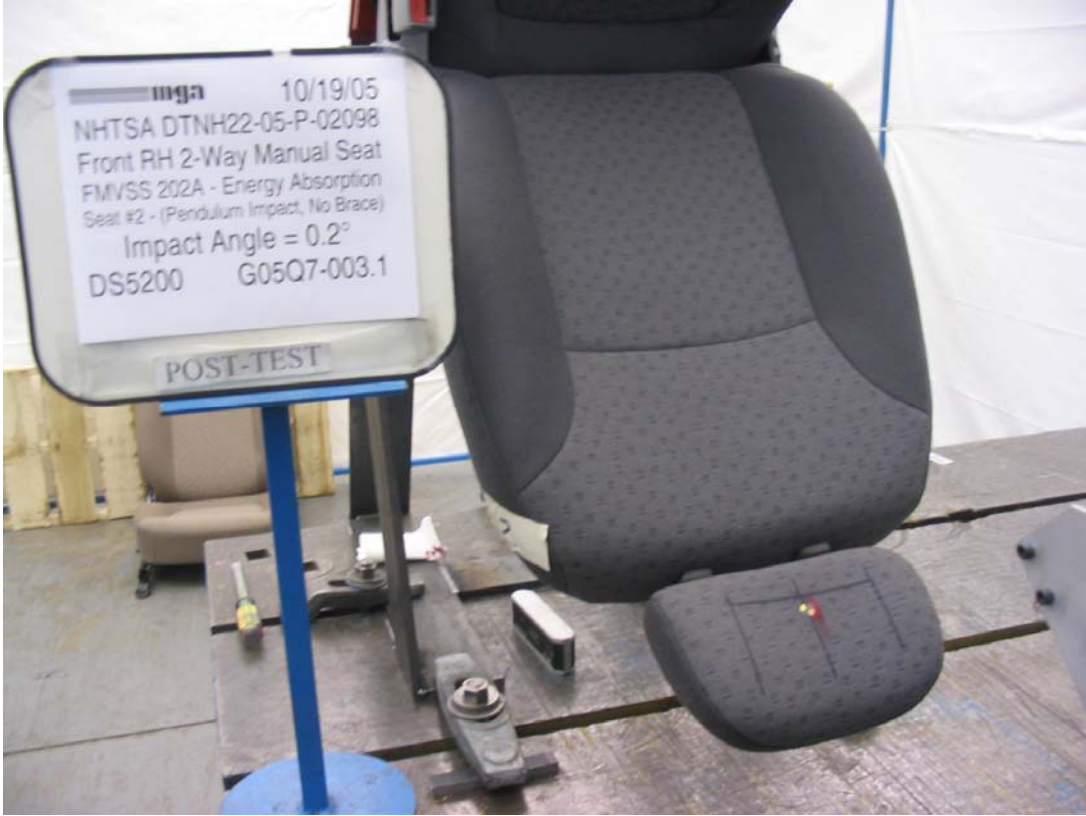
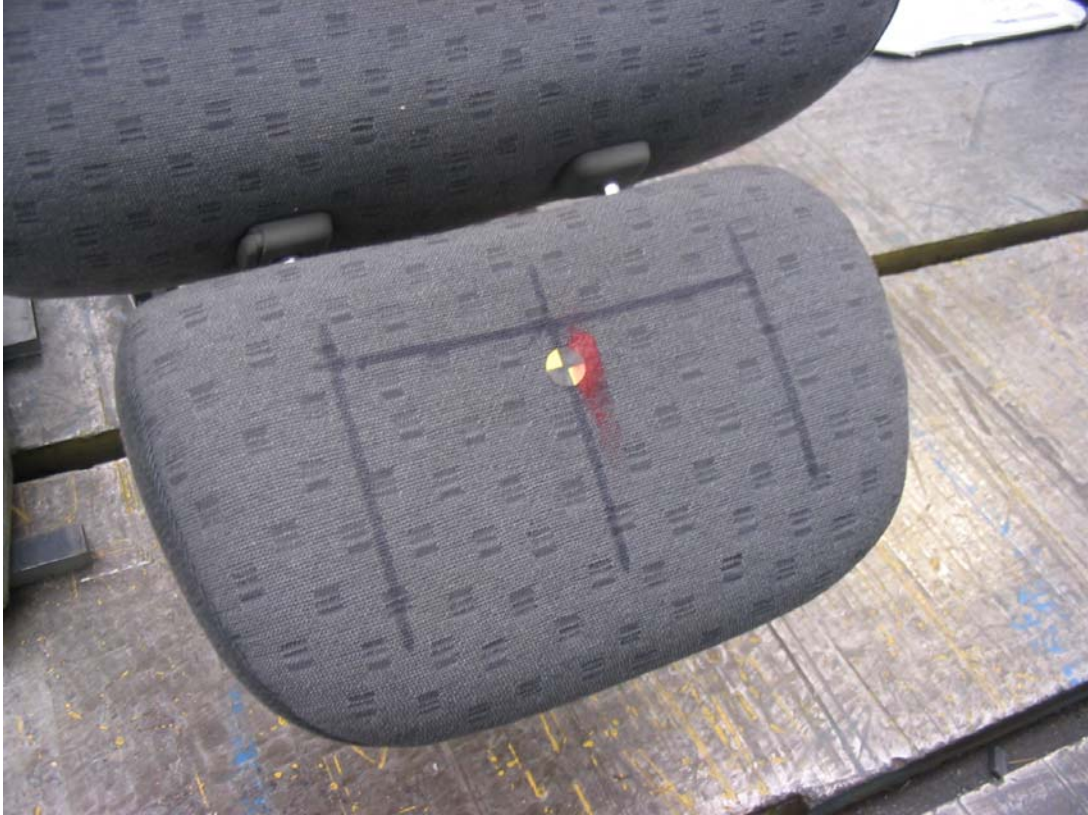
No sharp edges or damage evident.
* Recliner appears to have released on I/B side (see video).

Post-Test Photo #1 of Test #DS5200

Post-Test Photo #2 of Test #DS5200

Post-Test Photo #3 of Test #DS5200

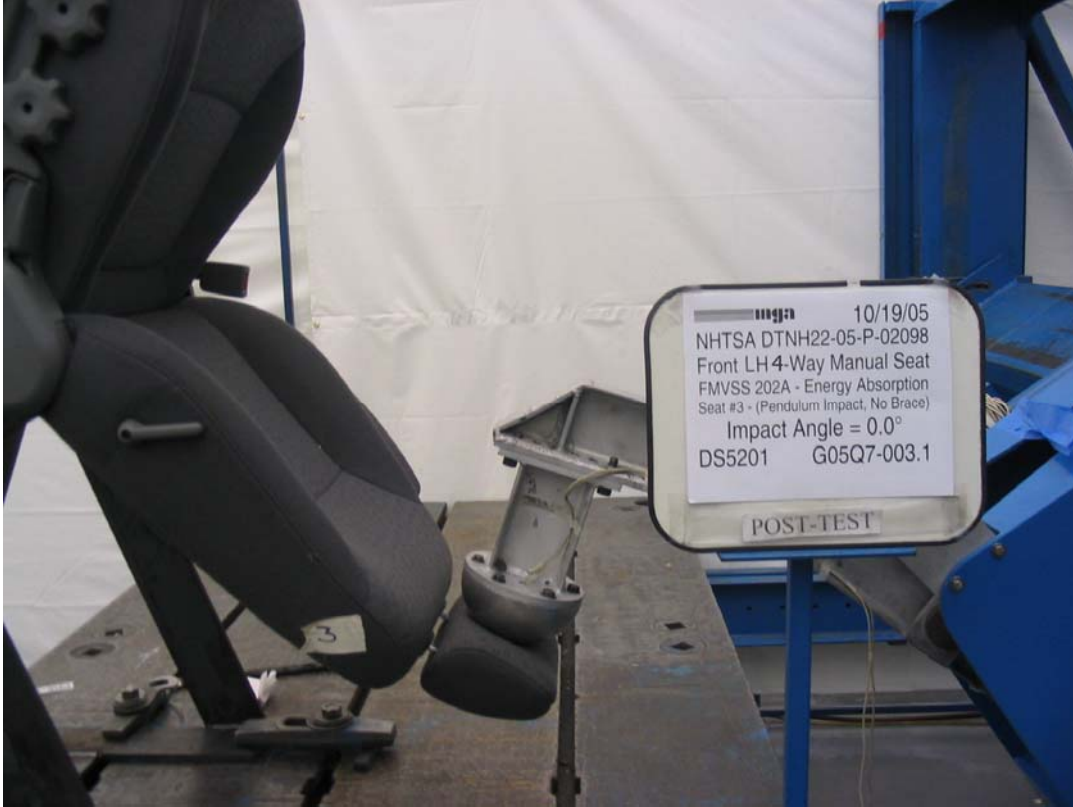
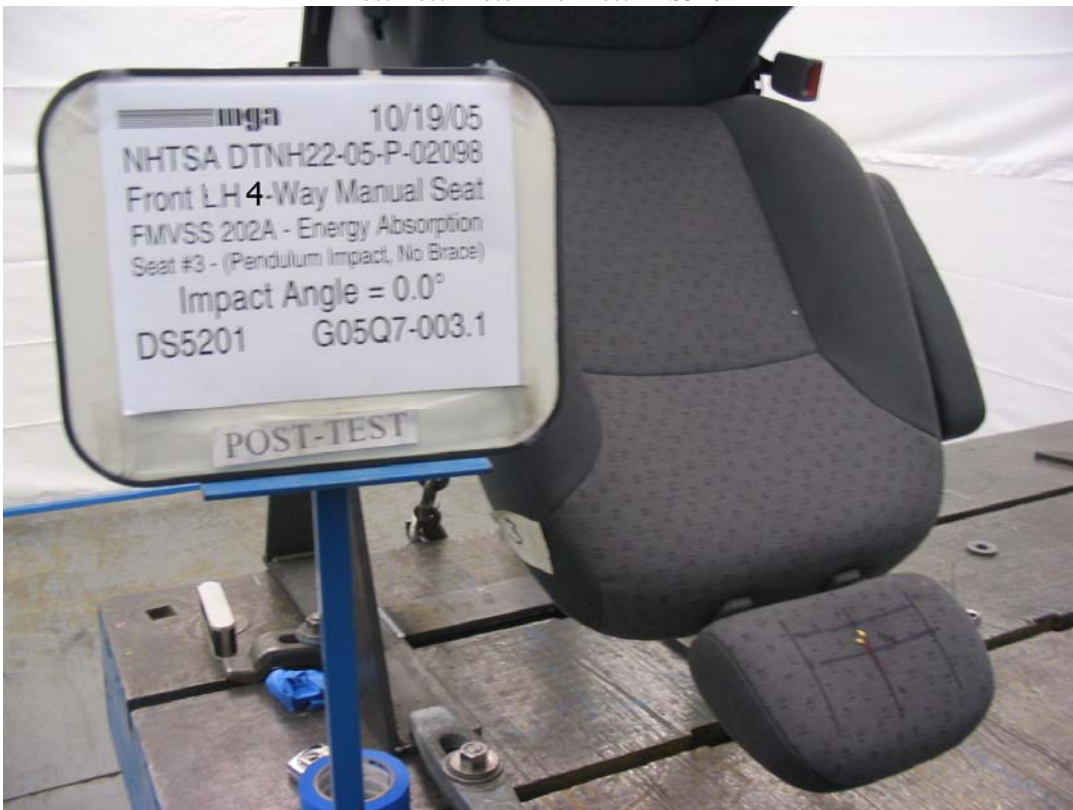
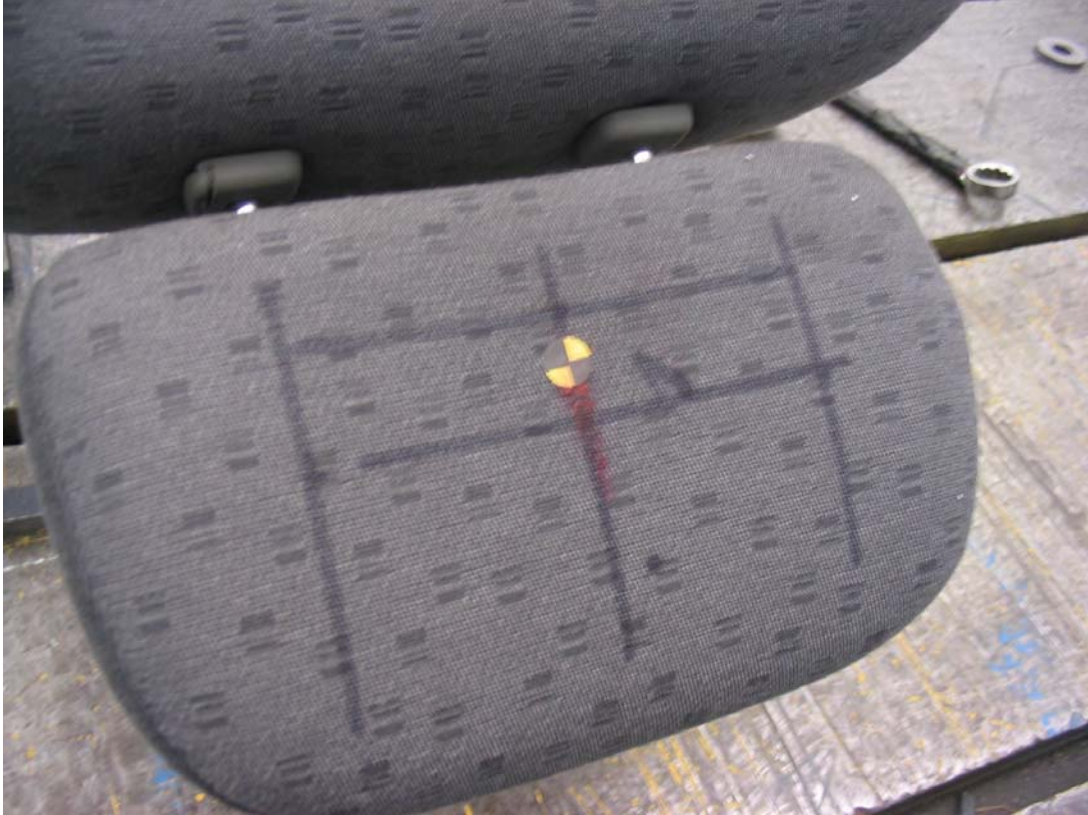
REMARKS: Test Variation # 1, PASS FAIL
(No Brace)

No sharp edges or damage evident.

Post-Test Photo #1 of Test #DS5201

Post-Test Photo #2 of Test #DS5201

Post-Test Photo #3 of Test #DS5201

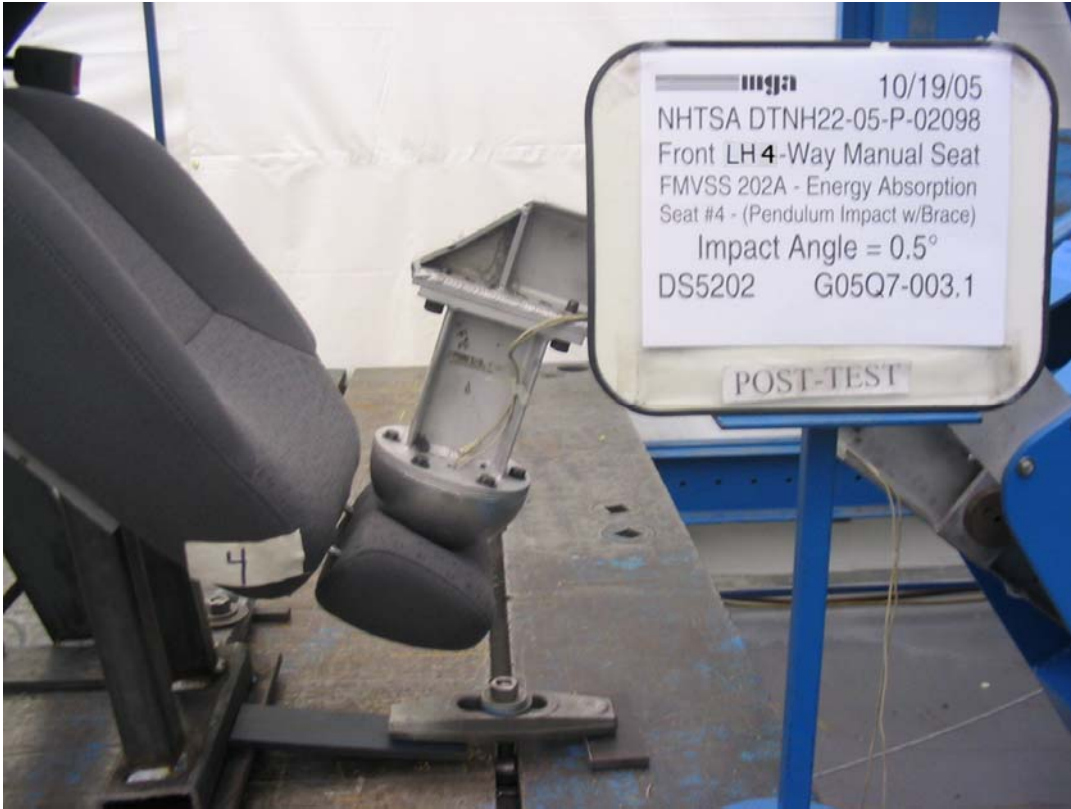
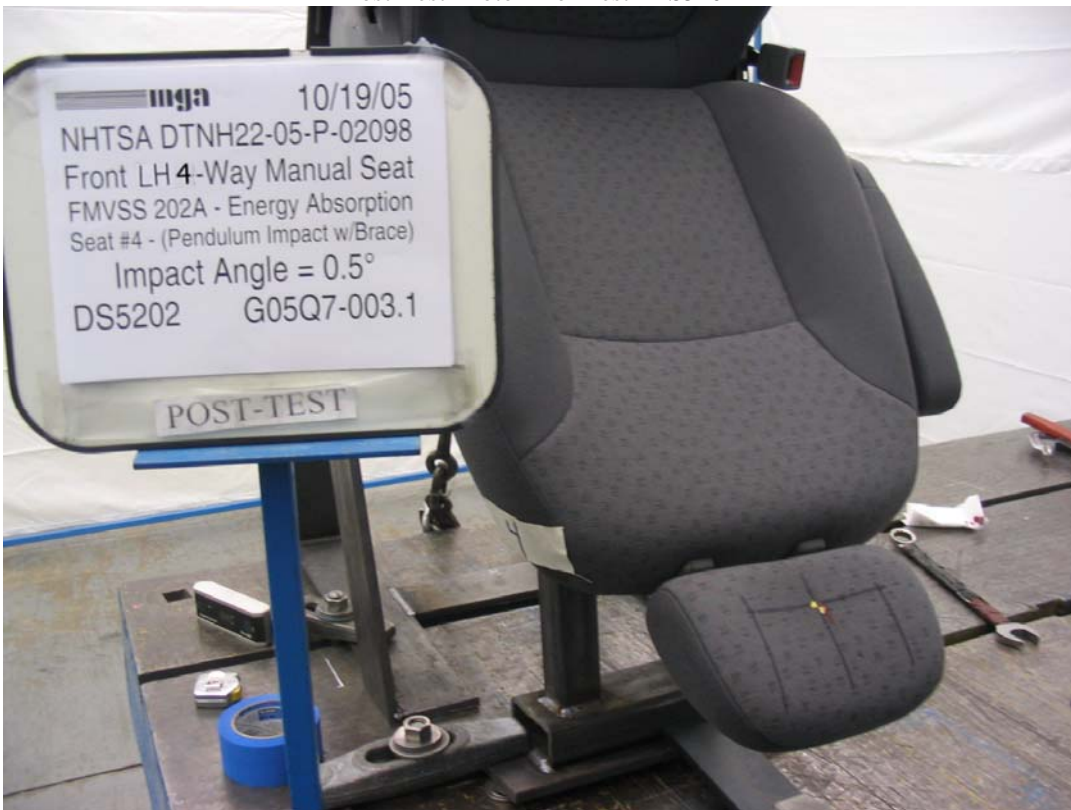
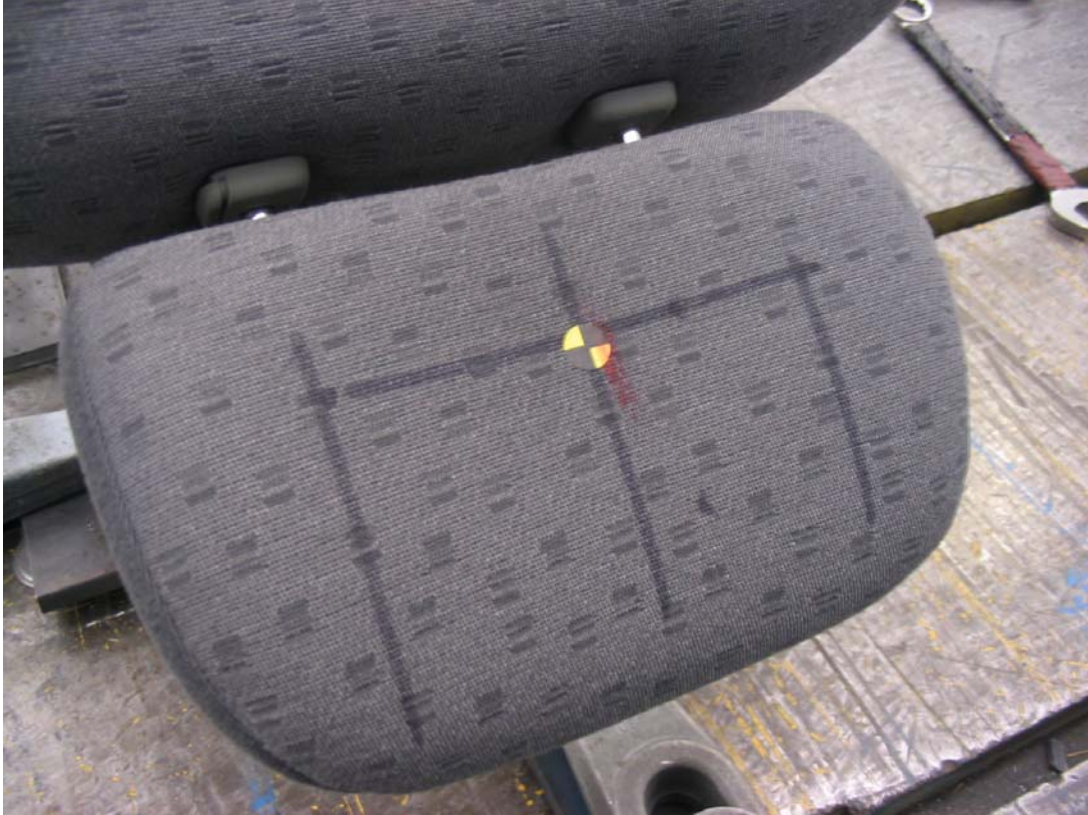
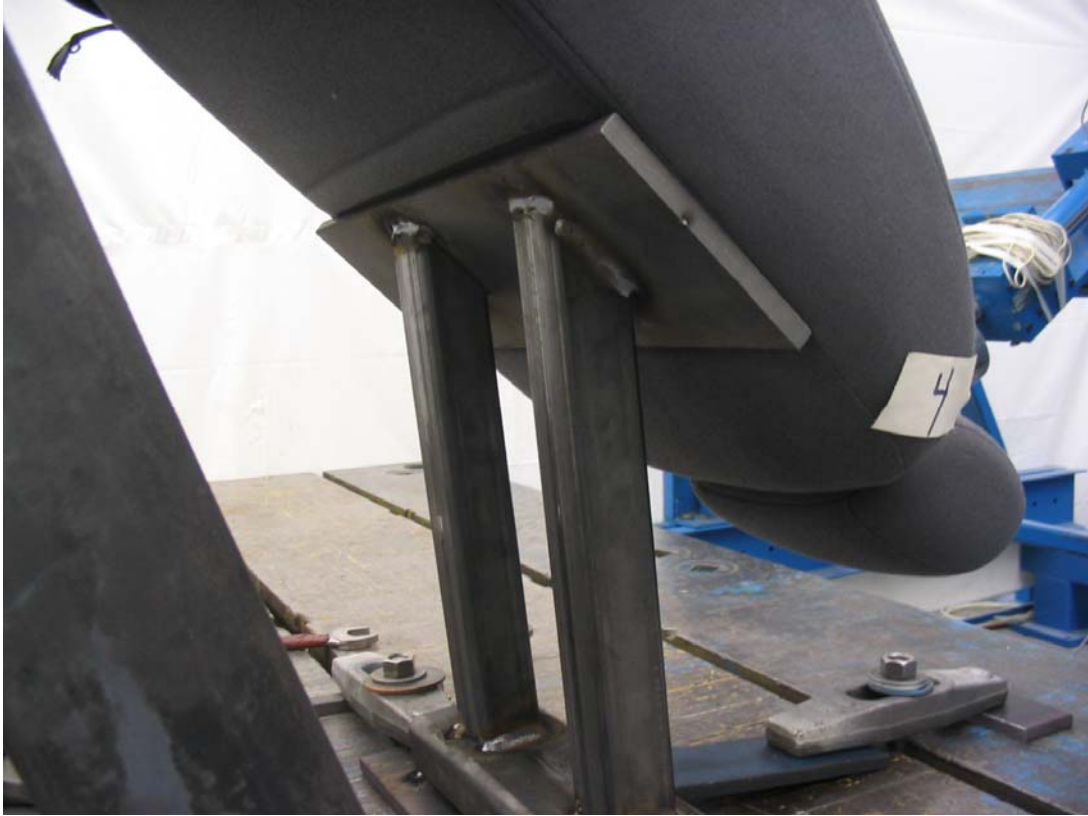
REMARKS: Test Variation # 2, PASS FAIL
(w/Brace)

No sharp edges or damage evident.

Post-Test Photo #1 of Test #DS5202

Post-Test Photo #2 of Test #DS5202

Post-Test Photo #3 of Test #DS5202

Post-Test Photo #4 of Test #DS5202

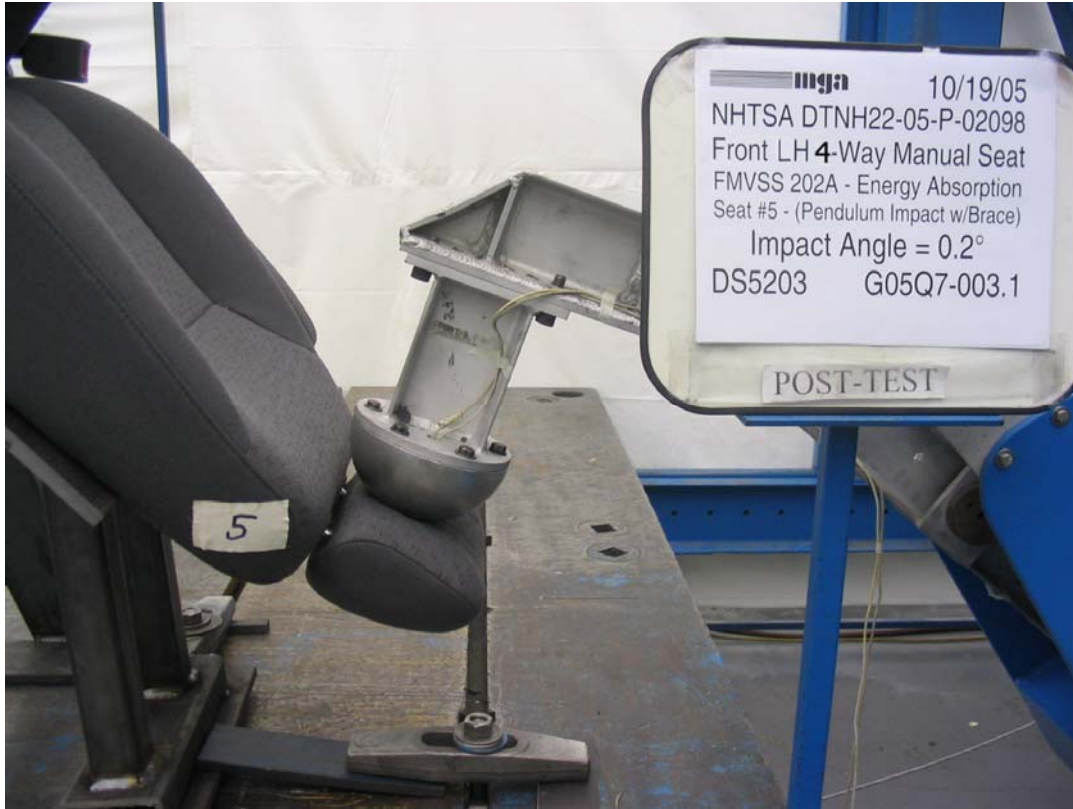
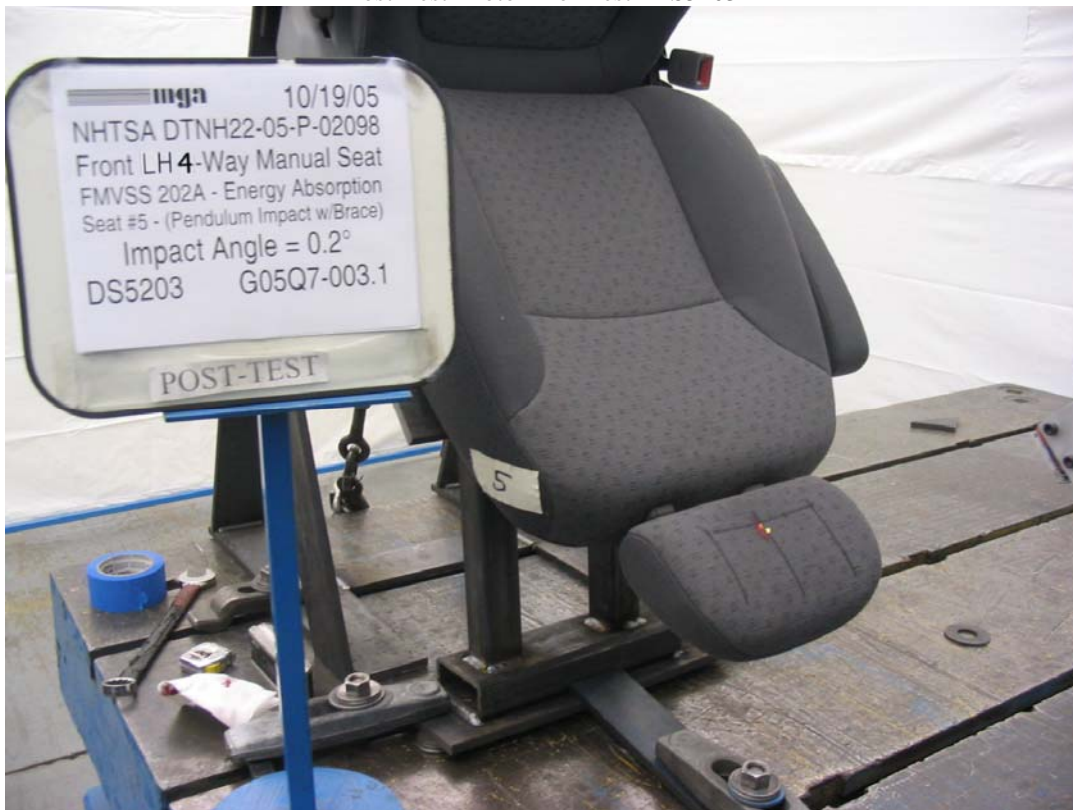
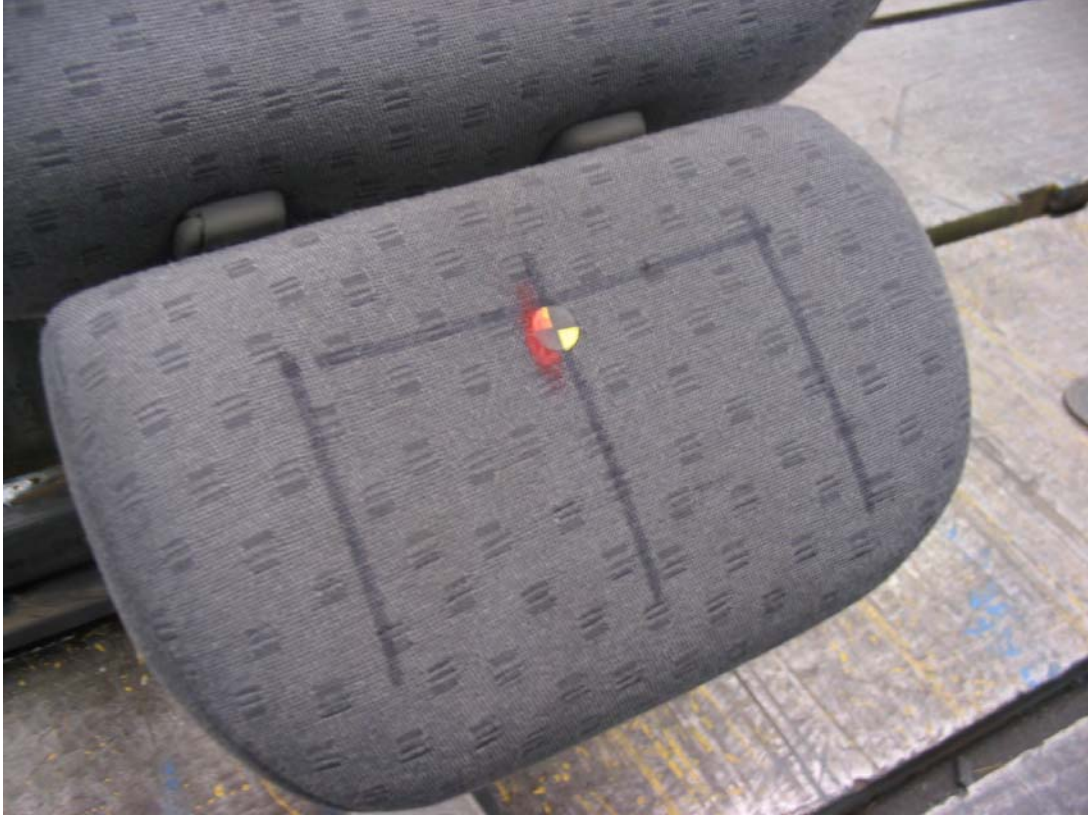
No sharp edges or damage evident.

Post-Test Photo #1 of Test #DS5203

Post-Test Photo #2 of Test #DS5203

Post-Test Photo #3 of Test #DS5203
