Informal document No. WP.29-144-27 (144th WP.29, 11-14 March 2008, Agenda item 6.)

NHTSA Motorcoach Crash Test

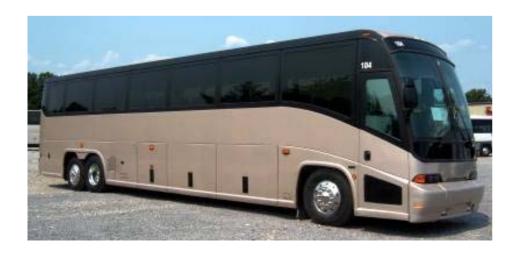
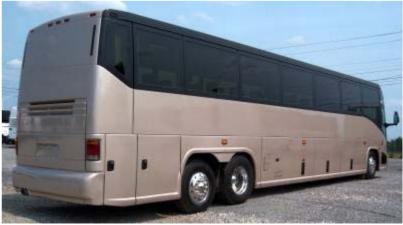
Motorcoach Details

- 2000 MCI 102EL3 Renaissance
- Series 60 diesel engine
- B500 Allison Automatic transmission
- 54 seats
- 45 ft long, 12 ft 6 inches tall

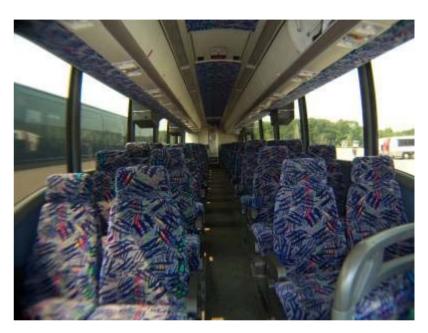
Seats on the Motorcoach

- Baseline seats
 - No belts
 - American Seating
- Seats with Belts
 - MCI/Amaya
 - 3 point belts 4 rows (dual seats)
 - 2 point belts 1 row (dual seats)
 - Freedman Seating
 - 3 point belts 1 row (dual seats)

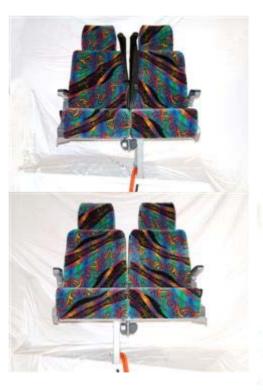
Freedman 3 – point

- -3 point
- -2 point

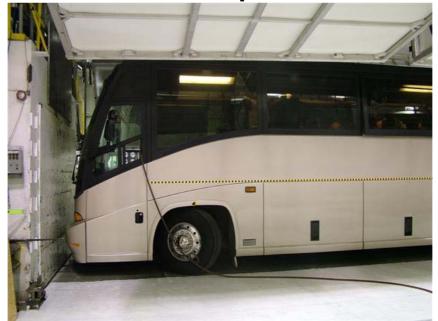
Test Conditions

- Speed: 30 mph (48.3 kph)
- Frontal impact: 0 degrees; full overlap
- Fixed Rigid Barrier
- Data channels: 355 dummy; 26 vehicle channels @ 12500 samples/sec

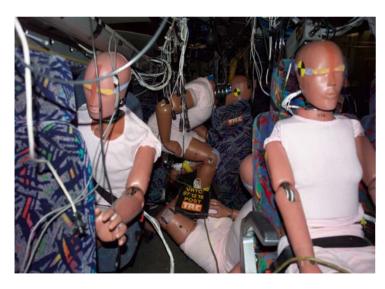
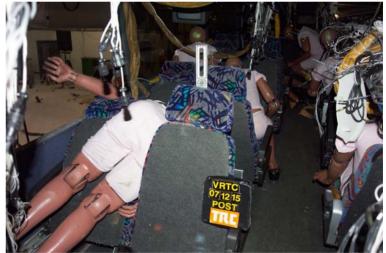
Observation- Unbelted Dummies

- Unbelted dummies typically made head contact with the backseat in front within 150-180 ms
- Dummies on the aisle seats ended up on the floor and dummies on the window seats ended up on the front seats or on the floor

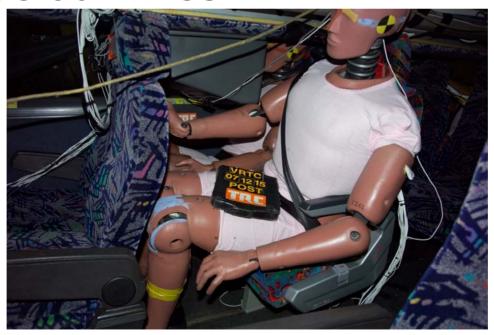
Observation – Belted Dummies

- Dummies stayed in seats
- Head/Knee contact with front backseat for 95th male dummies
