Informal document No. GRSP-45-16
(45th GRSP, 25-29 May 2009
agenda item 16(a))

***Performance as Test Procedures of the
PDB and ODB Tests for the Light and
Heavy Cars***

JAPAN

5th Meeting of the Informal Group on Frontal Impact

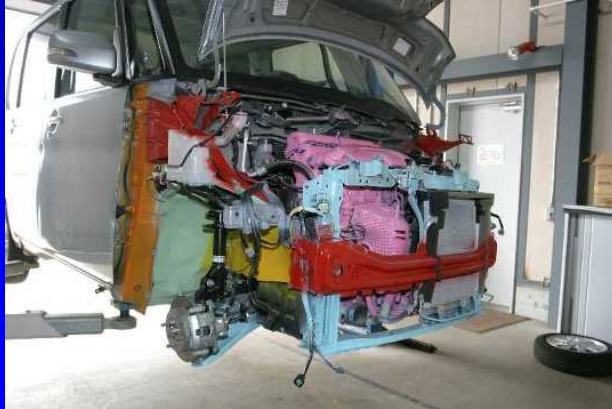
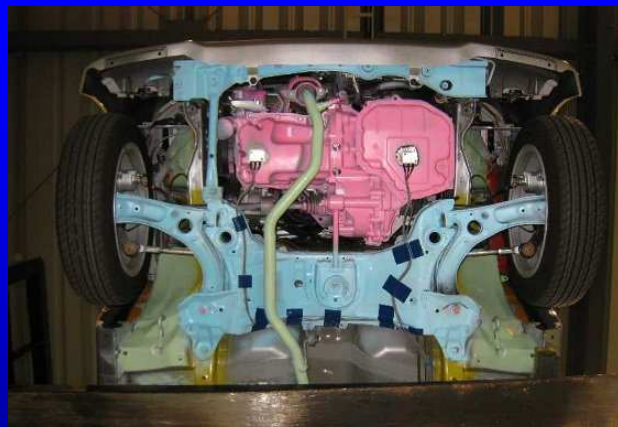
Mini-Car A

➤ Front Rail and Bumper Cross Beam

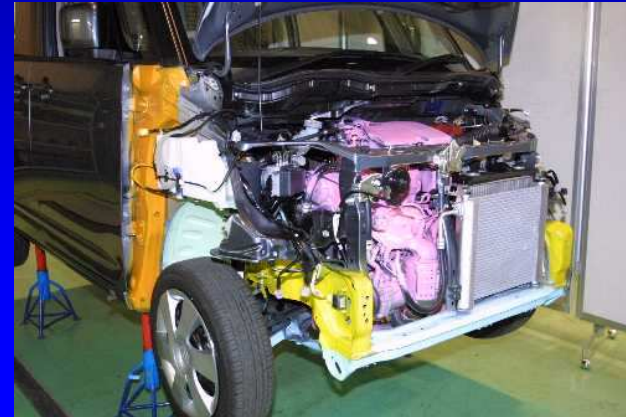
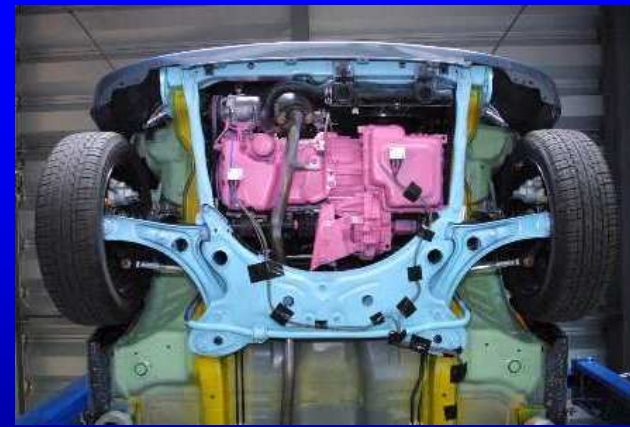
Mini-Car B

➤ Front Rail and Lower Cross Beam
(w/o Bumper Cross Beam)

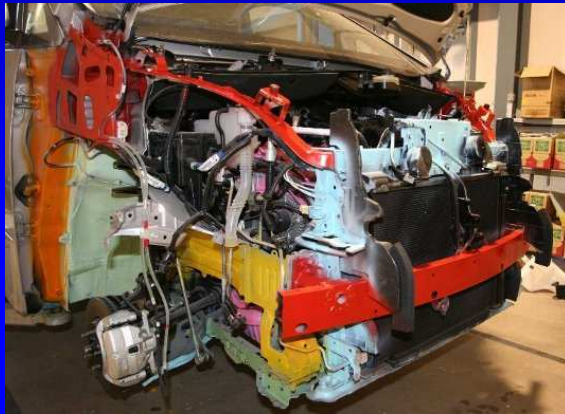
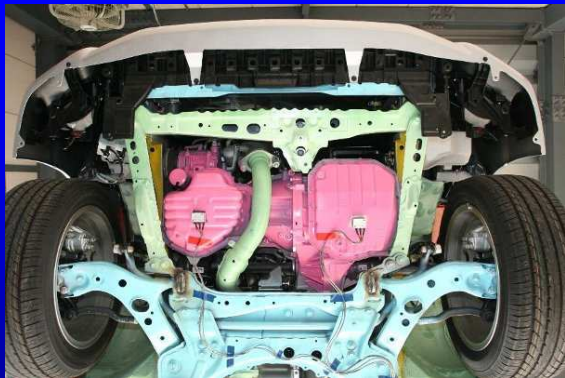
Minivan

- Front Rail, Bumper Cross Beam, and Sub-Frame

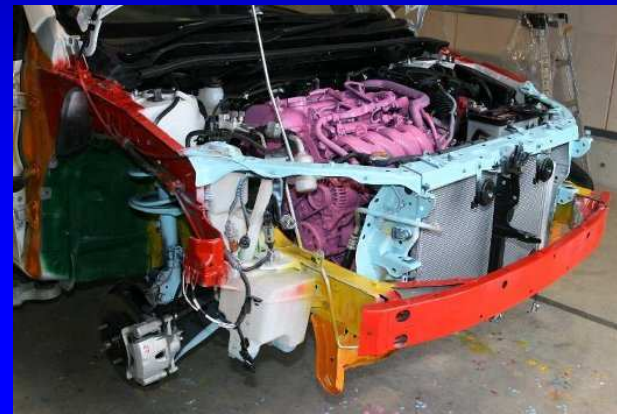
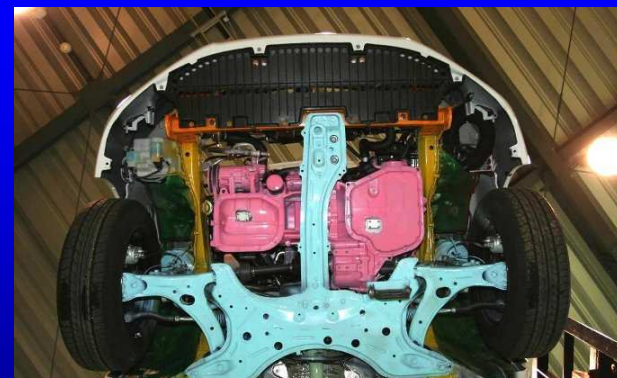
Passenger Car

- Front Rail and Bumper Cross Beam

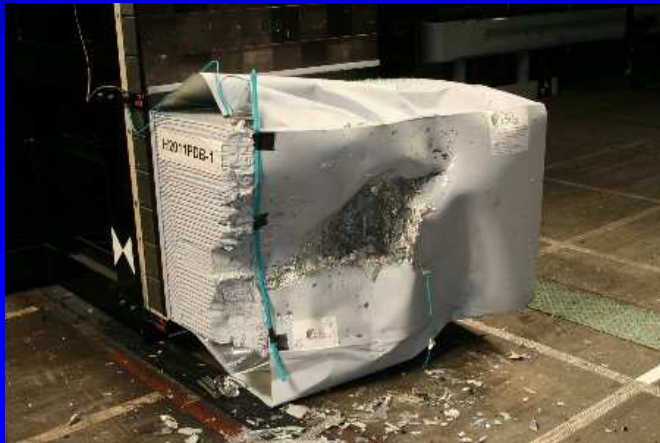
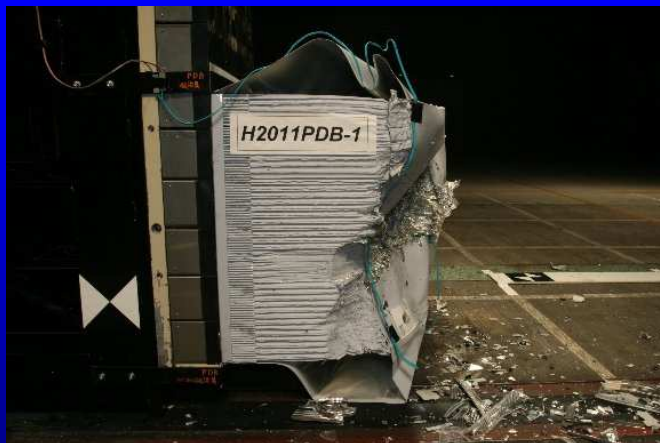
60PDB

➤ The front plate broke wide open.

- The bottom-out of the EEVC barrier was observed with the mini-car even under the 56ODB conditions (the current ECE R94).
- No bottom-out of the PDB was observed, even in the crash with Minivan (heavy car, 2,110 kg). However, the front rail of Mini-Cars and Minivan stuck into the PDB, deforming its front block significantly (causing its front plate to break wide open).

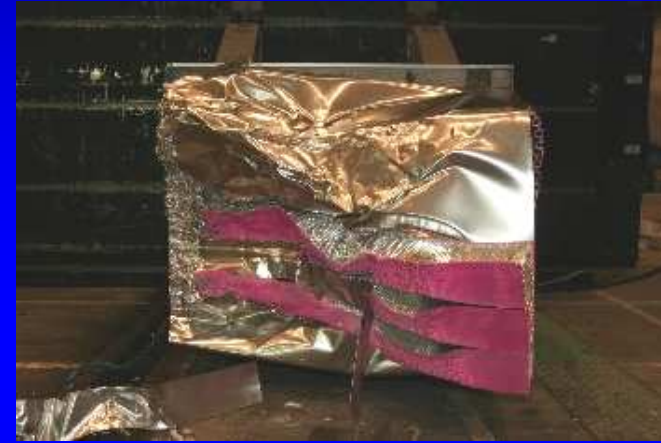
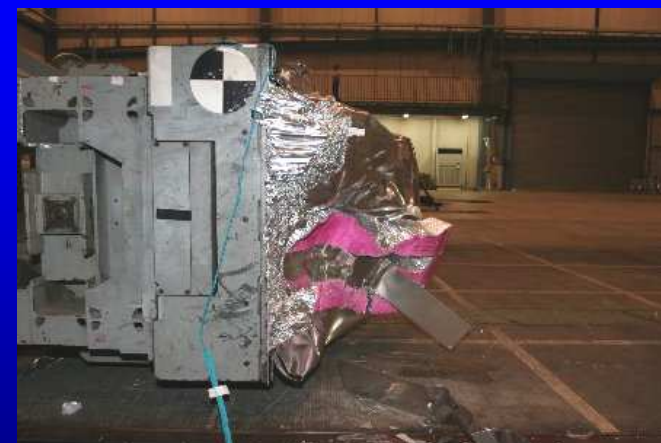
640DB (EEVC Barrier)

➤ The lower part of the honeycomb bottomed out completely.

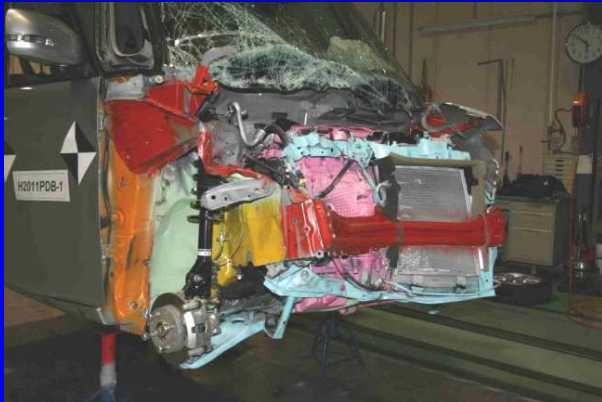
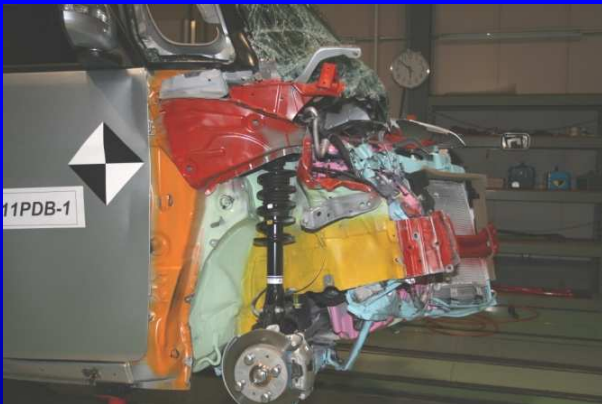
60PDB

- The front rail was rarely deformed.
- The bumper cross beam was bent significantly.

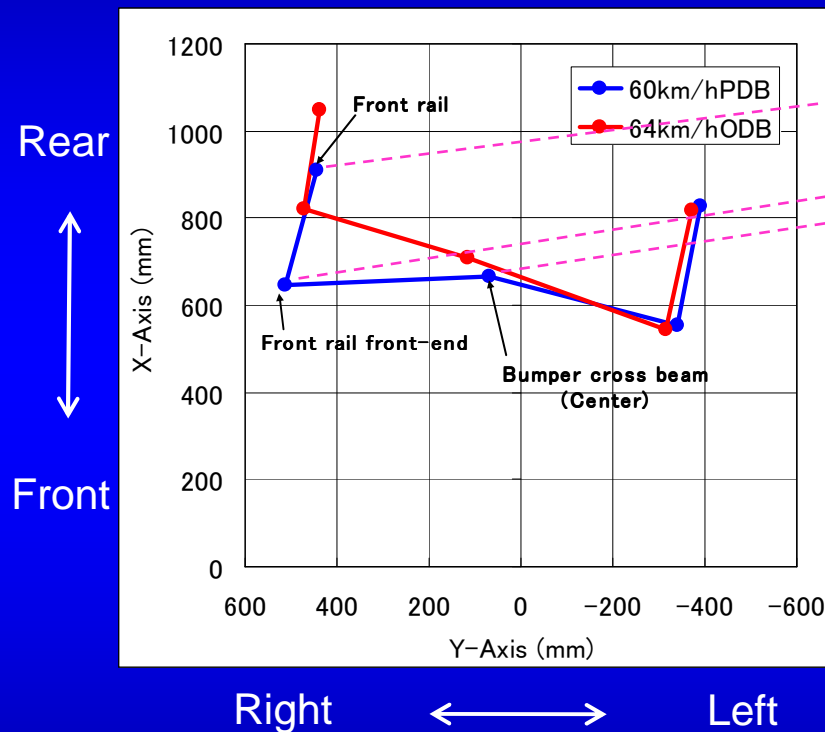
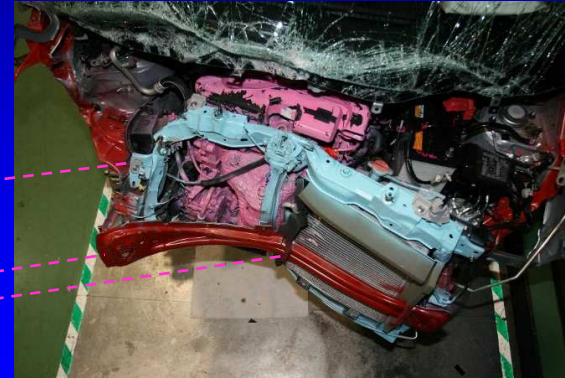
- In both 60PDB and 64ODB, the front rail front-end was deformed to the right of the vehicle.
- In 60PDB, due to the part of the front rail left undeformed, the deformation of the bumper cross beam was larger around its center.
- In 64ODB, the front rail was deformed in the axial direction, and the deformation of the bumper cross beam was larger at its right outer edge.

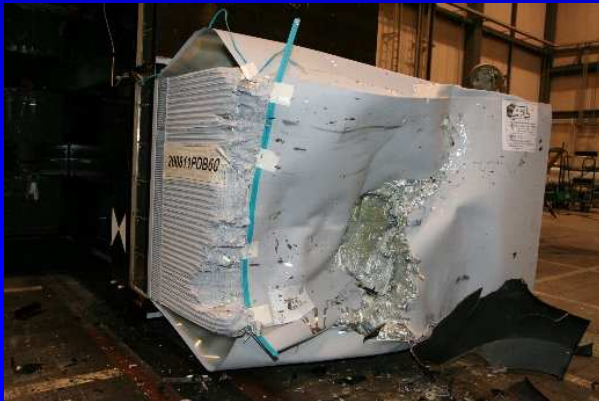
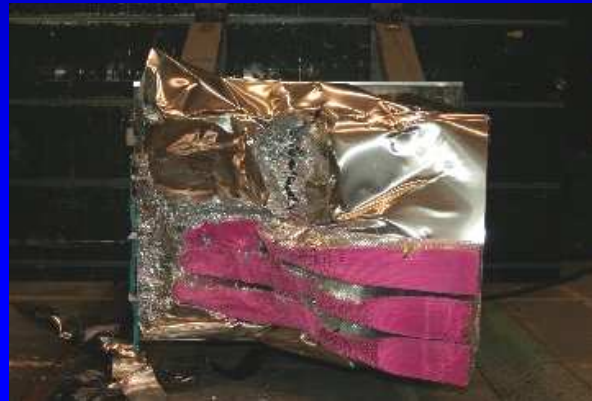
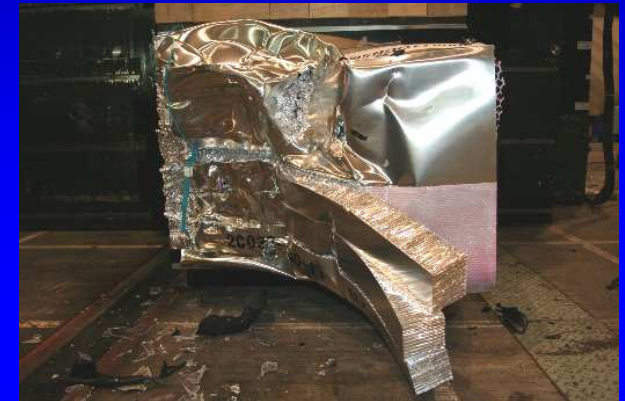
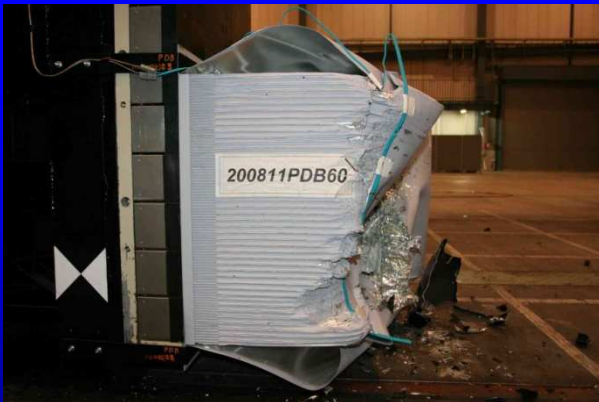
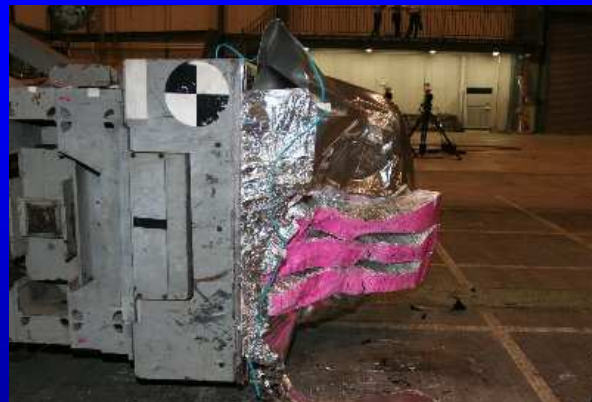
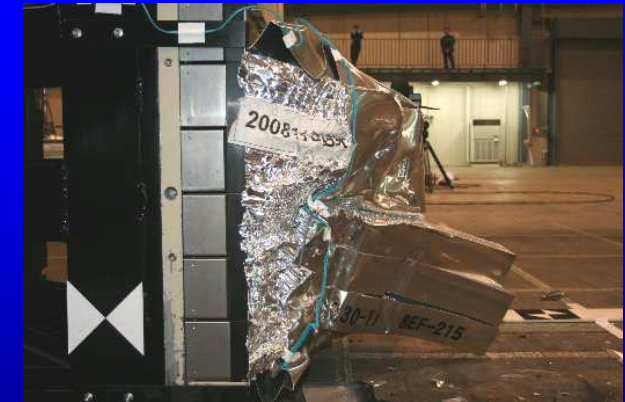
Mini-Car B

➤ The front plate broke wide open.

➤ The lower part of the honeycomb bottomed out completely.

➤ The lower part of the honeycomb bottomed out.

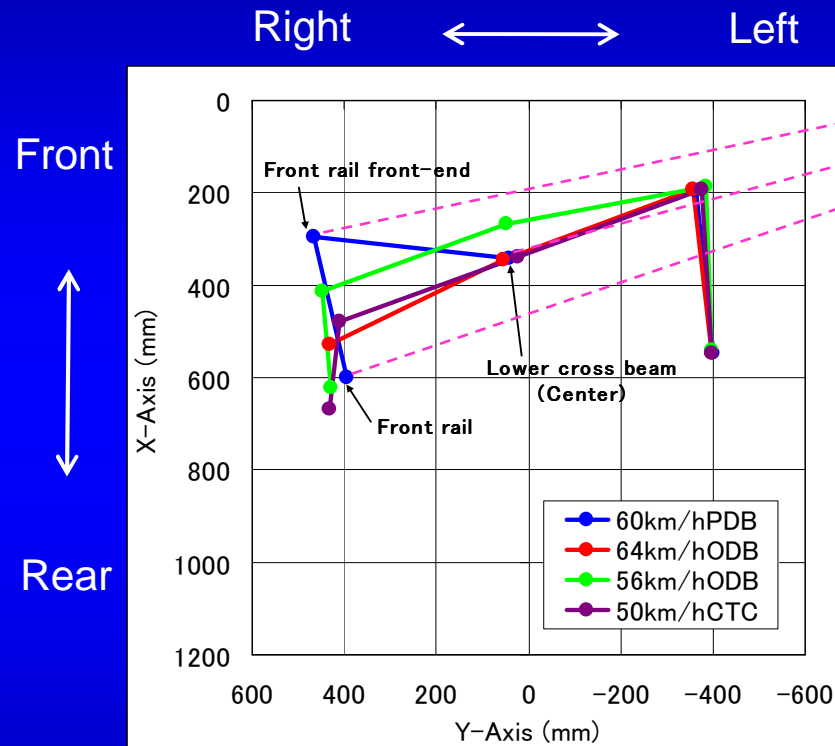
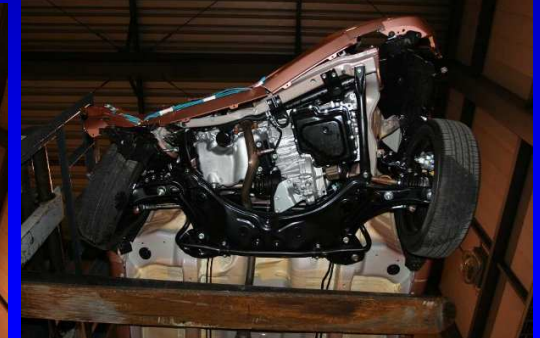
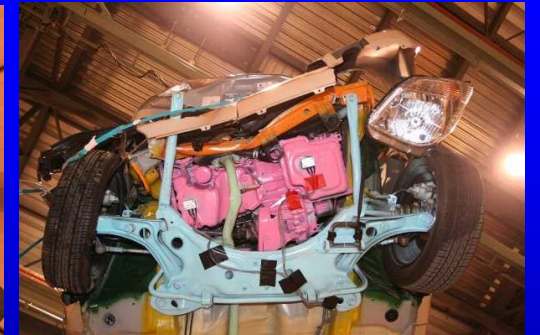
- 64ODB and 50CTC showed similar deformation modes.
- While the deformation in 56ODB was smaller than 64ODB and 50CTC, its deformation mode was similar to theirs.
- Only 60PDB showed the deformation mode that differed from the other three tests: The front rail was not deformed in the axial direction, and its front-end was deformed to the₁₂ outside of the vehicle.

- In Mini-Car B, the mode of the vehicle deformation was similar between ODB and CTC, but only mode of the vehicle deformation in PDB was different.
- Significant differences were seen in the deformation of the front rail between PDB versus ODB and CTC. Deformation in 60PDB was extremely smaller than that in 56 & 64 ODB and 50CTC.

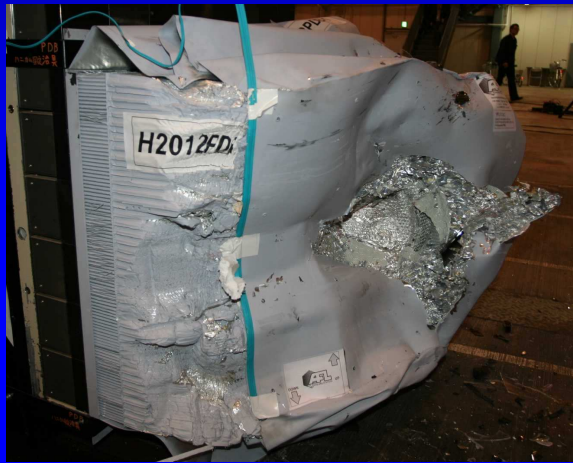
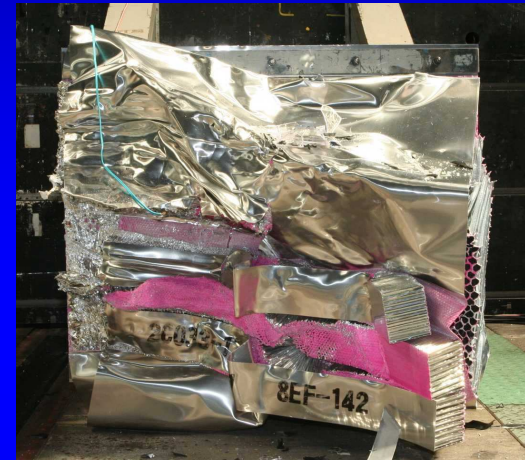
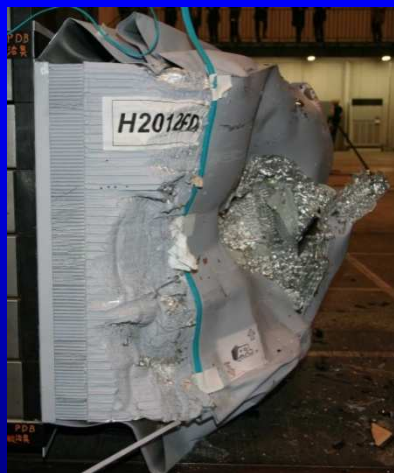
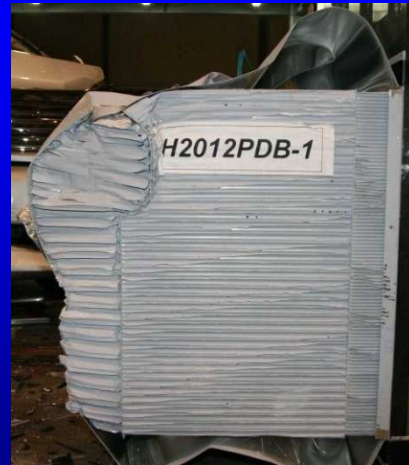
Minivan

- The front plate broke wide open.
- Deformation reached the right edge of the barrier.

- The honeycomb bottomed out completely.

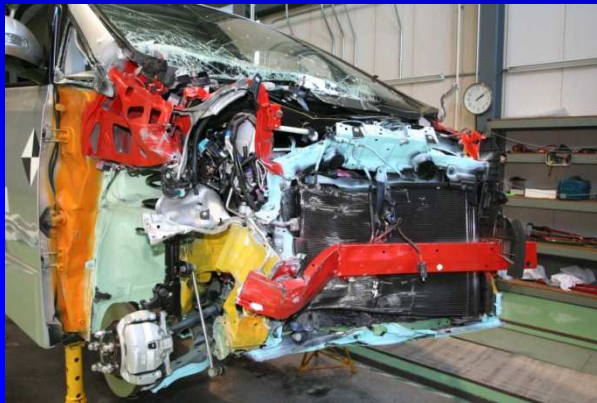
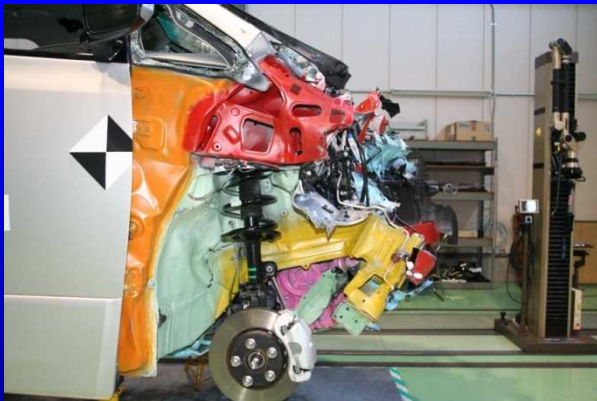
60PDB

- The front rail was slightly deformed; only its end was deformed downward.
- The sub-frame was bent significantly.

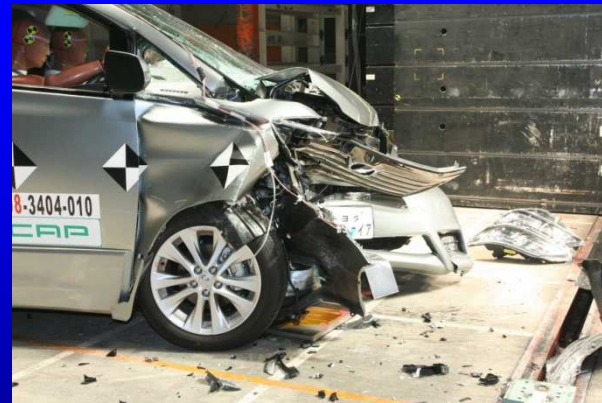
640DB (EEVC Barrier)

- The front rail was deformed.

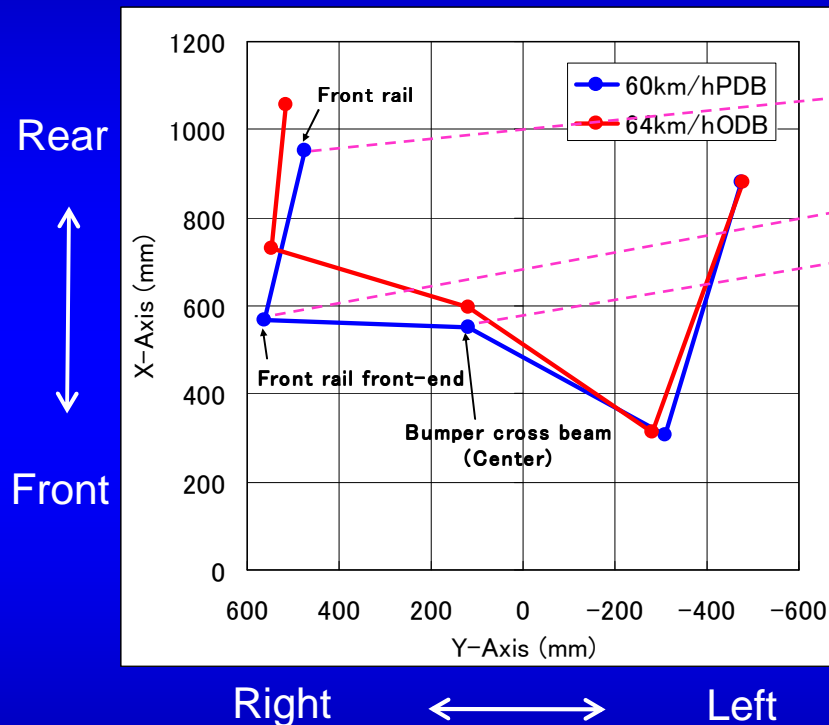
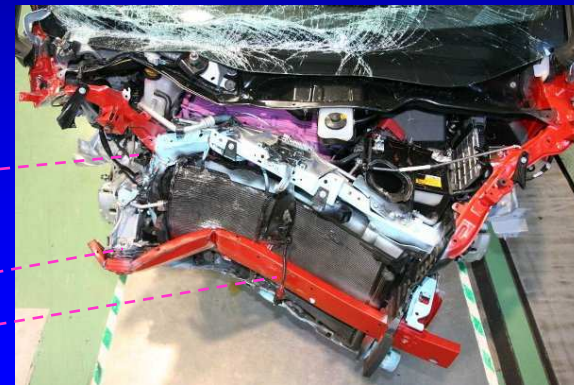
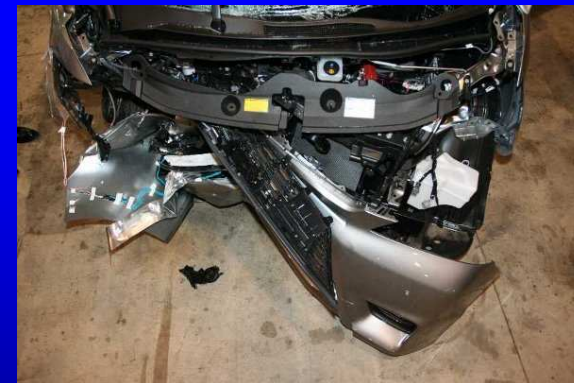
- In both 60PDB and 64ODB, the front rail front-end was deformed to the right of the vehicle.
- In 60PDB, due to the part of the front rail left undeformed, the deformation of the bumper cross beam was larger around its center.
- In 64ODB, the front rail was deformed in the axial direction, and the deformation of the bumper cross beam was larger at its right outer edge.

- Overall, the vehicle deformation of Minivan tended to be larger in 64ODB than in 60PDB.

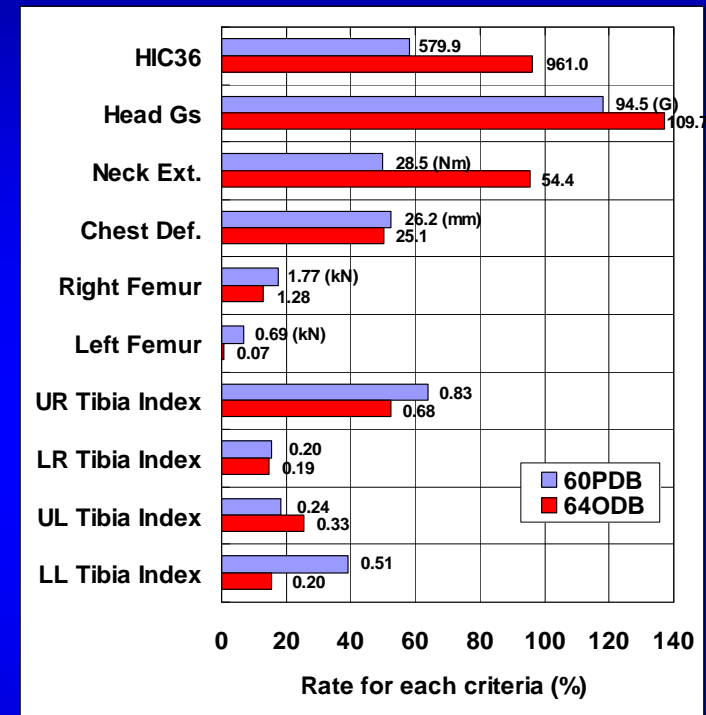
Passenger

- 64ODB showed higher levels for Head and Neck.
- No significant difference was observed between the two tests for Chest and Legs.
- The Head Gs criterion was exceeded in both tests.

- **Dummy injury criteria:** In Mini-Cars, no significant difference was observed among 60PDB, 64ODB, and 50CTC for Chest and Legs (in Mini-Car B, the Head injury level tended to be higher in 60PDB than 64ODB, 56ODB, and 50CTC). The criteria were sufficiently met for all injury indices, except Head Gs of the passenger dummy in Mini-Car A.

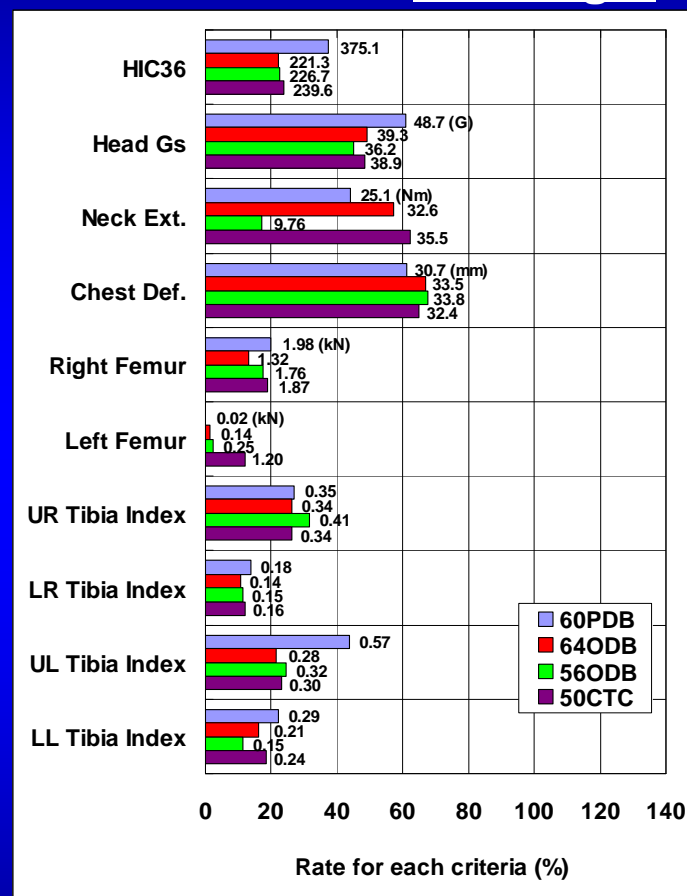
Passenger

- 60PDB showed the highest level for Head.
- Neck injury level was approximately same between 64ODB and 50CTC.
- No significant difference was observed among the four tests for Chest and Legs.
- The criteria were sufficiently met for all injury indices.

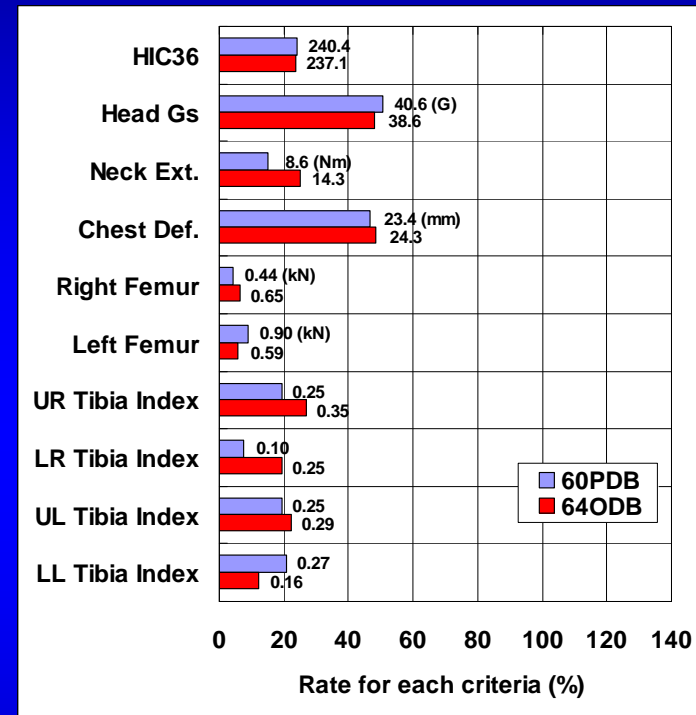
Passenger

- No significant difference was observed between the two tests for any injury index.
- The criteria were sufficiently met for all injury indices.

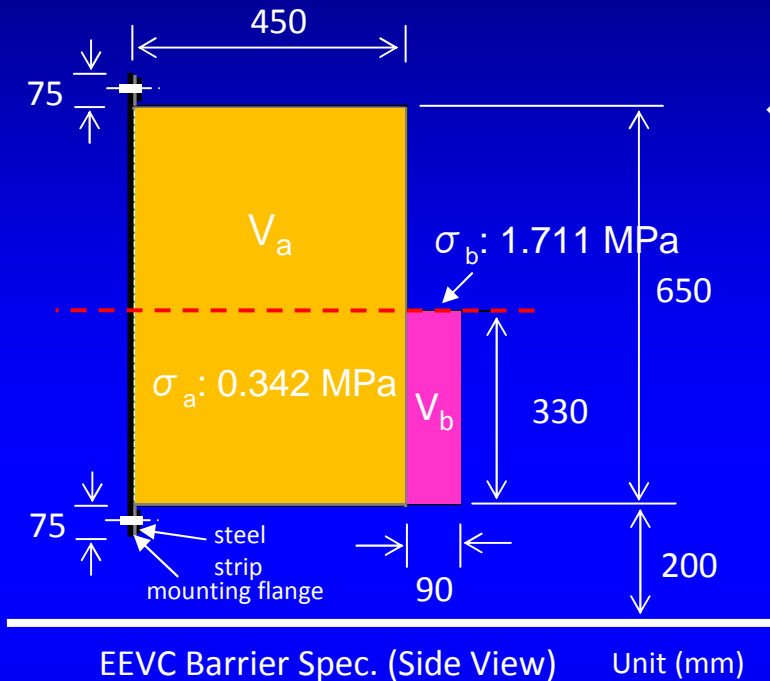
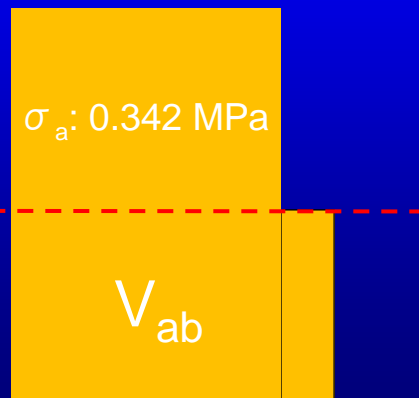
Calculation Method for EEVC Barrier Energy

- ◆ Energy (E) is calculated from deformation volume (V) and honeycomb stress (σ):

Equation for the true value of energy

$$E_{True} = V_a \times \sigma_a + V_b \times \sigma_b$$

Equation for energy used in this study

Due to difficulties in measuring the deformation volume separately for the main body and the bumper in the area below the red dotted line, the energy absorbed by the entire barrier was calculated simply as follows (the result is estimated to be slightly smaller than the true value):

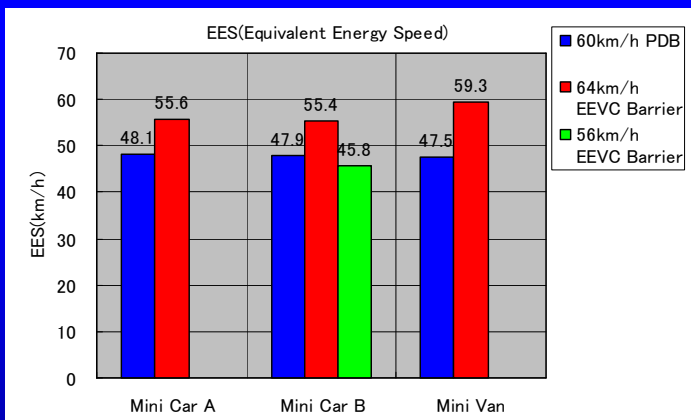
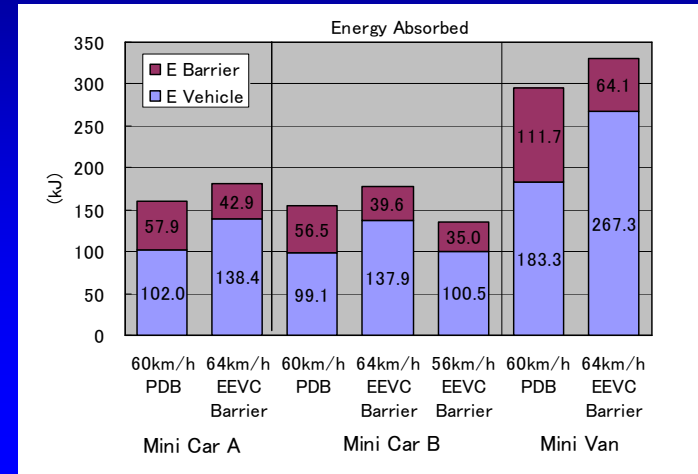
Vehicle Severity (EES)

Suppose the deformation energy of EEVC Barrier is 45kJ (UTAC Proposal) :

The deformation energy of EEVC Barrier was actually measured.

- 64ODB showed the highest EES.
- The EES in 60PDB was around the same level for Mini-Cars (light cars) and Minivan (heavy car).
- The EES in 64ODB was higher for Minivan than Mini-Cars. However, when the EEVC Barrier deformation energy was actually measured, the EES difference between Minivan and Mini-Cars was not as large as when it was calculated using the constant value of 45 kJ.

- The EES in 60PDB was around the same level for Mini-Cars and Minivan.
- The EES in 64ODB was higher for Minivan than Mini-Cars. However, when the EEVC Barrier deformation energy was actually measured, the EES difference between Minivan and Mini-Cars was not as large as when it was calculated using the constant value of 45 kJ.

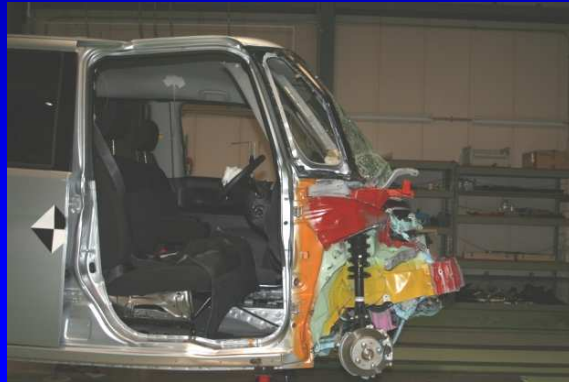
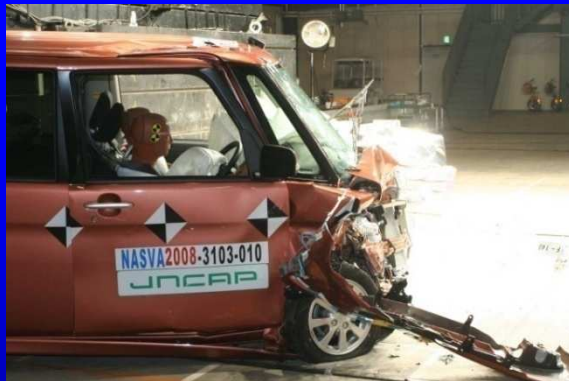
- There were big differences in the deformation of the front rail. In 60PDB, the front rail was deformed very slightly.
- The intrusion into the upper part of the cabin (instrument panel, A-pillar, etc.) tended to be large in 60PDB, while that into the lower part of the cabin (toe board, etc.) tended to be large in 64ODB.

- Overall, the vehicle deformation of Mini-Cars tended to be larger in 64ODB and 50CTC than in 60PDB (the intrusion into the lower part of the cabin [brake pedal and toe board, etc.] tended to be large in 64ODB and 50CTC).

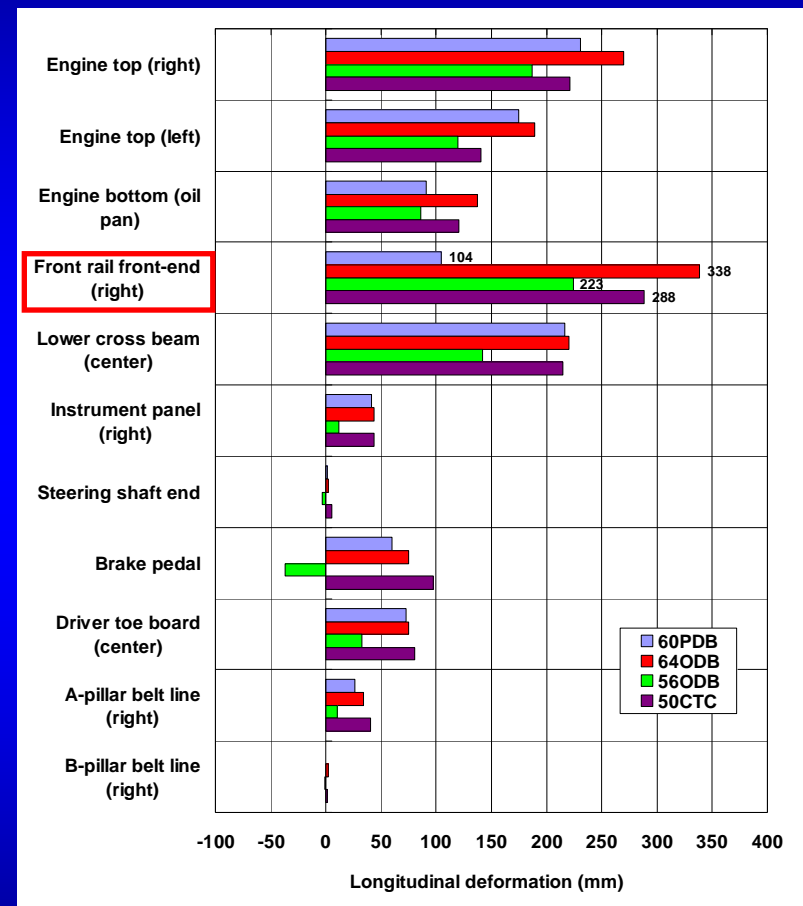
- Overall, vehicle deformation in 64ODB tended to be large.
- 60PDB showed the smallest deformation of the front rail.

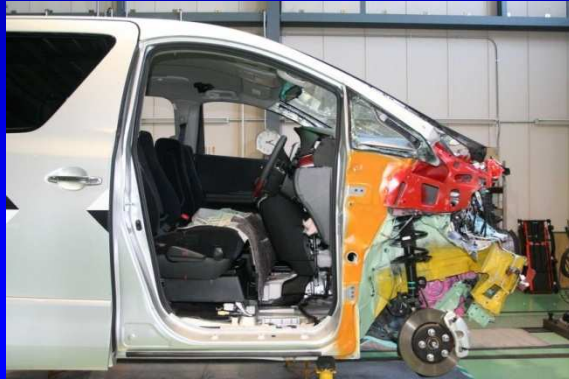
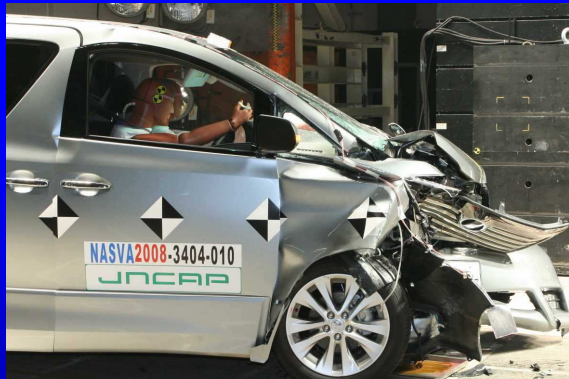
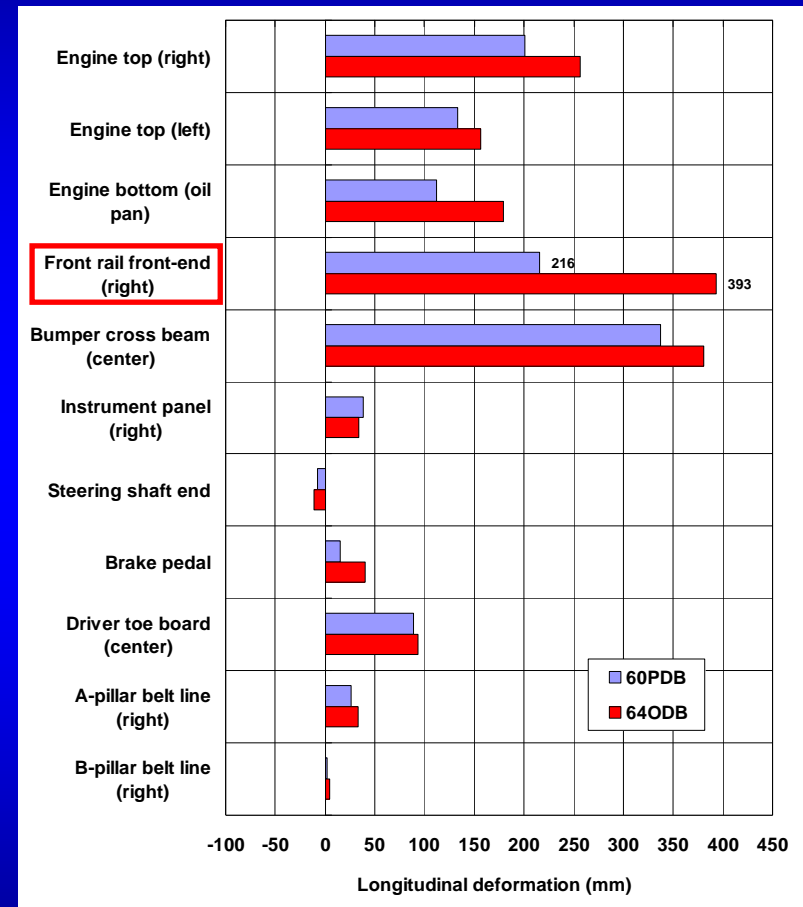
- Large difference in the deformation of the front rail: Smaller in 60PDB.
- Overall, vehicle deformation tended to be small in 60PDB.
