**Outcome of the Joint Meeting RID/ADR/ADN – Transport in  
tanks of UN 0133 – Test reports**

### Evaluation of the behaviour of ammonium nitrate emulsion in a modified vented pipe test in an aluminium container\*)

### Evaluation of the behaviour of Andex LD in a modified vented pipe test with a steel pipe \*)

### Evaluation of the behaviour of Andex LD in a modified vented pipe test in an aluminium container\*)

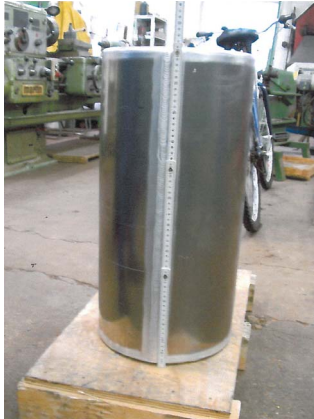
III. 1  
Aluminium container

An aluminium container with an external diameter of 310mm and external height of 600mm was used instead of a steel container. The opening in the lid had a diameter of 75mm. The container had a wall (and lid and bottom) thickness of 5mm. The container was made from an aluminium sheet and had a longitudinal weld joint of the same quality as aluminium transport tanks. The bottom and the lid were welded on with the same quality.

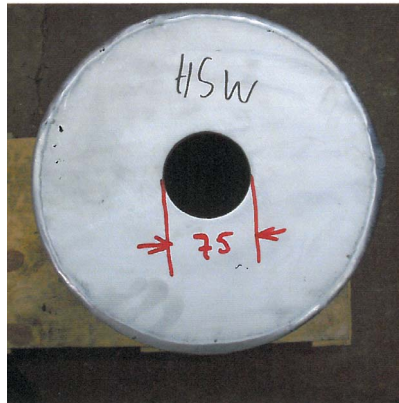
III. 2  
Lid

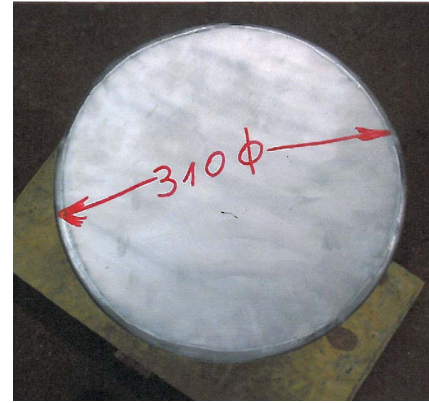
III. 3  
Bottom

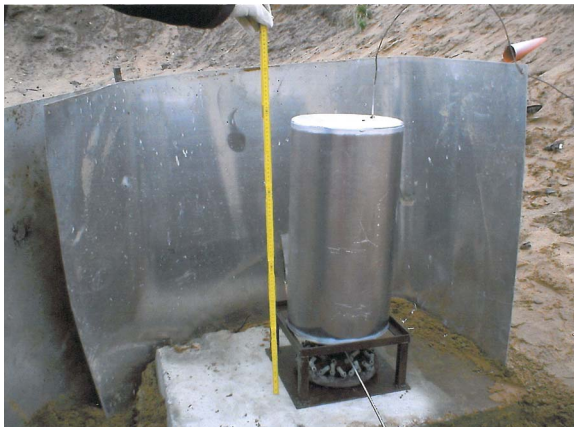
III. 4  
Test set-up

The container was filled with 23.3kg of test substance, reaching a height of 450mm.

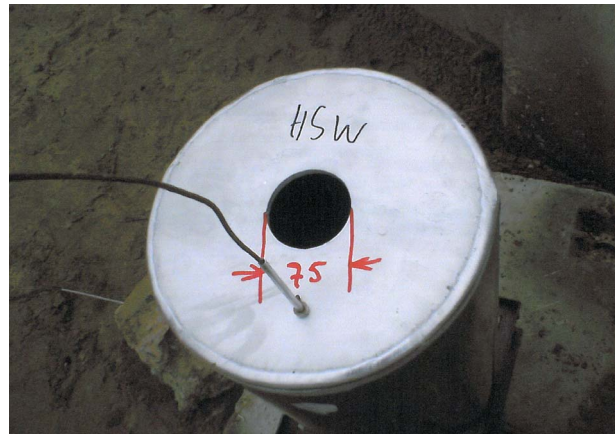
III. 5  
Thermo-element for measuring the inside temperature

The temperature was measured with thermo-elements in the container approx. 80mm above the bottom and in the gas flame under the container and was recorded.

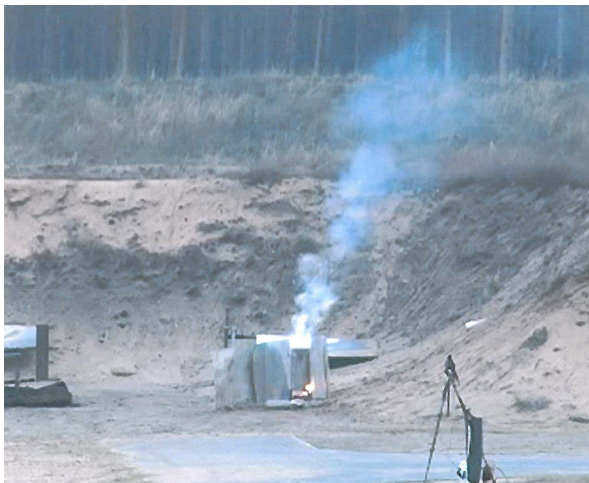
III. 6  
Initial flames

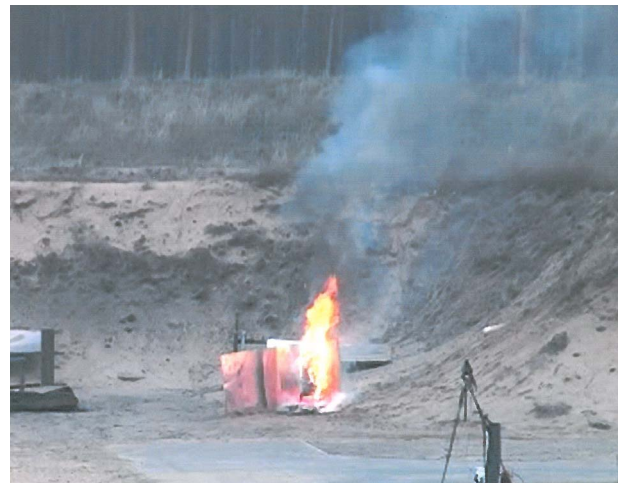
III. 7  
Ejection of burning substance

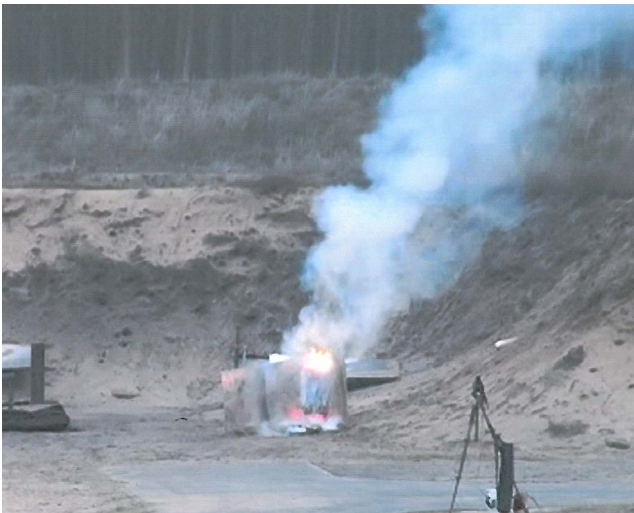
III. 8  
Ejection of non-burning substance

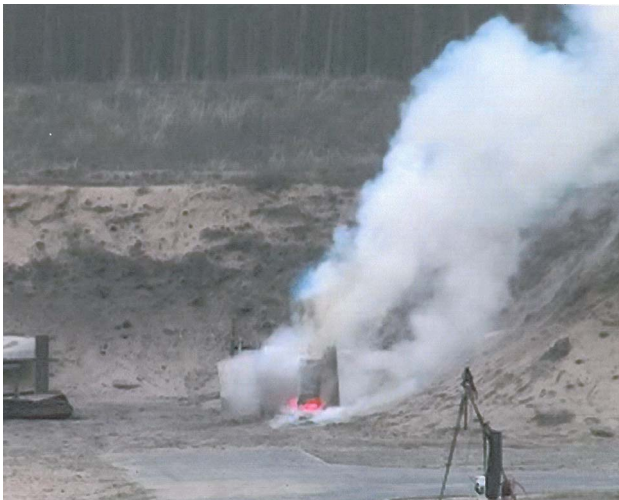
III. 9  
Discharge of non-burning substance

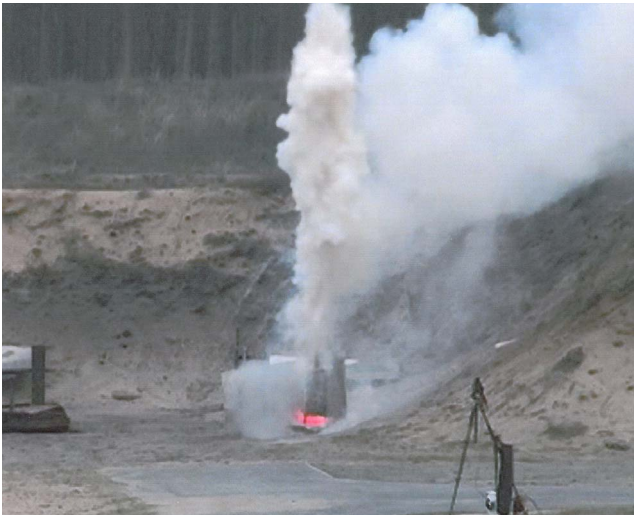
III. 9  
Last strong discharge

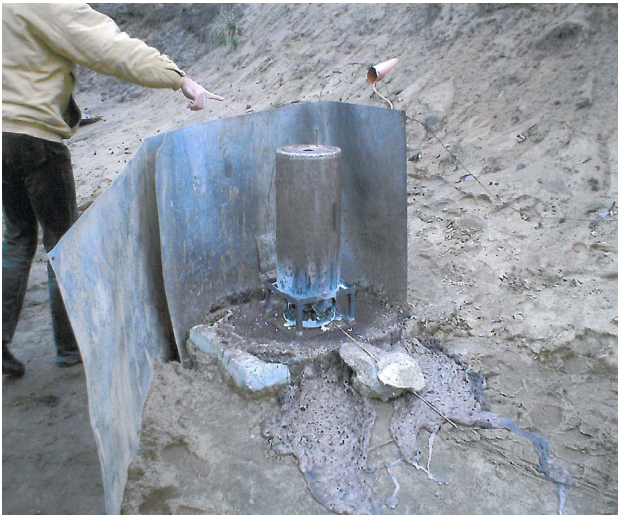
III. 10  
Test set-up after completion of the test

After the test, it was found that the bottom of the container was torn open and partially melted. There was little solidified substance or ash from burned substance found beside the test set-up.

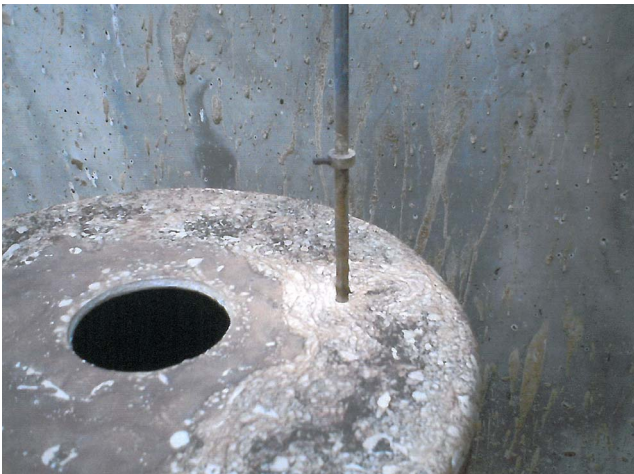
III. 11  
Lid with thermo-element

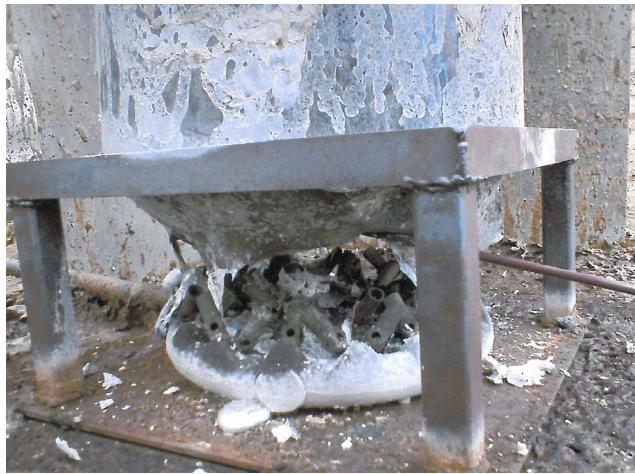
III. 12  
Bottom torn open

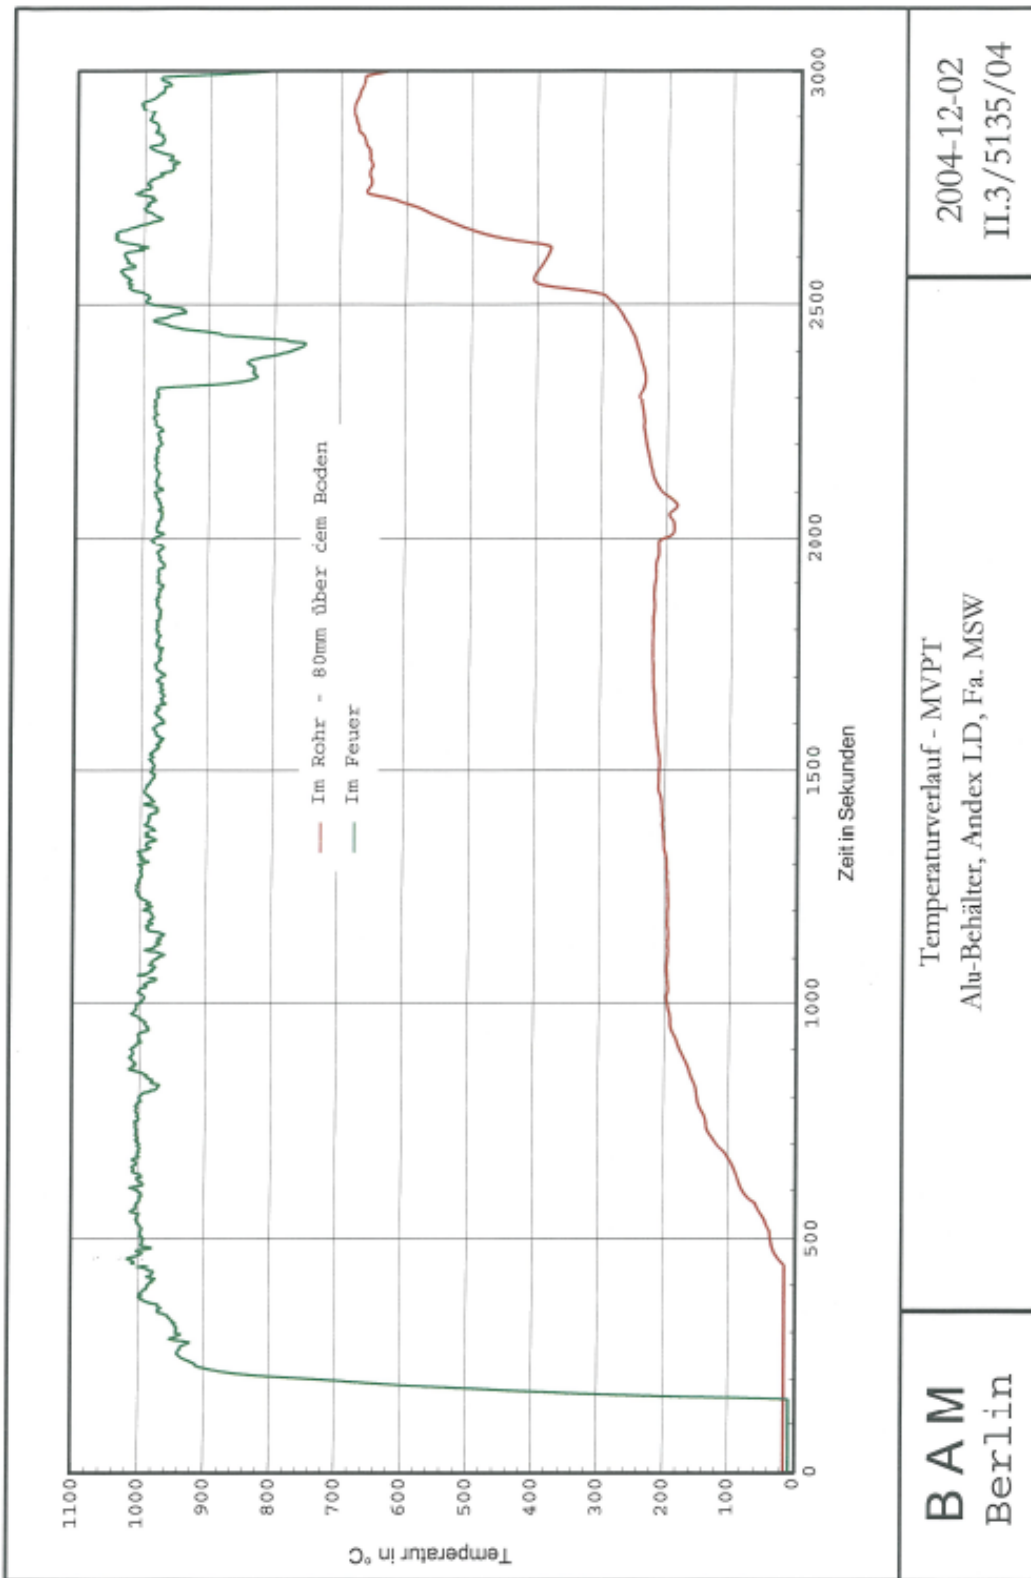
Temperaturverlauf - MVPT  
Alu-Behälter, Andex LD, Fa. MSW

| “Im Rohr - 80mm über dem Boden” | > | In the pipe - 80mm above the container bottom |
| “Im Feuer” | > | In the fire |
| “Zeit in Sekunden” | > | Time in seconds |
| “Temperaturverlauf - MVPT” | > | Temperature progression - MVPT |

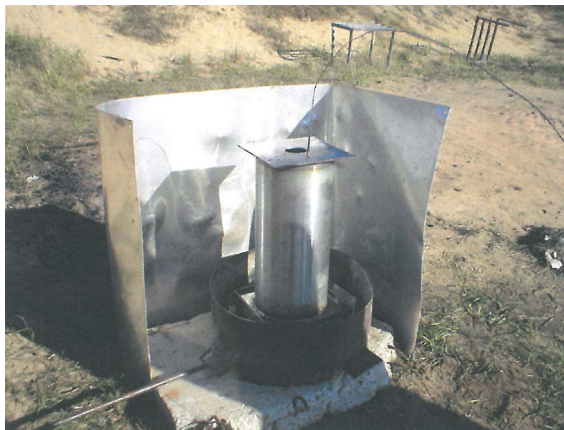
III. 1

Test set-up

The steel pipe was 580mm high and had a wall thickness of 5mm. The bottom and the lid were made of 6mm-thick steel sheet and were welded on using a fillet weld.

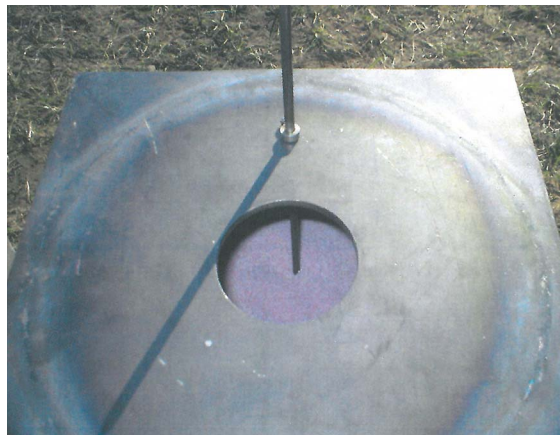
III. 2

Lid of the filled pipe

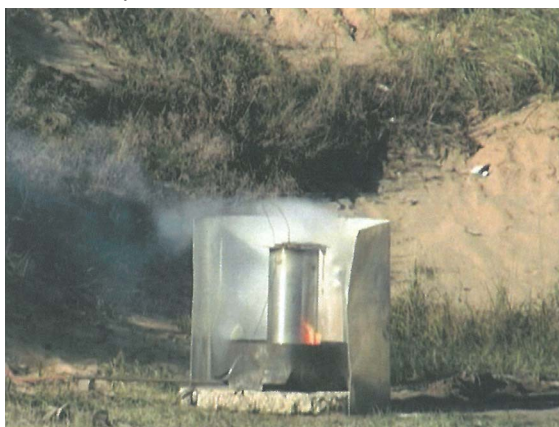
III. 3

First melted substance runs over

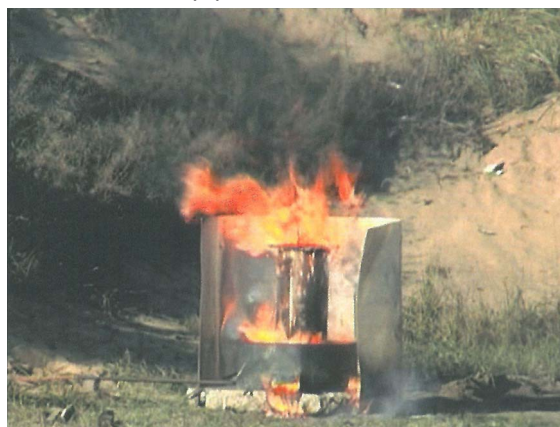
III. 4

Burning melted substance at the top and bottom

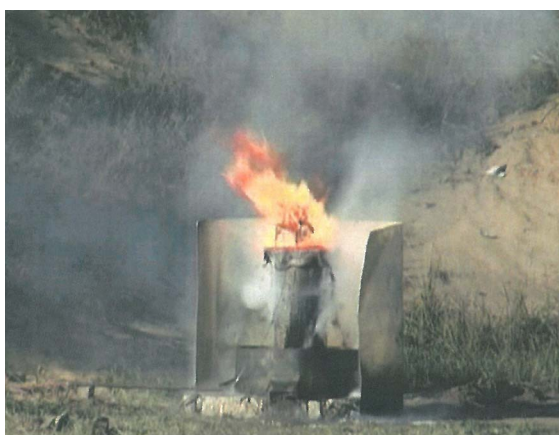
III. 5

Ejected melted substance, burning

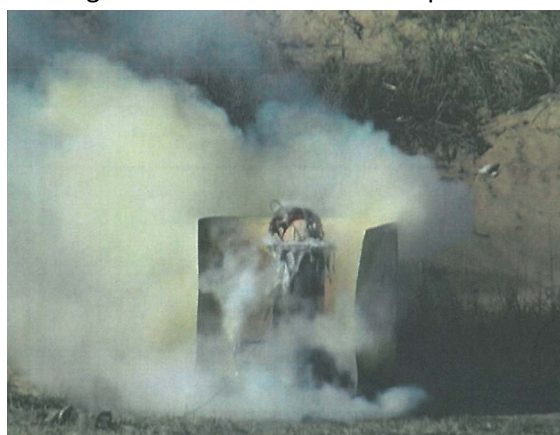
III. 6

Ejected melted substance, decomposition products

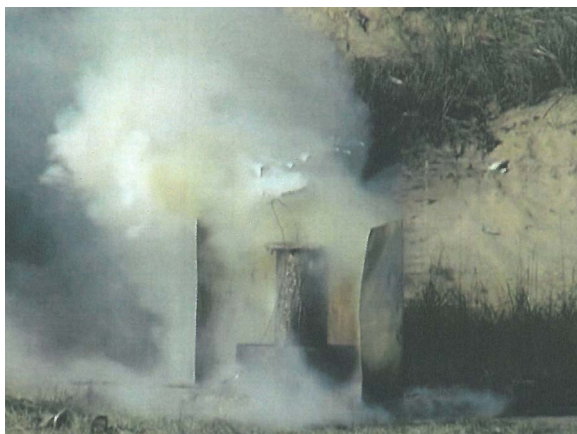
III. 7  
Ejected melted substance, decomposing

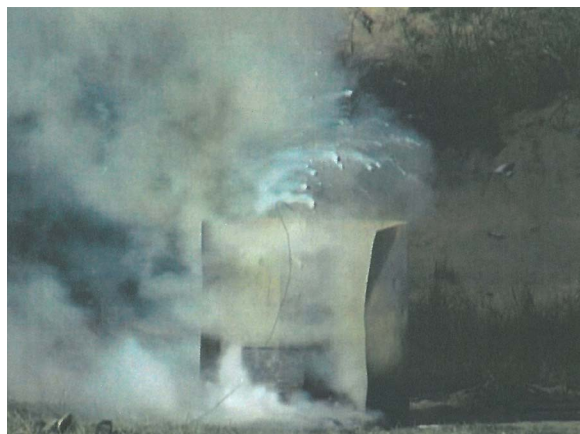
III. 8  
Ejected melted substance, decomposing

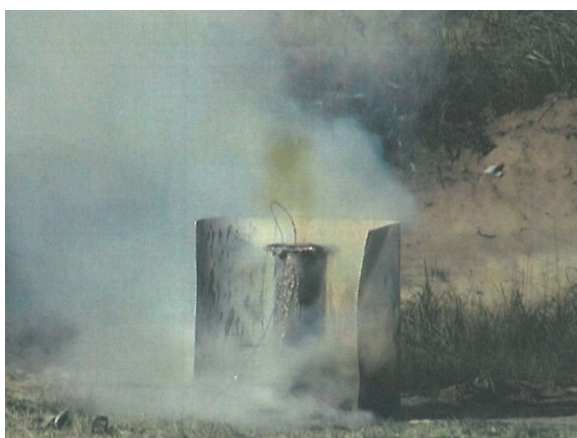
III. 9  
Discharge of nitrous gases

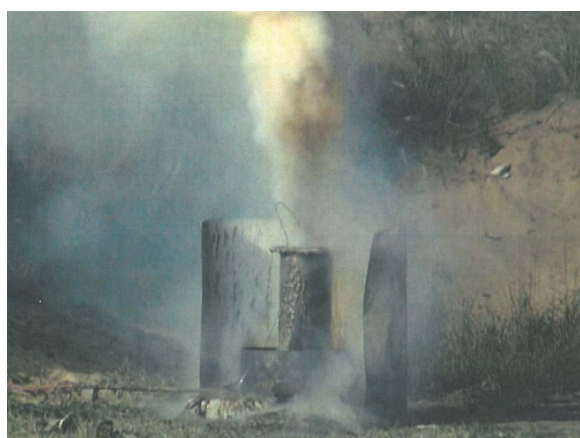
III. 10  
Last strong smoke discharge

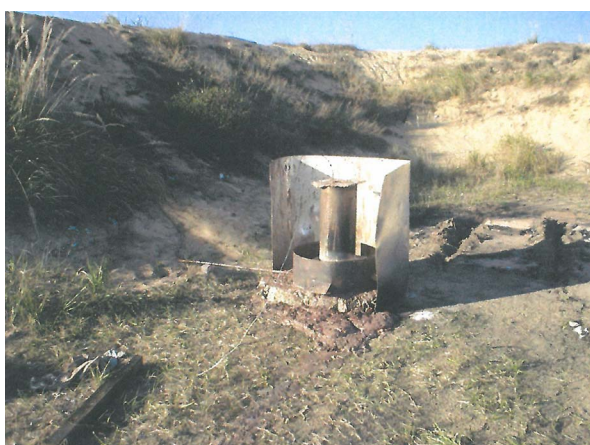
III. 11  
Test set-up after the test

The pipe was empty after the test. The pipe, with its bottom and lid, was undamaged. Ash from burned substance and solidified melted substance were to be found beside the test set-up.

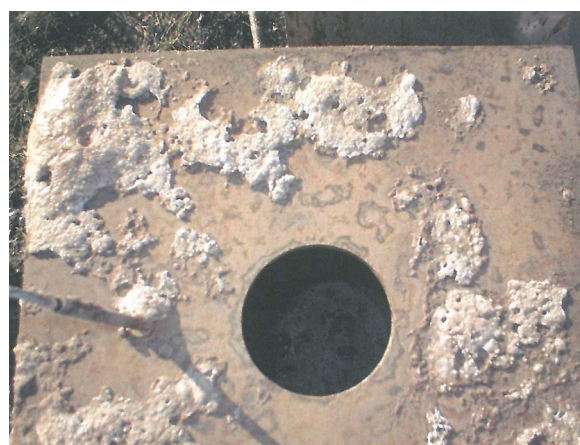
III. 12  
Lid

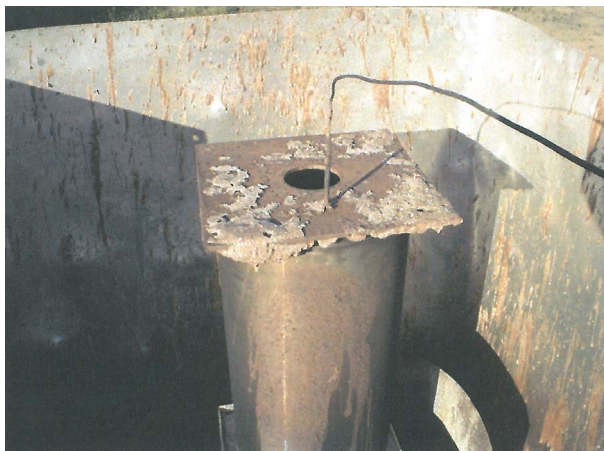
III. 13  
Lid and wind guard with left-over substance at  
the bottom of the test set-up

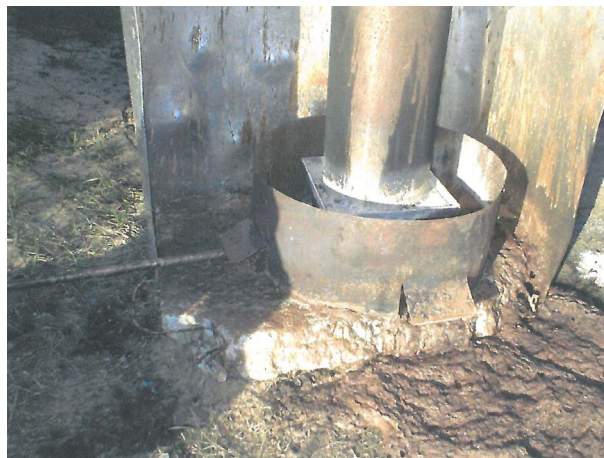
III. 14  
Cinders (combustion product)

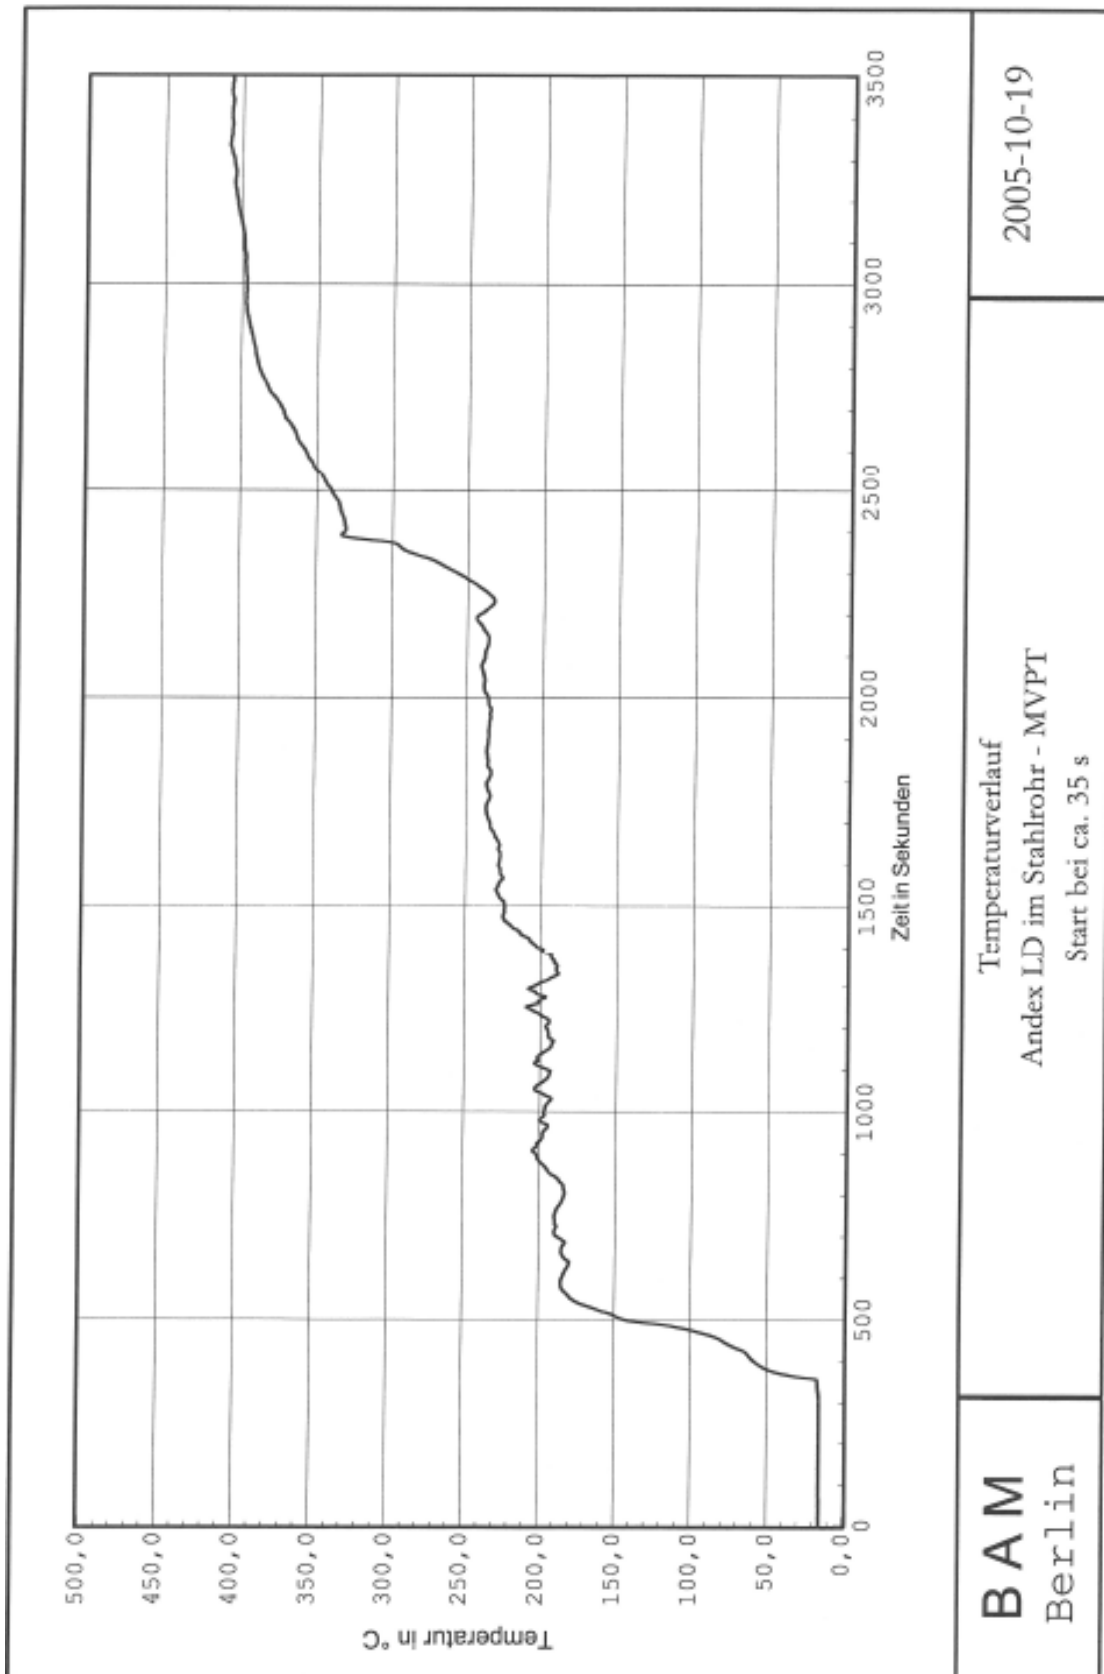
Temperaturverlauf  
Andex LD im Stahlrohr - MVPT  
Start bei ca. 35 s

- "Zeit in Sekunden" > Time in seconds
- "Andex LD im Stahlrohr - MVPT" > Andex LD in a steel pipe - MVPT
- "Start bei ca. 35s" > Start at approx. 35 seconds.

The temperature was measured with a thermo-element in the pipe approx. 80mm above the bottom of the pipe and was recorded.

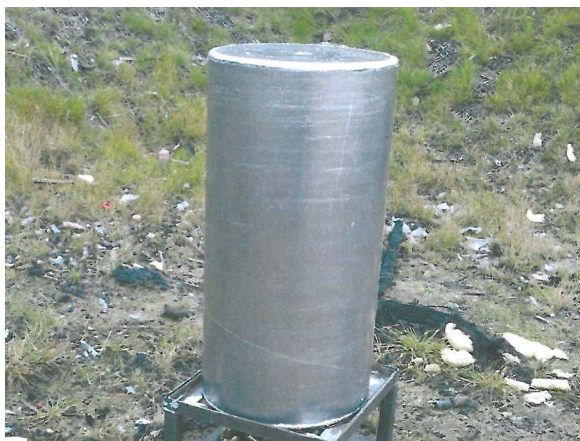
III. 1  
Aluminium container

An aluminium container with an external diameter of 310mm and external height of 600mm was used instead of a steel container. The opening in the lid had a diameter of 26.3mm. The container had a wall (and lid and bottom) thickness of 5mm. The container was made from an aluminium sheet and had a longitudinal weld joint of the same quality as in aluminium transport tanks. The bottom and the lid were welded on with the same quality.

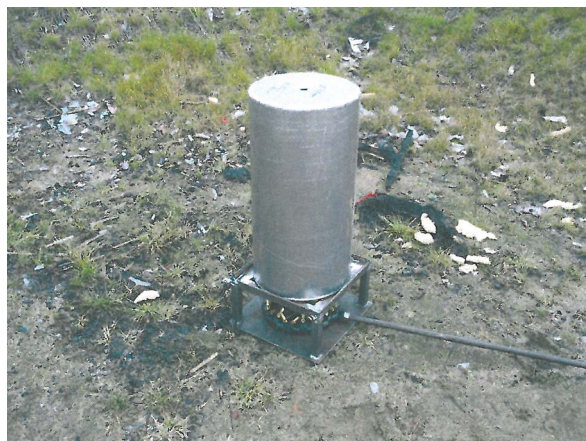
III. 2  
Test set-up

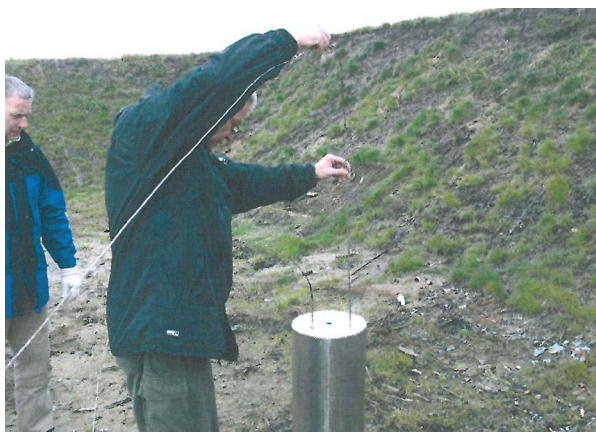
III. 3  
Insertion of the thermo-elements to  
measure the temperature inside

The temperature was measured with 3 thermo-elements in the container approx. 5, 22 and 51,5cm above the bottom of the container and was recorded.

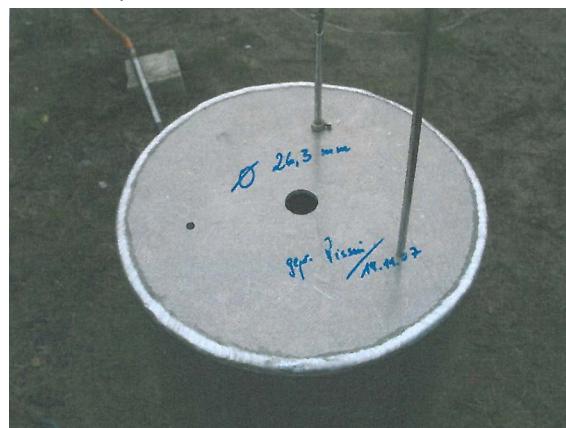
III. 4  
Lid

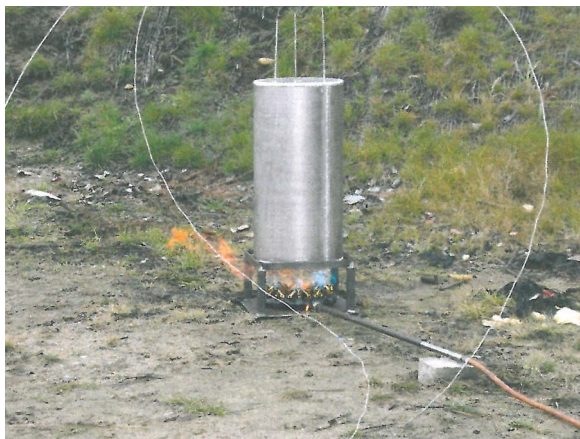
III. 5  
Ignition of the gas flame

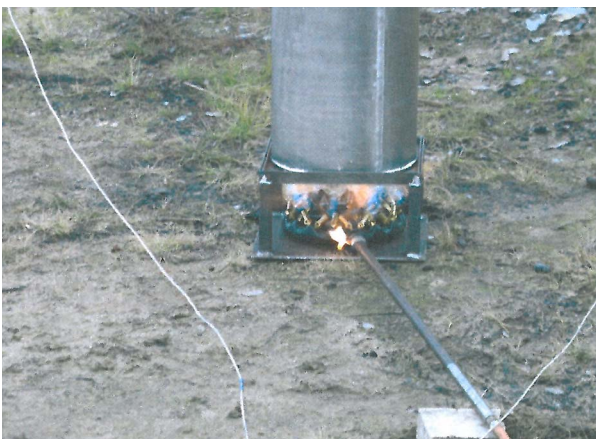
III. 6  
Propane burner

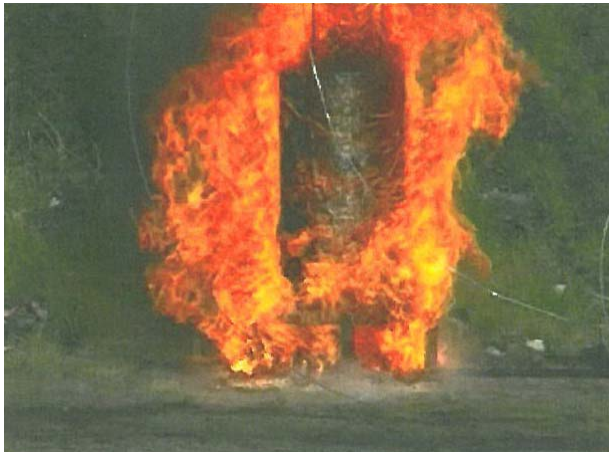
III. 7  
Overflowing combusted substance

| Occurrences/Observations: | Time in minutes | Time in seconds |
|---|---|---|
| Melted substance runs out of the opening over the edge and is combusted. | 44 | 2640 |

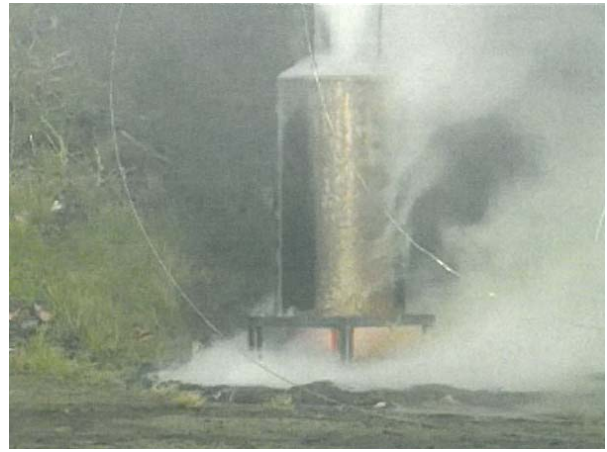
III. 8  
Strong smoke discharge from the opening

| Occurrences/Observations: | Time in minutes | Time in seconds |
|---|---|---|
| Strong smoke emission from the opening together with ejection of melted substance | 47 | 2820 |

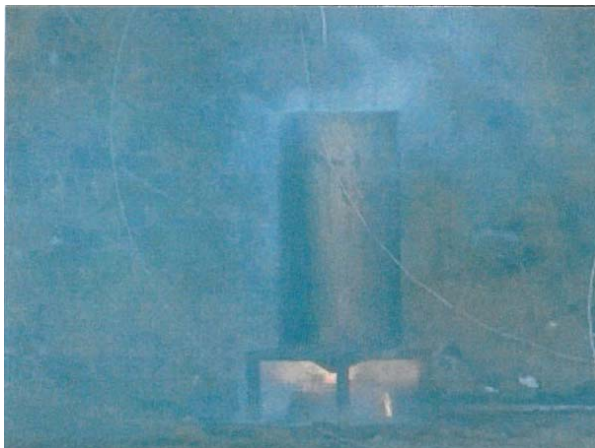
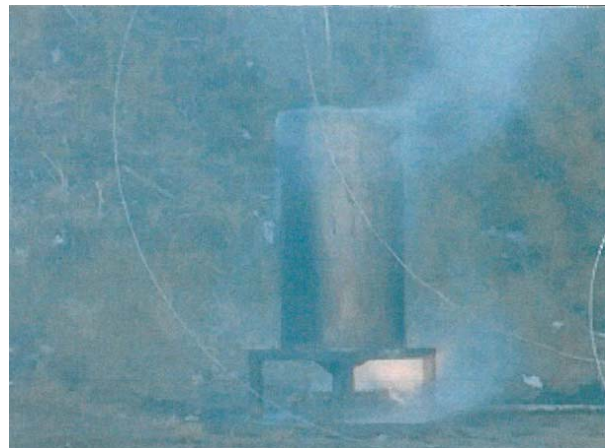
III. 9  
The bottom of the container bulges

III. 10  
The bottom of the container bulges

| Occurrences/Observations: | Time in minutes | Time in seconds |
|---|---|---|
| The bottom of the container bulges | 53 | 3180 |

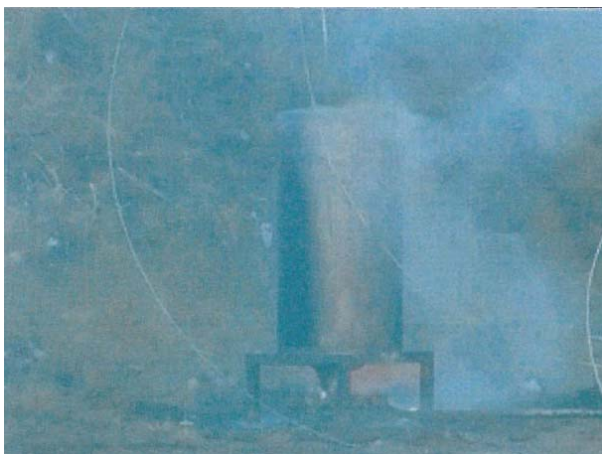
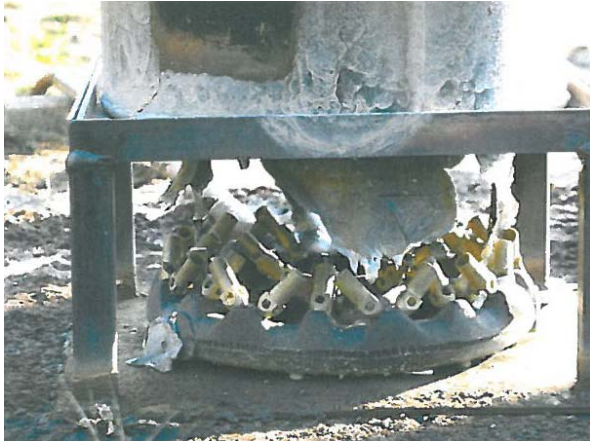
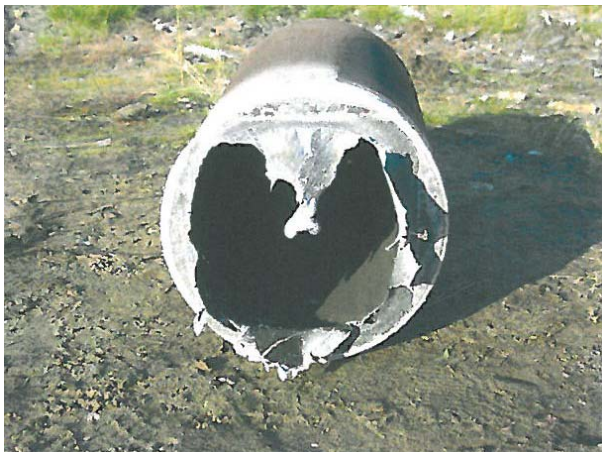
III. 11  
Opened container bottom

III. 13  
Opened container bottom

III. 15  
Opened container bottom

| Occurrences/Observations: | Time in minutes | Time in seconds |
|---|---|---|
| The bottom of the container opens | 53:30 | 3210 |

The bottom of the container was partially melted after the test. Ash from burned substance and solidified melted substance were to be found beside the test set-up.

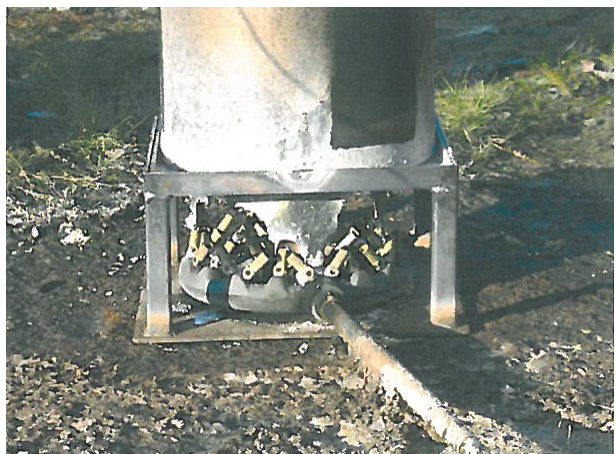
III. 12  
Container after the test

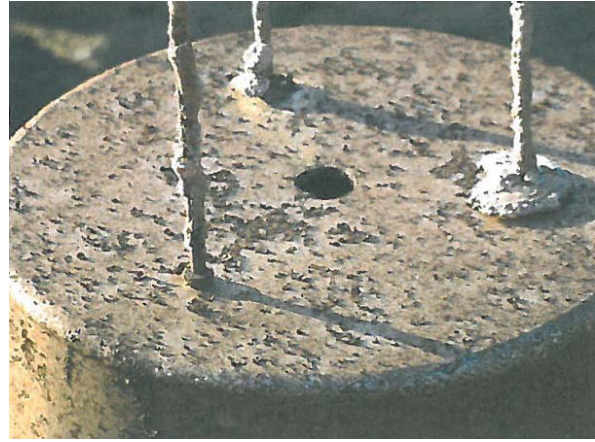
III. 14  
Lid following the test

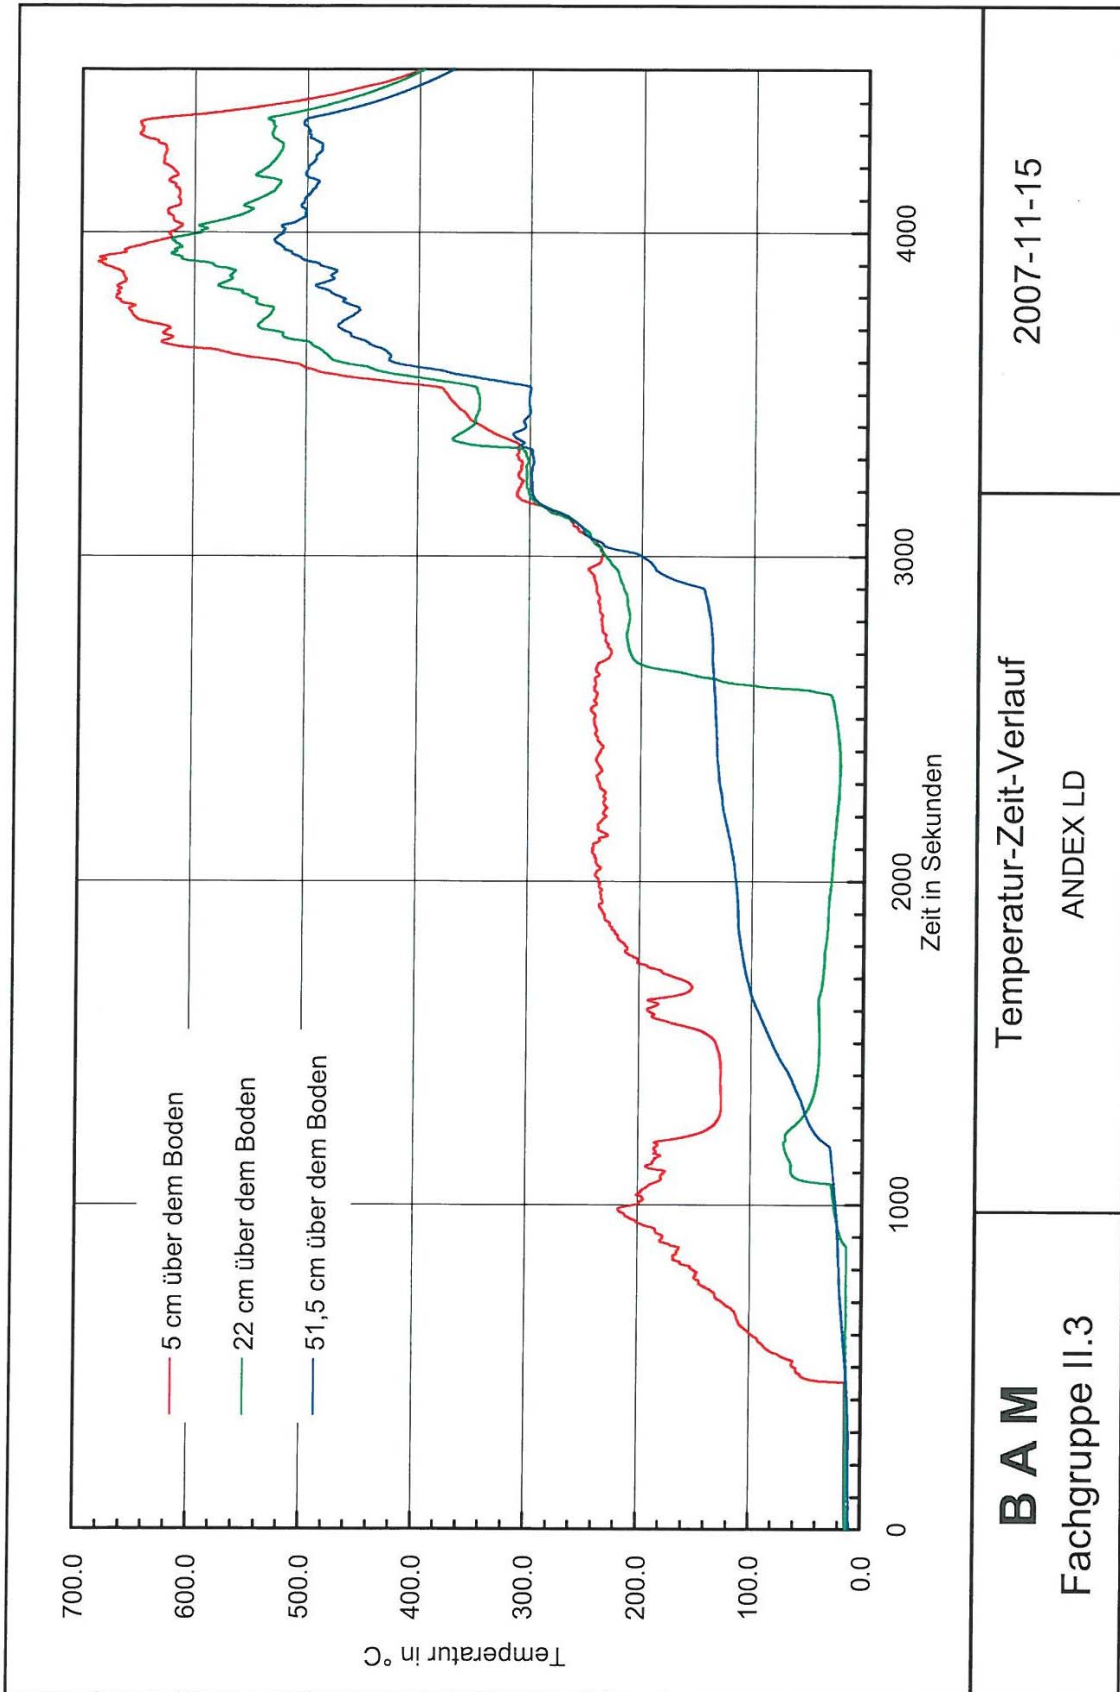
Temperatur-Zeit-Verlauf  
 ANDEX LD

- “über dem Boden” > From the bottom of the container
- “Zeit in Sekunden” > Time in seconds
- “Temperatur-Zeit-Verlauf” > Temperature progression over time
- “Fachgruppe II.3” > Division II.3
