Tanks: United Kingdom experience with improperly manufactured and wrongly certificated road tank vehicles

Presentation on Petroleum road fuel tankers: construction issues and research into tanker integrity

Transmitted by the Government of United Kingdom

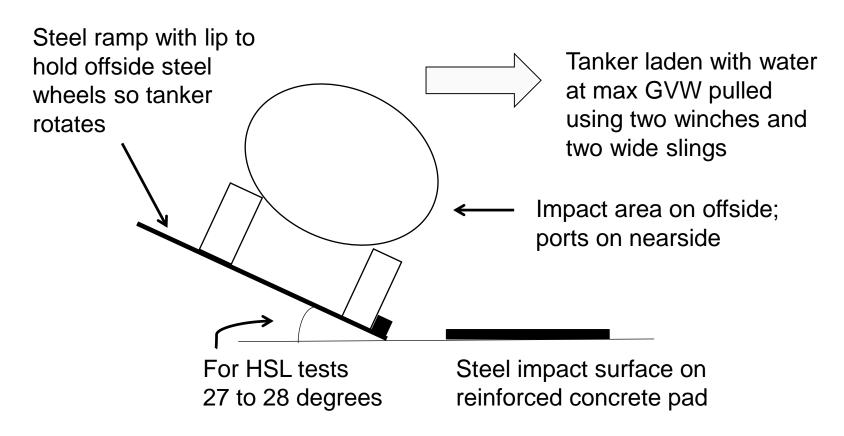
Full Scale Testing and Modelling (4)

Position tanker on point of instability and nudge

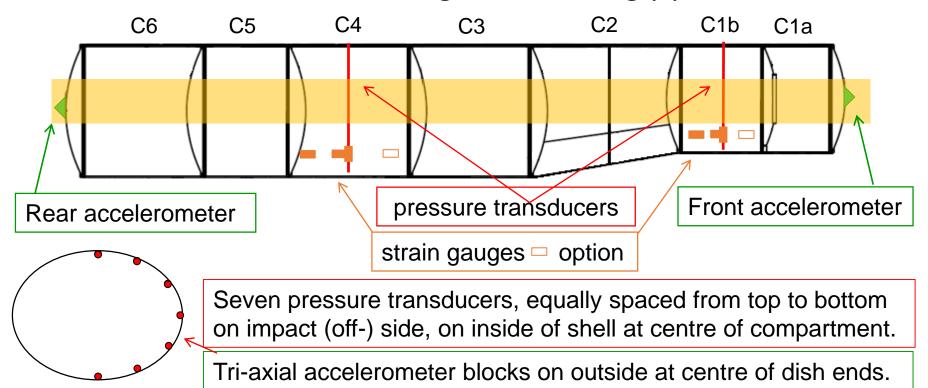
Full Scale Testing and Modelling (5)

Strain gauges with matching positions on inside and outside of shell. Both tests: longitudinal strain near rear bulkhead, longitudinal and hoop strain at compartment centre. Option: 2011 - longitudinal strain near front baffle/bulkhead of C1b/C4.

Instrumentation – offside – 50,000 samples per second – one every 0.02 ms

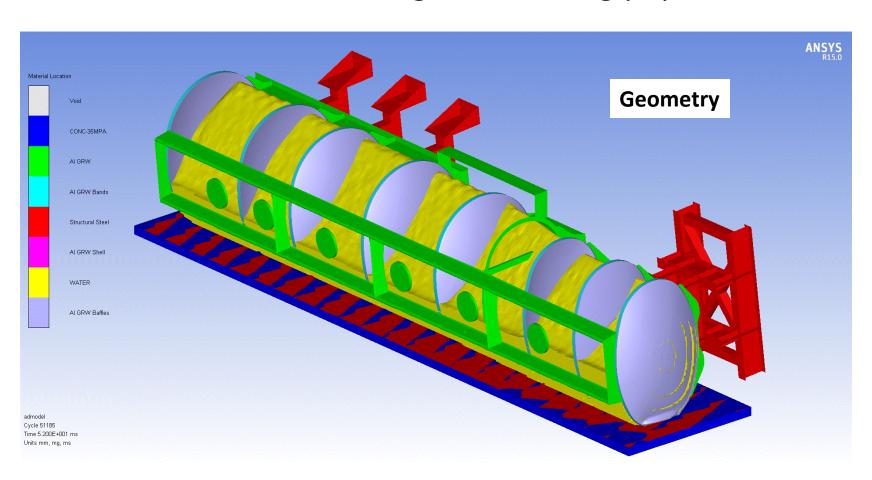
Full Scale Testing and Modelling (19)

- Deflections, pressures, and bending stresses agreed reasonably well at most important locations with those measured in the tests (within 3 - 5%)
- Highest strains commensurate with failure correlate with leaks from impact damage at end dish joint in both topple tests, and with through-wall crack on 2008 tanker, all at top of impact zone

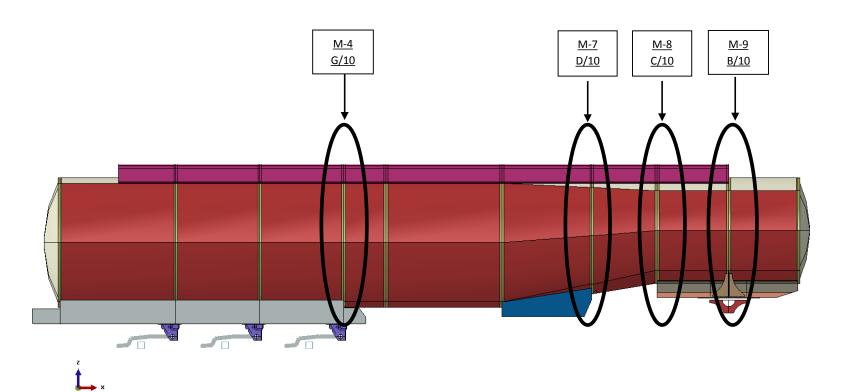
Strain gauge locations for fatigue data collection

- Tanker driven for 5 hours empty
 - 80 miles A road and 70 miles B road
- Tanker driven for 5 hours laden
 - Equivalent mass of water
 - 80 miles A road and 70 miles B road
- Figure-of-eight manoeuvres and emergency stop tests
- Filling and emptying recorded
- Corresponding tachograph, GPS and telematics data provided by operator
- Annual duty cycle constructed 220,000km per year, Class A/B roads, 6 fill/empty cycles per day
- · Stress range histograms generated for most severely stressed locations on tanker

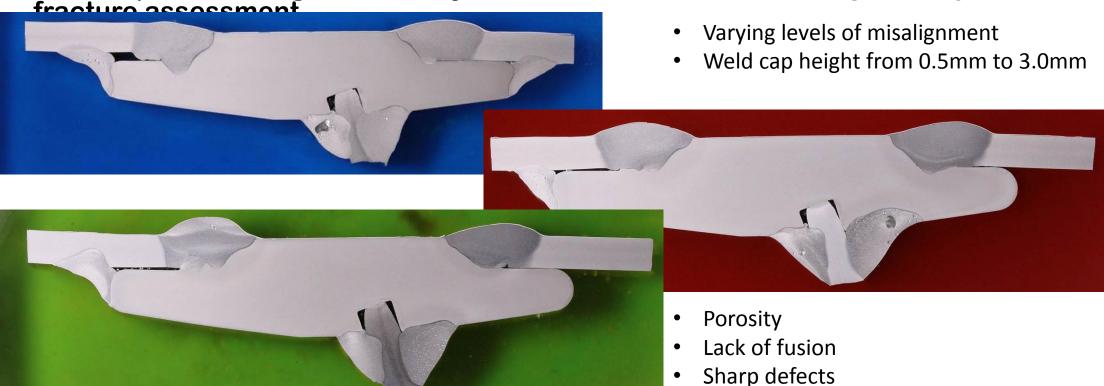
Multiple samples taken from weld metal and tanker shell from various locations around various tankers and tested to determine tensile properties and fracture toughness

• Weld cap and misalignment study used to understand effect of geometry on

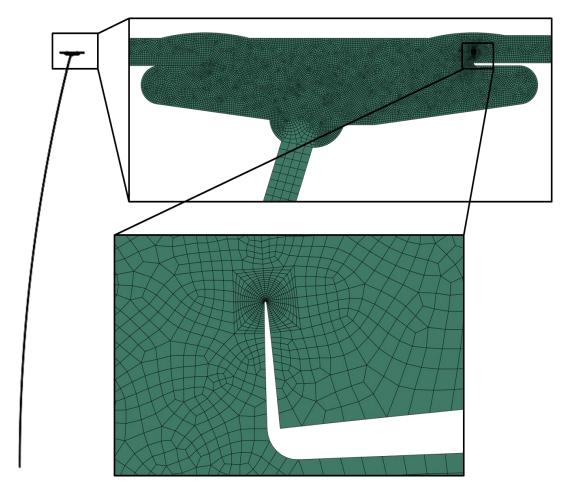
Typical Finite Element Mesh

- Maximum acceptable defect size (aka critical crack size) determined for different weld cap and misalignment geometries under fatigue stresses, applied stresses – based on ADR 6.8.2.1.2 and rollover loads – and welding residual stresses (simulated from GRW welding procedure specification)

- **Under normal service conditions** the cradle positions above the fifth wheel coupling and above the front of the rear longitudinal support members are most susceptible to fatigue crack growth

- Minimum critical defect height is greater than 2.0 mm and may be 4.0 mm or more depending on presence of an internal fillet weld, magnitude of misalignment and size of weld cap

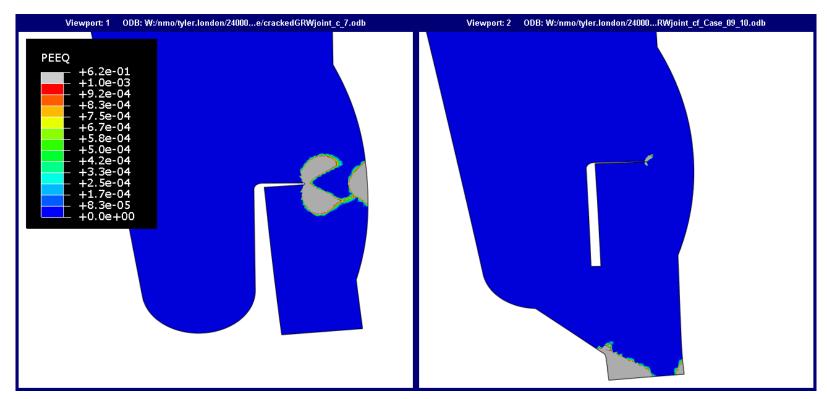
Effect of suitable internal fillet weld

Fillet weld <u>not</u> present:

- Collapse in section containing crack
- "Local collapse"
- Strength depends on geometry

- Under rollover conditions, critical defect height for a weld of "average" geometry is 1.1 mm when no internal fillet weld is present
- Agrees well with experimental observation of through-wall rupture of circumferential weld resulting from lack of fusion defect 1.0 mm deep and longer than 230 mm in a 2008 tanker
